Technical Service Bulletin

SUBJECT: STARTER DOES NOT ENGAGE WHEN TURNING IGNITION KEY / CHECK ENGINE LIGHT ILLUMINATES DTC P0014 - REVISION			No: TSB-20-13-002REV
			DATE: November 2020
			MODEL: See Below
CIRCULATE TO:	<input type="checkbox"/> GENERAL MANAGER	<input checked="" type="checkbox"/> PARTS MANAGER	<input checked="" type="checkbox"/> TECHNICIAN
<input checked="" type="checkbox"/> SERVICE ADVISOR	<input checked="" type="checkbox"/> SERVICE MANAGER	<input checked="" type="checkbox"/> WARRANTY PROCESSOR	<input type="checkbox"/> SALES MANAGER

2018 - 2022 Eclipse Cross ◀

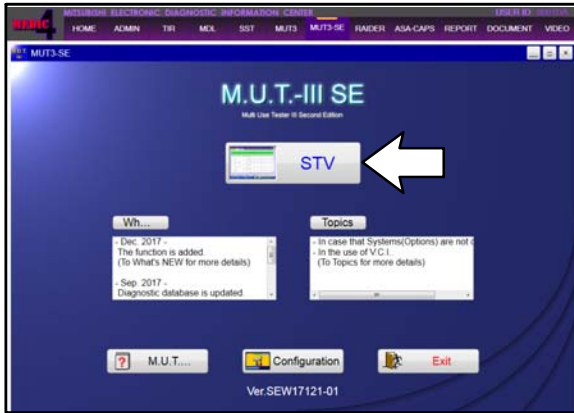
4. If the MEDIC update screen advises updates are available, click the "Begin" button. After all updates are complete, **GO TO THE REPROGRAMMING PROCEDURE.**
