Service Bulletin

Bulletin No.: 21-NA-086

Subject: Unintended Parking Brake Engagement

Brand:	Model:	Model Year:		VIN:		Engine:	Transmission:
		from	to	from	to		
Cadillac	XT4	2021	2021	—	—	—	—

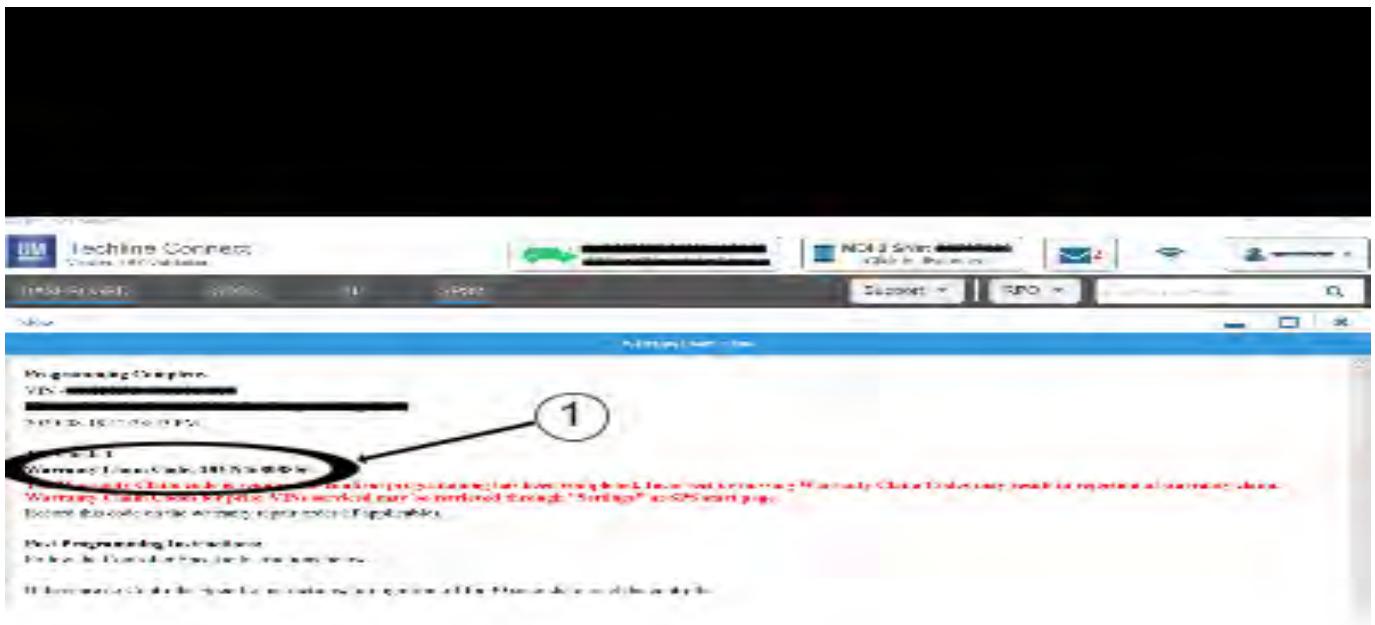
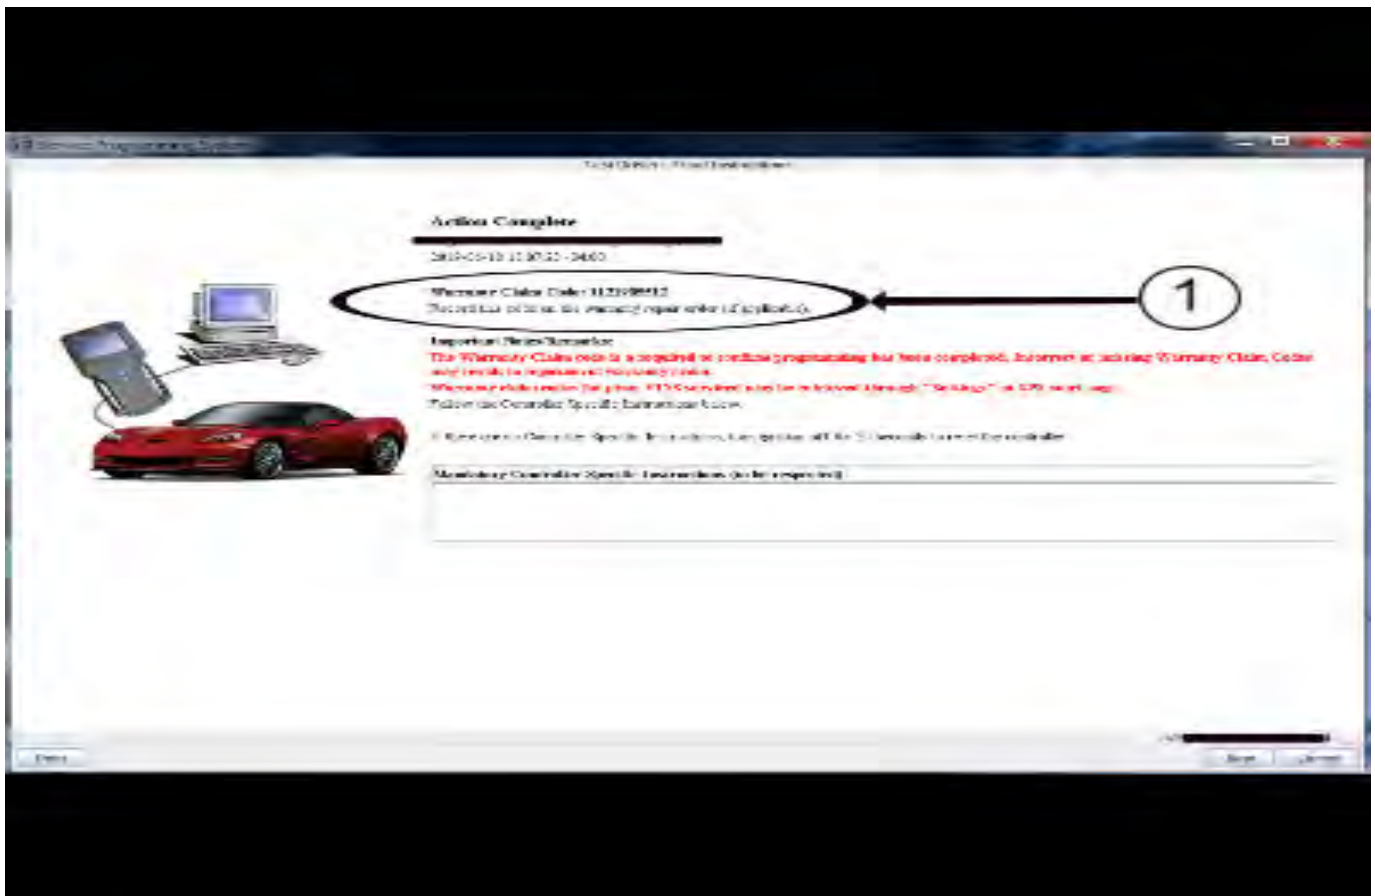
Note: The screenshots above are an example of module programming and may not be indicative of the specific module that is being programmed. Module selection and VIN information have been blacked out.

Important: If the same calibration/software warning is noted on the TLC or SPS Summary screen, select OK and follow screen instructions. After a successful programming event, the WCC is located in the Service Programming System dialogue box of the SPS Summary screen. No further action is required. Refer to the Warranty Information section of this bulletin.
