Service Bulletin

Bulletin No.: 21-NA-087

Subject: Incorrect Rear View Displayed with Trailer Attached During Backing Event

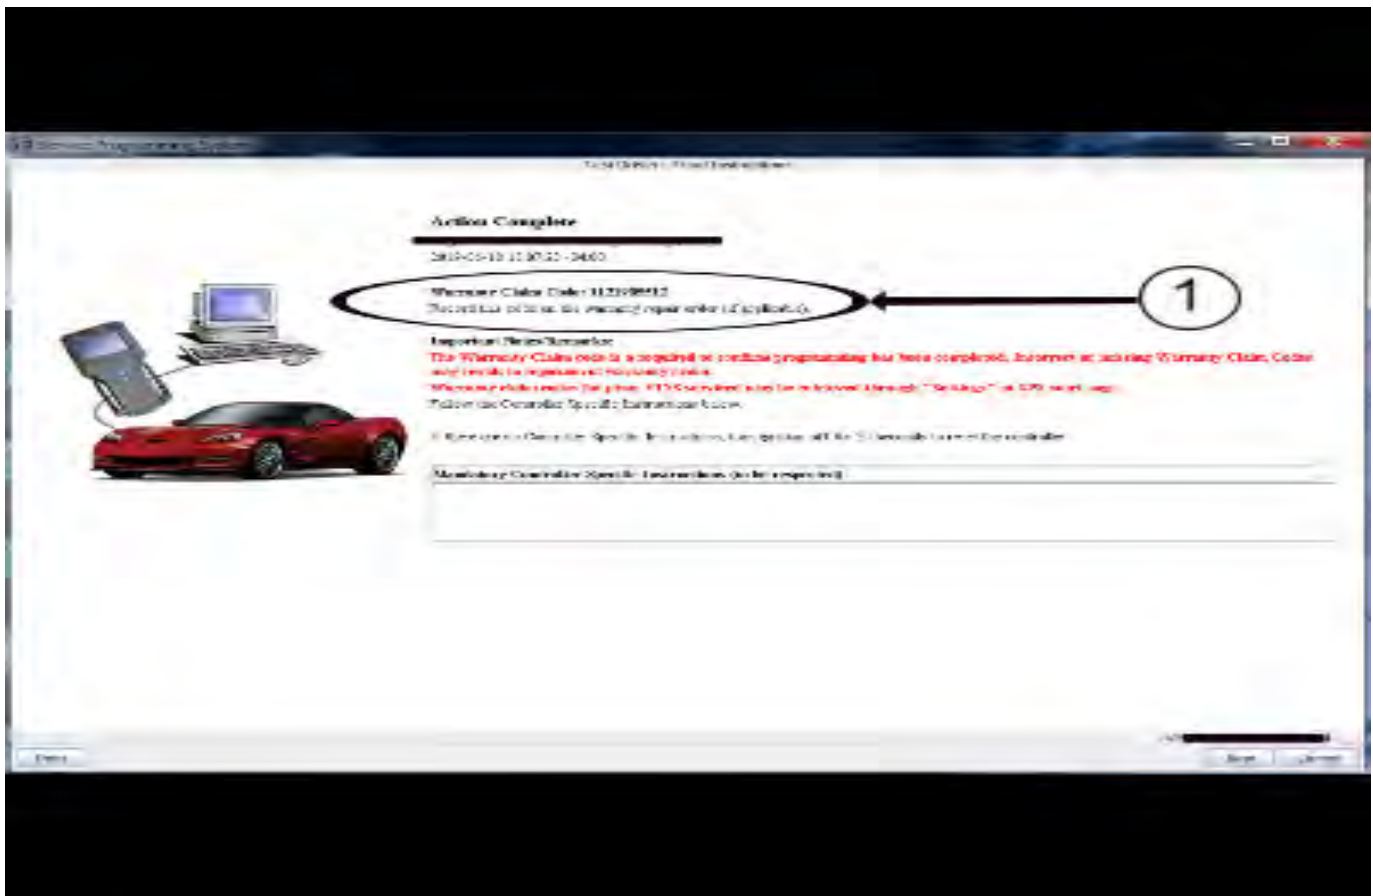
5431209

Note: The screenshots above are an example of module programming and may not be indicative of the specific module that is being programmed. Module selection and VIN information have been blacked out.
