Service Bulletin

Bulletin No.: 21-NA-092

Subject: Intermittent Malfunction Indicator Lamp (MIL) Illuminated – DTC P146F Set

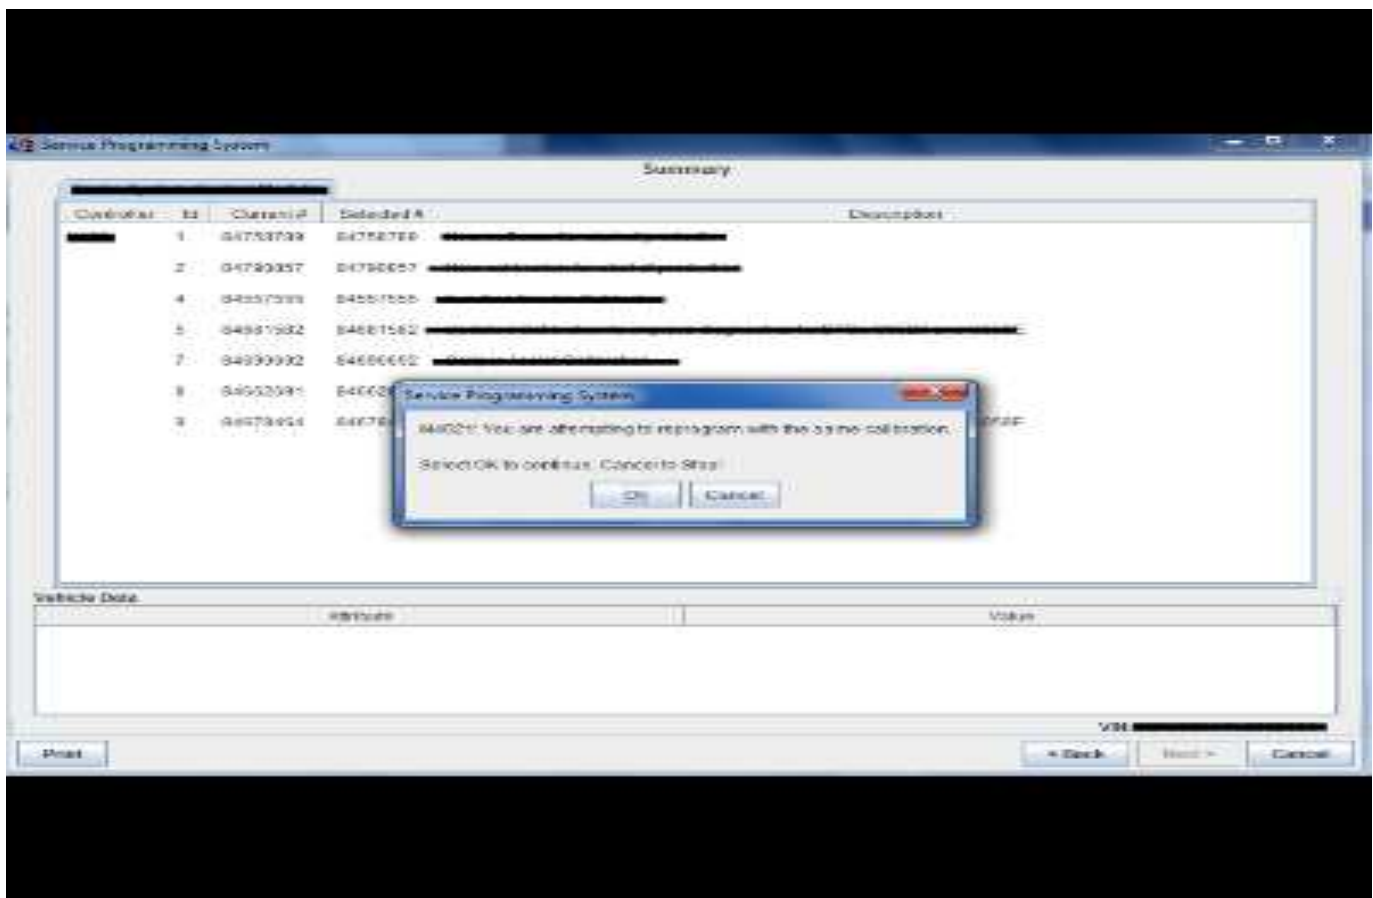
5431207

Important: Techline Connect and TIS2WEB screens shown above.

Important: If the same calibration/software warning is noted on the TLC or SPS Summary screen, select OK and follow screen instructions. After a successful programming event, the WCC is located in the Service Programming System dialogue box of the SPS Summary screen. No further action is required. Refer to the Warranty Information section of this bulletin.
