GLOBAL SAFETY FIELD INVESTIGATIONS
DCS5774
URGENT - DISTRIBUTE IMMEDIATELY

Subject: N202307080 - Service Update
Auto Stop with Low Battery State of Charge

Models: 2020-2021 Cadillac CT4, CT5
Equipped with Engine-Gas: Engine-Gas: 4 CYL, L4, 2.7L/ 4 CYL, L4,
2.0L/6 CYL, 3.0L (RPO L3B/LSY/LGY)

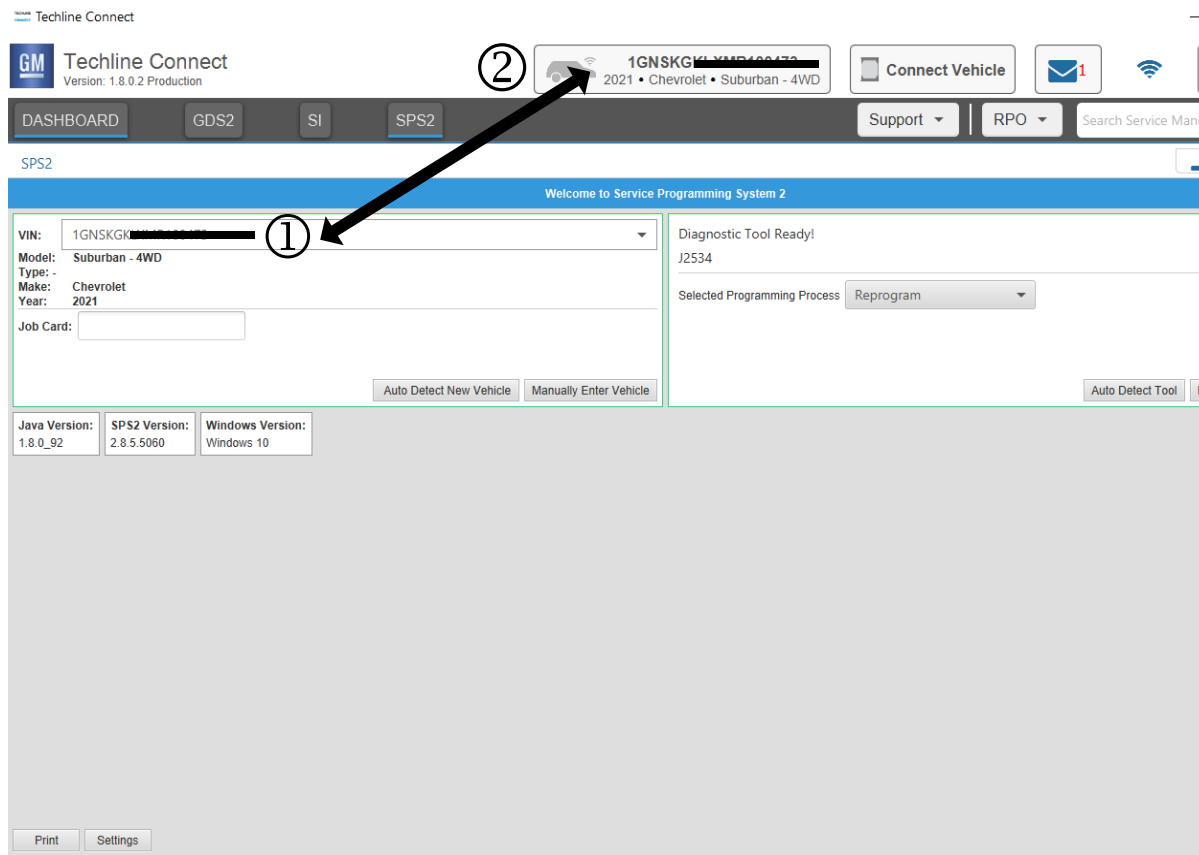
5644477

Caution: Be sure the VIN selected in the drop-down menu (1) is the same as the vehicle connected (2) before beginning programming.

M4521: You are attempting to reprogram with the same calibration.
 Select OK to continue, Cancel to Stop!

Important: If the same calibration/software warning is noted on the TLC or SPS Summary screen, select OK and follow screen instructions. After a successful programming event, the WCC is located in the Service Programming System dialogue box of the SPS Summary screen. No further action is required. Refer to the Warranty section of the bulletin.

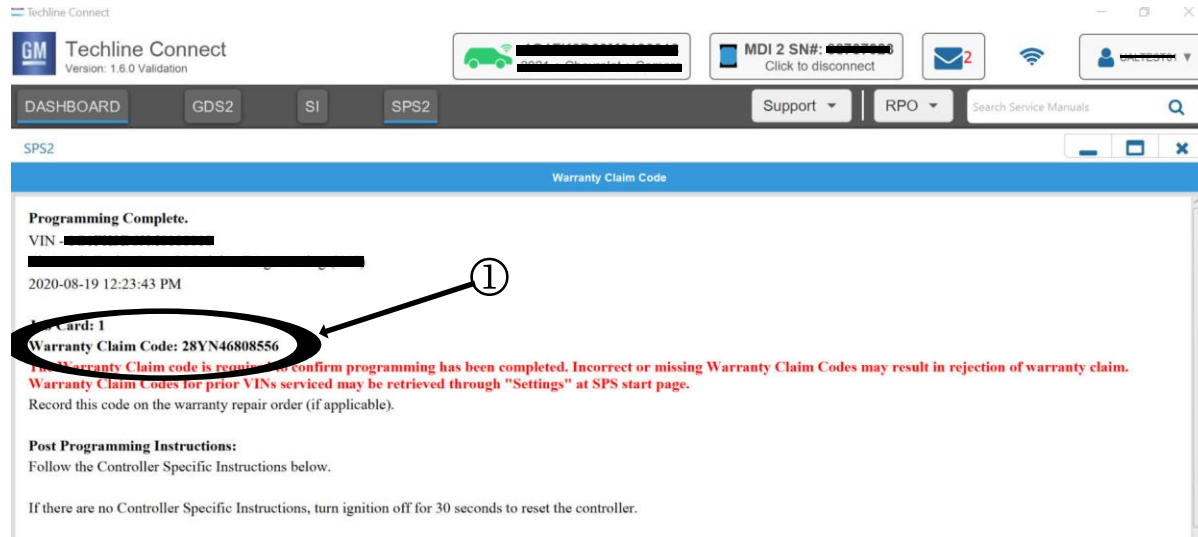
5644478

Important: When programming a module in GM's new Vehicle Intelligence Platform, or VIP, the power mode (ignition) needs to be off or errors may occur. This involves the 2020 Chevrolet Corvette, Cadillac CT5 and CT4, as well as the upcoming full-size Chevrolet, GMC, Cadillac SUVs and Buick Envision. Serial Data Message Authentication also needs to have the ignition off.

1. Reprogram the Engine Control Module. Refer to *K20 Engine Control Module: Programming and Setup* in SI.
