Customer Satisfaction Program

N202323690 Advanced Onboard Diagnostics Upgrade

| Condition | Certain 2019 model year Chevrolet Bolt EV vehicles have a new software package of advanced onboard diagnostics. |
| Correction | Dealers will update the software on the body control module and HPCM2 module. |

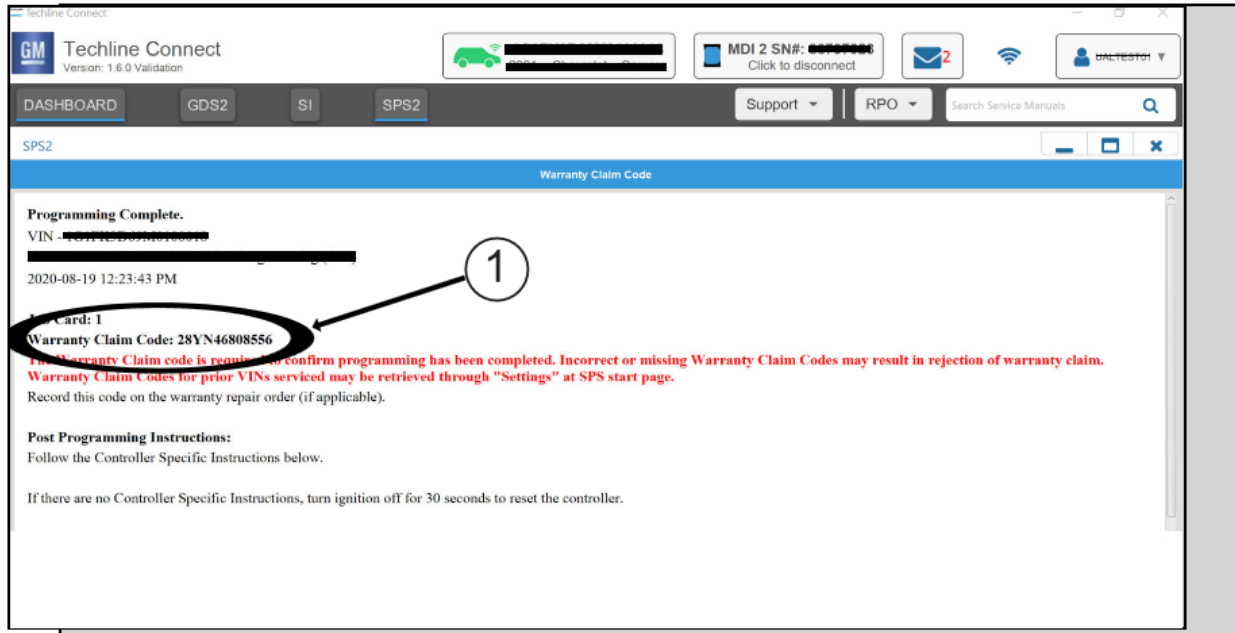
2. Reprogram the K9 Body Control Module. Refer to *K9 Body Control Module Programming and Setup* in SI.

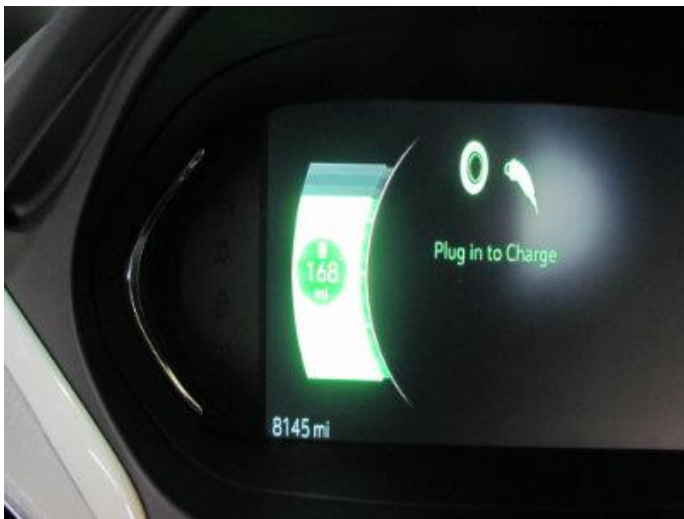
5816637

1. Vehicle ON, perform the Diagnostic System Check – Vehicle.
 - If any DTCs are set, store any Freeze Frame/Failure Records and go to Diagnostic Trouble Code (DTC) List – Vehicle in Si. Return to this procedure after DTC repair.
 - If no DTCs are set, go to Step 2.
2. Vehicle ON, use GDS2 to view Specific DTC status:
 - From Module Diagnostics, select Hybrid Powertrain Control Module 2.
 - Select Diagnostic Trouble Codes folder
 - Select Specific DTC
 - Ensure the following DTCs have Ran and Passed this ignition: DTC P0BBD.
 - If the DTCs have ran and passed proceed to Step 3
 - If the DTCs have failed go to Diagnostic Trouble Code (DTC) List – Vehicle
 - If DTC P0BBD is not supported an error has occurred during programming, repeat Procedure 3: Software Flashing Procedure.
