## MAS002199/B

## New ETM Software Volta 6 – Troubleshooting guides

**MODELS: Levante, Quattroporte and Ghibli Model Years 17, 18, 19 and 20**

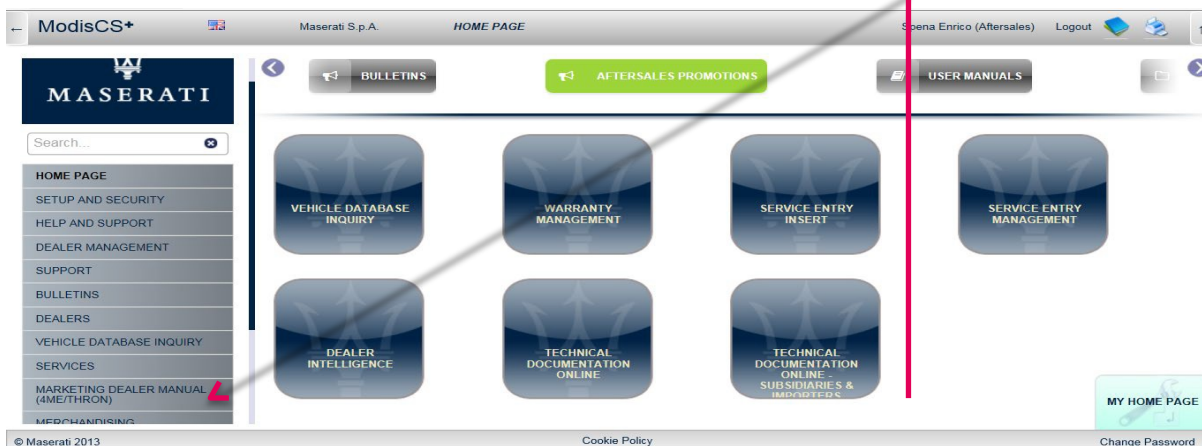
**A.1.** In ModisCS+ Select **MARKETING DEALER MANUAL (4ME/THRON)**.

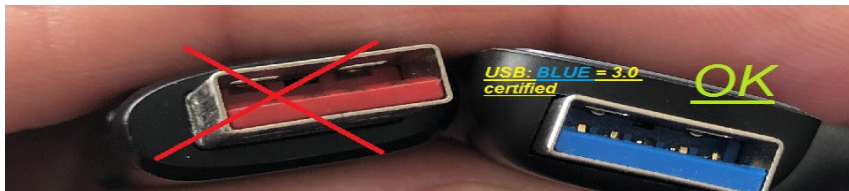
- A.6.** 1. Use only a 8GB or larger Sandisk, Verbatim, Kingston or Transcend “3.0 Certified” (Blue contact plate) USB PEN Drive with the NTFS format.

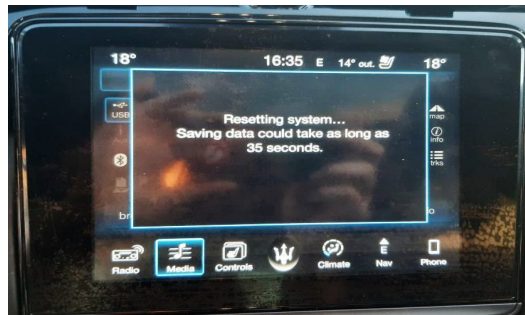
- B.1.** BRIDGE software installation (ETM update). Follow the table in this bulletin (MY 17 Sedans) for the vehicles requiring this s/w..
- B.2.** Download the software from the MARKETING DEALER MANUAL (4ME-THRON) (Follow Section A)
- B.3.** Extract all the files in an empty USB stick with the following specifications (as per Bulletin MAS001272):
- USB 3.0
  - At least 8GB or higher
- B.4.** Insert the USB stick in the USB port inside the vehicle.
- B.5.** Follow the on screen prompts.
- Please keep the vehicle in Key ON state (with a battery charger connected to the vehicle) and leave the USB stick inserted for the entire duration of the update.
  - Removal of the USB stick during the update will result in a non-functional head unit.
  - The time may depend on the market, the s/w version and the speed of the USB memory stick. The installation could take up to 1 hour.

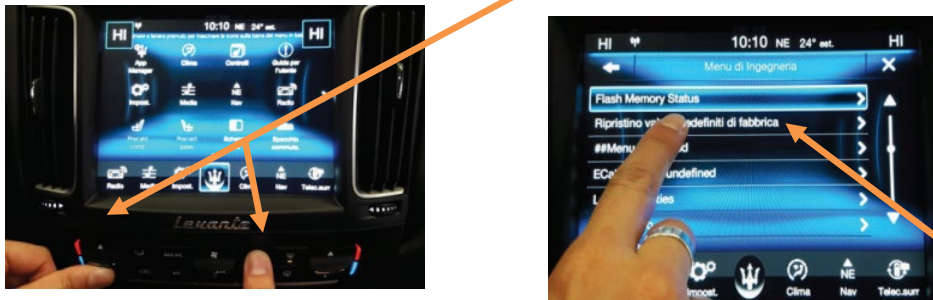
- B.6.** At the end of the BRIDGE software installation, a factory reset is needed.  
Go into the Engineering Mode by pressing “Left Temp Up” & “Sync.”

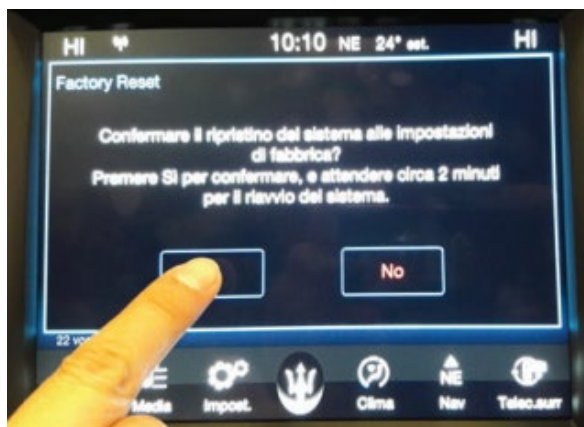
Scroll the menu up to “Reset to factory default”. Then press “Reset to factory default”.

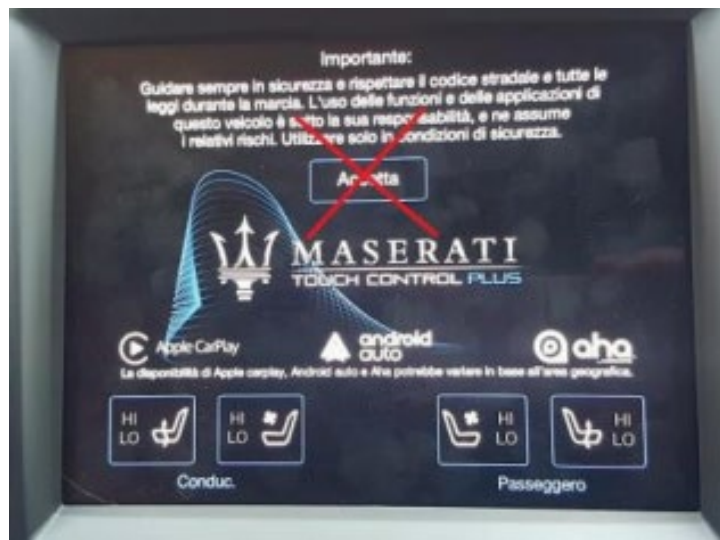
Press “Yes” and wait for the reboot of the system.

**NOTE: DO NOT Press “Accept”.**

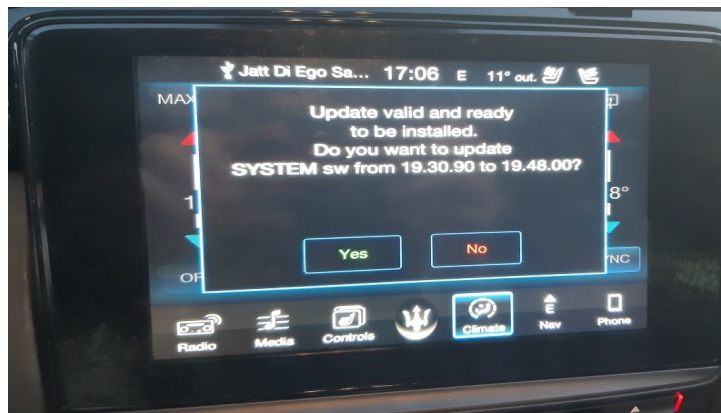
- C.1.** Download the software from the MARKETING DEALER MANUAL (4ME-THRON) (follow Section A)
- C.2.** Extract all the files in an empty USB stick with the following specifications:
  - USB 3.0;
  - At least 8GB or higher.
- C.3.** Insert the USB stick in the USB port inside the vehicle.
- C.4.** Follow the on screen prompts.
  - Please keep the vehicle in Key ON state (with a battery charger connected to the vehicle) and leave the USB stick inserted for the entire duration of the update.
  - Removal of the USB stick during update will result in a non-functional head unit.
  - The time may depend on the market s/w version and the speed of the USB memory stick. The installation could take up to 1 hour.
