MODEL
2008 Rio / Rio5 (JB)

TECHNICAL SERVICE BULLETIN

SUBJECT: COMBINED TSB/SERVICE ACTION: ECM UPGRADE FOR MULTIPLE DTC'S LISTED P0300, P0128, P0140, P0451, P0461(SA 036)

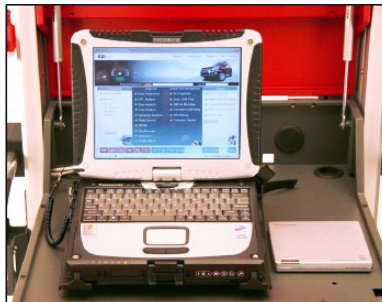
Global Diagnostic System (GDS)

To correct this condition, the ECM should be reprogrammed using the GDS download as described in this bulletin.
