MODEL
2011MY
Sorento (XMa)
w/2.4L MPI

NUMBER
PI2101 (Rev 1, 05/28/2021)

PRODUCT IMPROVEMENT CAMPAIGN

**SUBJECT: THETA 2.4L MPI - KNOCK SENSOR DETECTION SYSTEM
(KSDS) ECU LOGIC IMPROVEMENT (PI2101)**

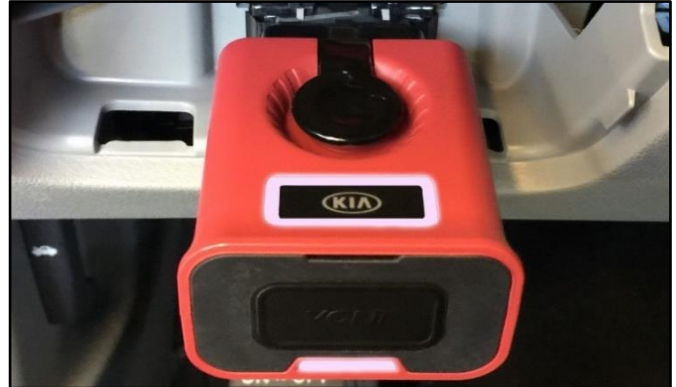
The ECU upgrade function on KDS operates wirelessly. It is not necessary to perform the upgrade via USB cable.

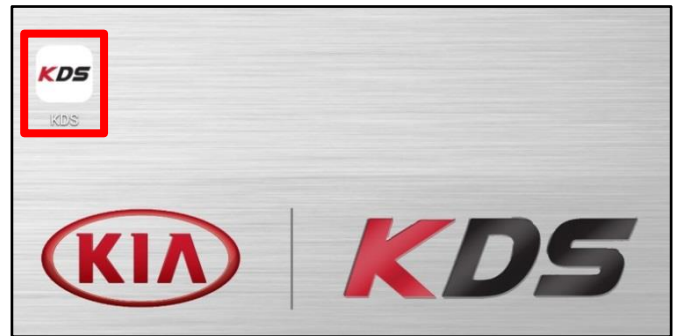
2. With the ignition ON, turn ON the KDS tablet. Select **KDS** from the home screen.

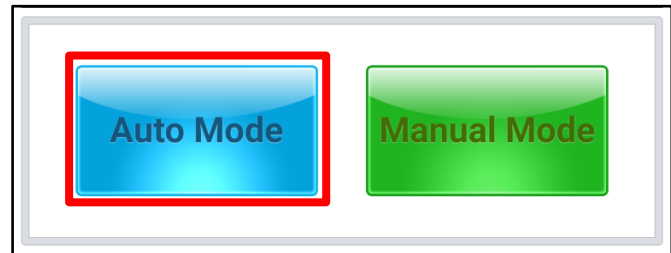
- Select Auto Mode.

Do NOT attempt to perform a Manual Mode upgrade UNLESS Auto Mode fails. Always follow the instructions given on the KDS in either Auto or Manual mode.

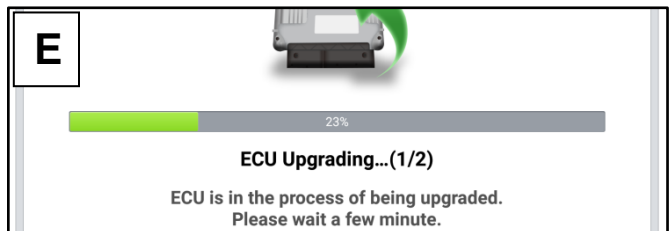
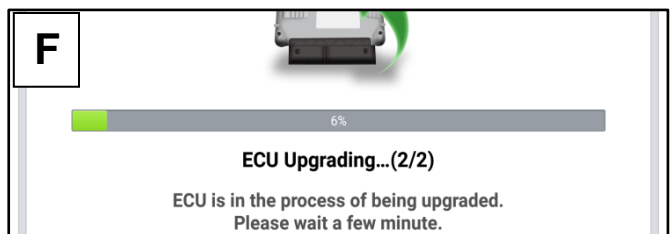
- The ECU upgrade will begin and the progress of the upgrade will appear on the bar graph. Upgrade part (1/2) (E) will download the upgrade event to the VCI-II. Upgrade part (2/2) (F) will upgrade the ECU.

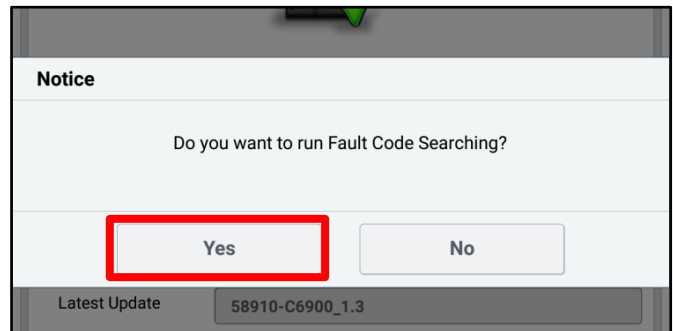
- When prompted, select **YES** to check for Diagnostic Trouble Codes (DTC) and erase any DTCs stored such as EPS, ESC, and TPMS that may have been set during the upgrade.
