**WMA5 - Updating Software for Various Control Units (Workshop Campaign)**

Model Line: **Taycan (Y1A)**

Concerns: **Software update (software version VR12.1.1)**

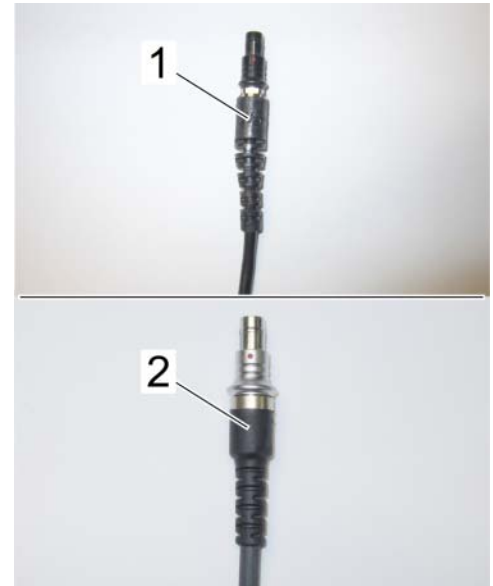
*PIWIS Tester data cable*

If the connection between the vehicle and PIWIS Tester is interrupted, check the data cable for the PIWIS Tester for signs of damage. If the data cable is damaged, it **must** be **replaced**. To do this, follow the instructions in the PPN for "Returning faulty USB cable caps" (PPN portal > Dr Ing. h.c. Porsche AG > Aftersales > Workshop > PIWIS > Documents).
