Technical product information

Topic	New Continental GT and GTC- Repeat window drop glass concerns
Market area	Russische Föderation (5RU),Australia E04 Bentley rest Asia and Australia (6E04),China 796 VW Import Comp. Ltd (Vico), Beijing (6796),Germany E02 Bentley rest Europe (6E02),Japan E03 Bentley Japan (6E03),Korea, (South) E08 Bentley South Korea (6E08),United Arab Emirates E06 Bentley Middle East and Africa (6E06),United Kingdom E01 Bentley UK (6E01),United States E05 Bentley USA and rest America (6E05)
Brand	Bentley
Transaction No.	2062035/5
Level	EH
Status	Approval
Release date

New Continental GT and GTC

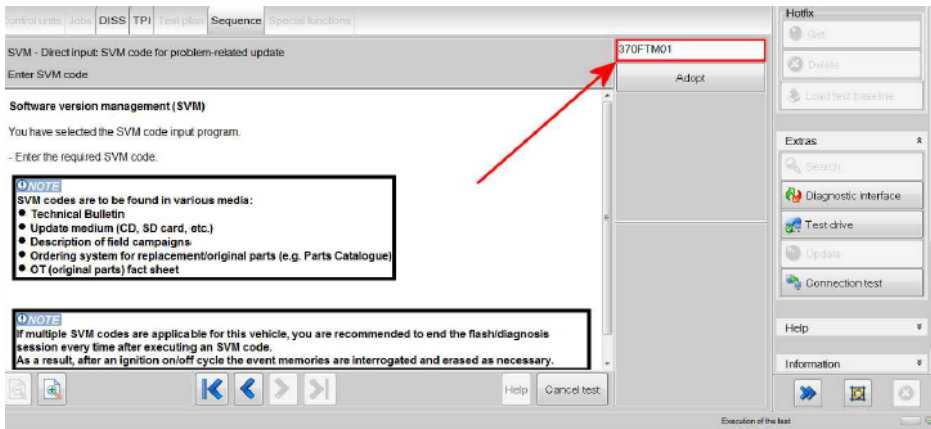
2) Referring to Figure 2 – Enter the SVM code 370FTM01

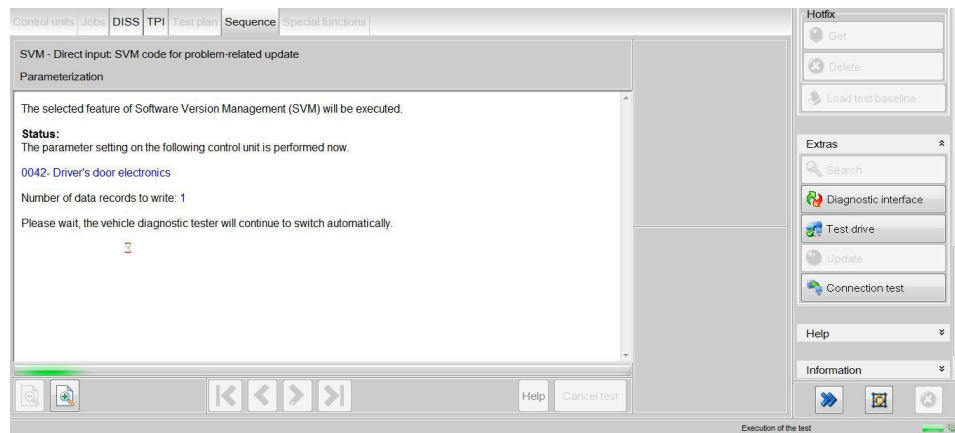
Figure 3

3) The Required control units will be automatically updated in the order shown in Figures 3 through to 6

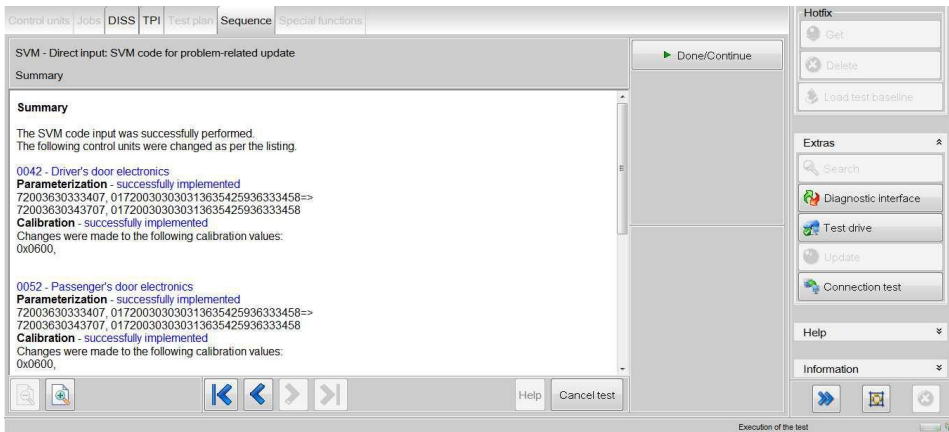
4) Once the update is complete the screen shown in Figure 7 will be evident
