## QUARANTINE NOTICE

Reference number:	QN-30-1525	Issued: 25 May, 2021
Subject:	Flash the Front Seat Modules	
Model(s):	DBX	
VIN Range:	Refer to the separately published list of affected Vehicle Identification Numbers (VINs)	
Applicable to:	All Dealers	
Distribute to:	After Sales Manager Executive Manager Service Manager Sales Manager	Warranty Staff Technician(s) Parts Staff

Aston Martin has found it is possible that the front seats do not move to a fully rearward position. Do the workshop procedure that follows to update the front seat modules to correct this problem.

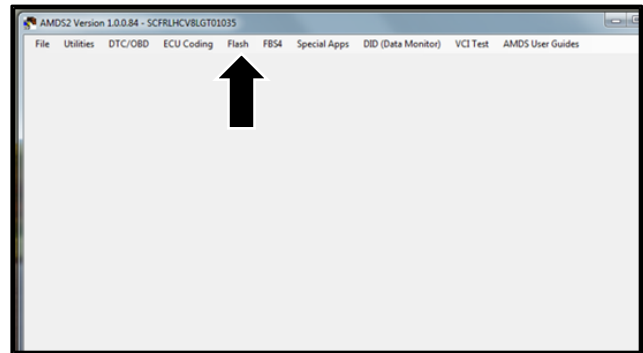
Figure 1

1. Set the ignition to on but do not start the engine.
2. Connect the Vehicle Communication Interface (VCI) to the vehicle by using the Diagnostic Link Cable (DLC).
3. Start the AMDS 2.0 software and, if necessary, update to the latest version.
4. Select “Flash” (refer to Figure 1).

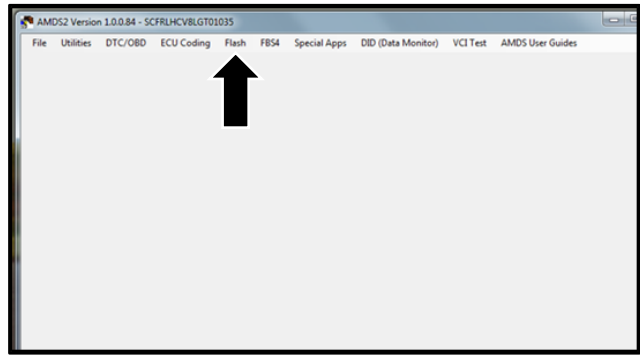
Figure 7

11. Select "Flash" (refer to Figure 7).

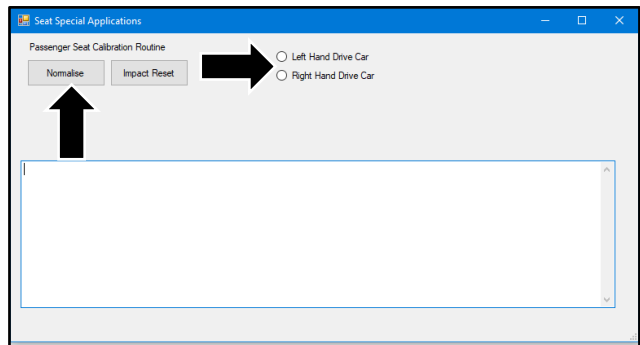
Figure 12

- Select the applicable hand of drive, then click “Normalise” (refer to Figure 12).
