## SERVICE ACTION

Reference number:	SA-30-1525	Issued: 25 May, 2021
Subject:	Flash the Front Seat Modules	
Model(s):	DBX	
VIN Range:	Refer to the separately published list of affected Vehicle Identification Numbers (VINs)	
Applicable to:	All Dealers	
Distribute to:	After Sales Manager Executive Manager Service Manager Sales Manager	Warranty Staff Technician(s) Parts Staff

### Reason for this Service Action

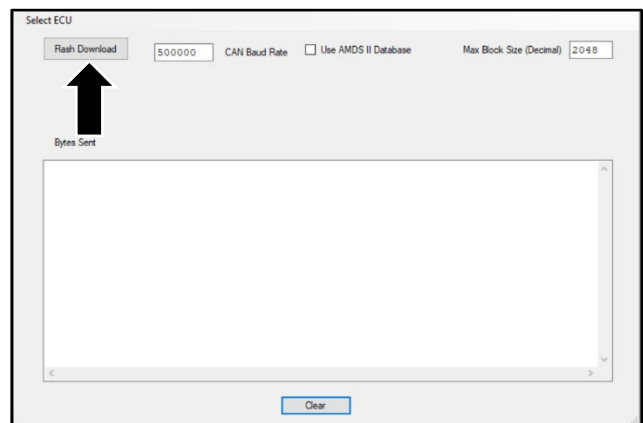
Figure 3

6. Select “Flash Download” (refer to Figure 3).

7. When the software update is complete, close the “Flash” window.

**Note: The update is complete when “Post-programming sequence completed OK. VCI Disconnected. DRVU reset OK” is shown.**

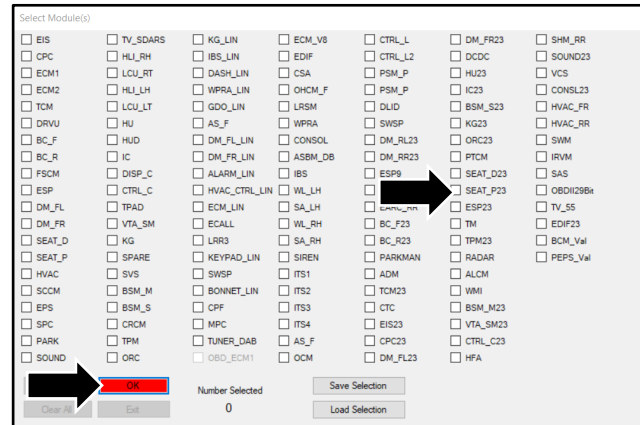
Figure 5

- Select the “SEAT\_P23” module then click the “OK” button (refer to Figure 5).
