Technical Service Bulletin

GROUP CAMPAIGN	NUMBER 21-01-023H-1
DATE MAY 2021	MODEL(S) APPLICABLE VEHICLES BELOW

SUBJECT: ENGINE MONITORING LOGIC (SERVICE CAMPAIGN 966)

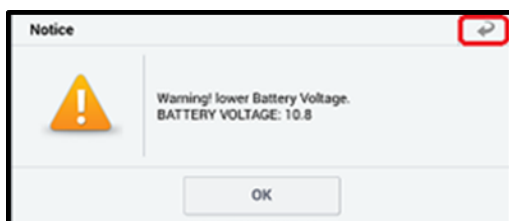
GDS Vehicle Battery Voltage Warning:

If voltage is below 12 volts as per the GDS warning, then select **Back** and run the engine at least 15 minutes to reach an adequate battery state of charge to prevent ECU Update failure. Cycle the ignition **OFF/ON** before retrying ECU update again.
