TECHNICAL SERVICE BULLETIN

Technical Service Bulletin: 15-1360

Forest River is alerting you to an issue involving certain 2021 Cardinal fifth wheel travel trailer recreational trailers. Please see the information below, which describes the issue and provides you with details on the steps you should take to have your vehicle repaired.

The holding tank monitor panel only allows for five holding tanks. The vehicle has six holding tanks. A separate holding tank monitor panel needs to be installed.

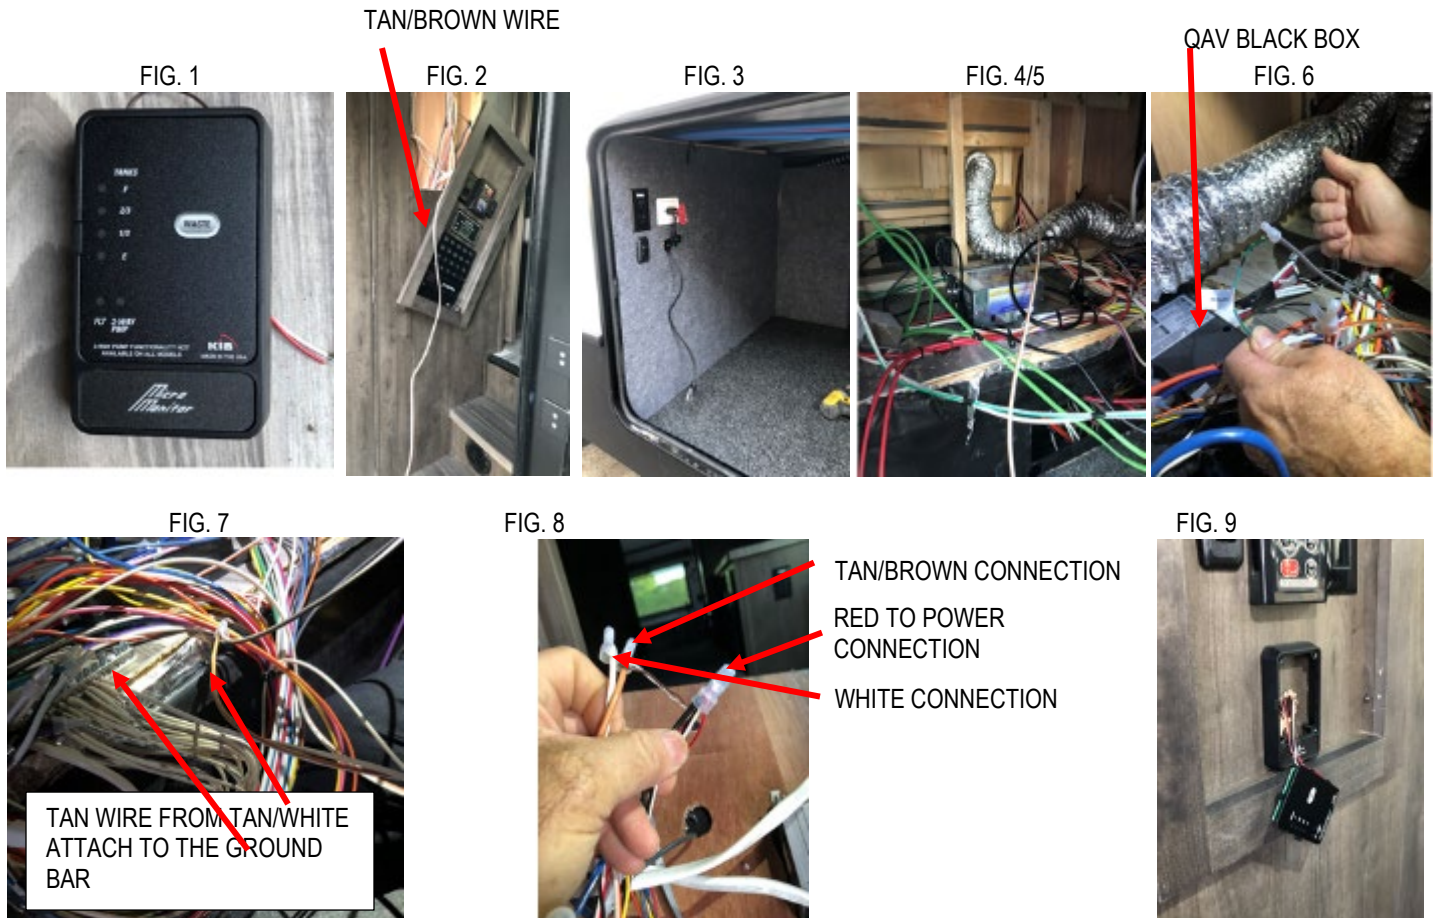
STEP 5: ON KIB SINGLE MONITOR PANEL, HOOK UP WHITE TO WHITE, BROWN FROM PANEL TO TAN, RED FROM PANEL TO BLACK POWER WIRE ON THE BACK OF MONITOR BOX (FIG. 8 & FIG. 9);
