91-19-02 - MIB2 MQB Composition & Discover Media Infotainment System Malfunctions

This procedure resolves the concern(s) specified above by updating the MIB2 Infotainment System software to the latest level **0757**

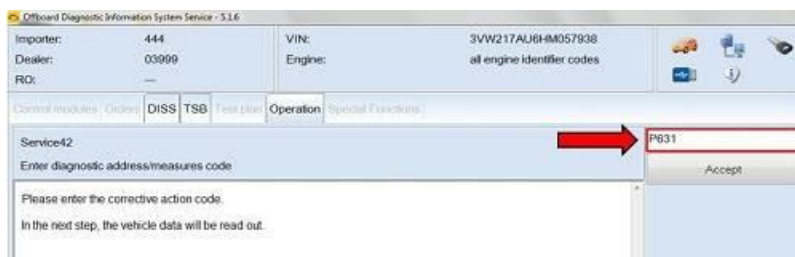
- From the SVM menu screen, select option 2 “Software update via measure code”.

- When prompted, enter measure code **P631**.
