Audio Head Unit Software Update (Pioneer)

Service Category Audio/Visual/Telematics

Section Navigation/Multi Info Display

Introduction

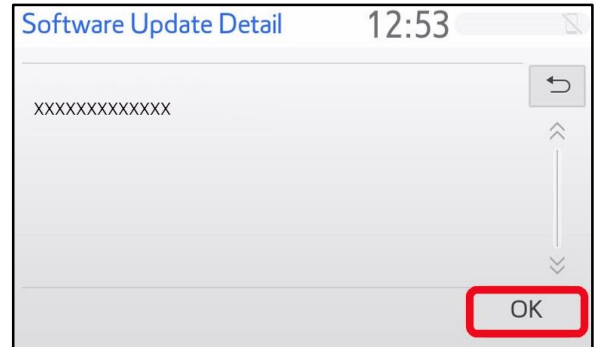
Figure 8.

12. Select OK on the Software Update Detail screen.

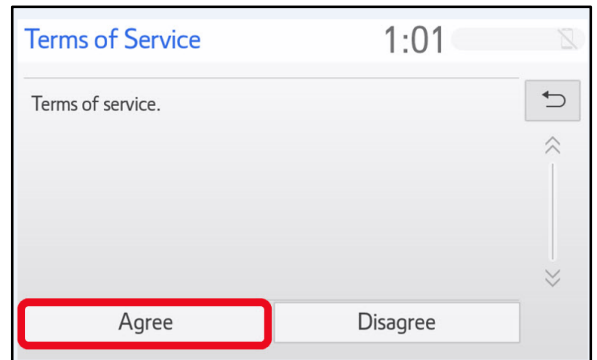
Figure 9.

13. Select Agree on the Terms of Service screen.
