# Entune Audio Head Unit Software Update (Pioneer)

**Service Category** Audio/Visual/Telematics

**Section** Navigation/Multi Info Display

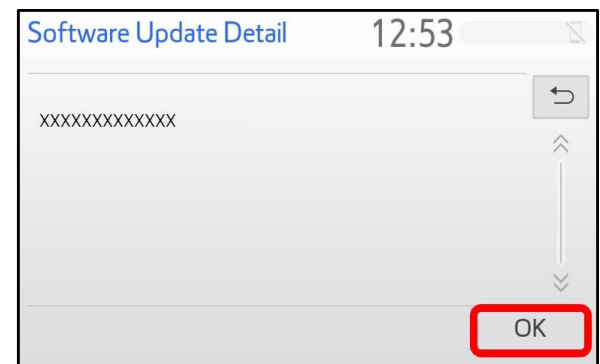
**Figure 8.**

- Select OK on the Software Update Detail screen.
