NUMBER: 08-093-21

GROUP: 08 - Electrical

UAS, UAQ, UCS, UAV, UCV and UCQ Radio Over The Air Software Version Updates

OVERVIEW:

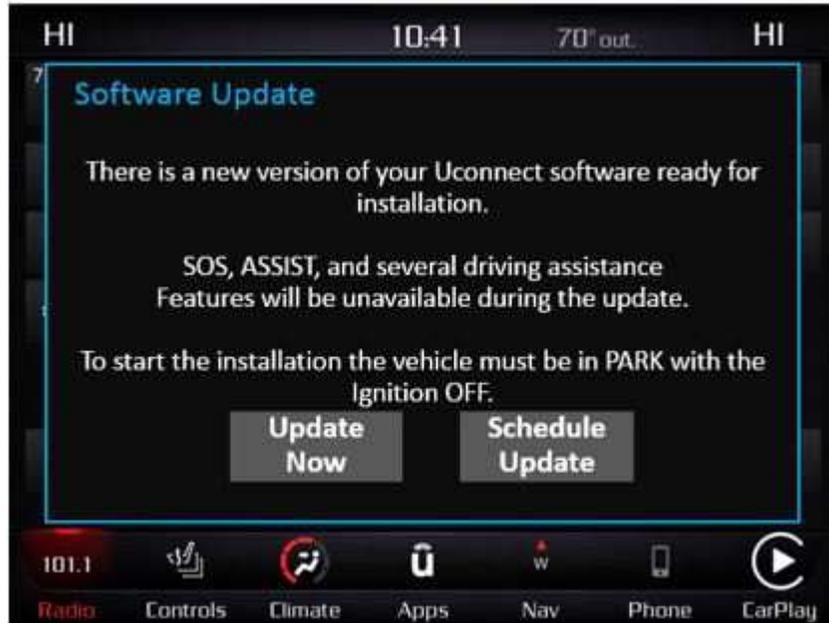
Fig. 1
Software Acceptance Screen

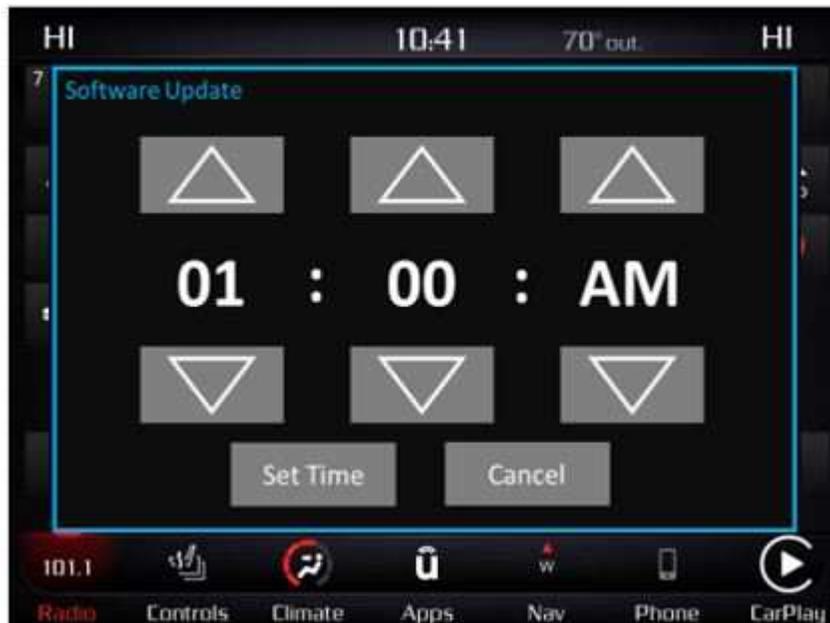
NOTE: If selecting “Schedule Update” the screen below will be displayed. The customer can select the exact time they want the update to begin (Fig. 2) .

Fig. 2
Schedule Update Screen

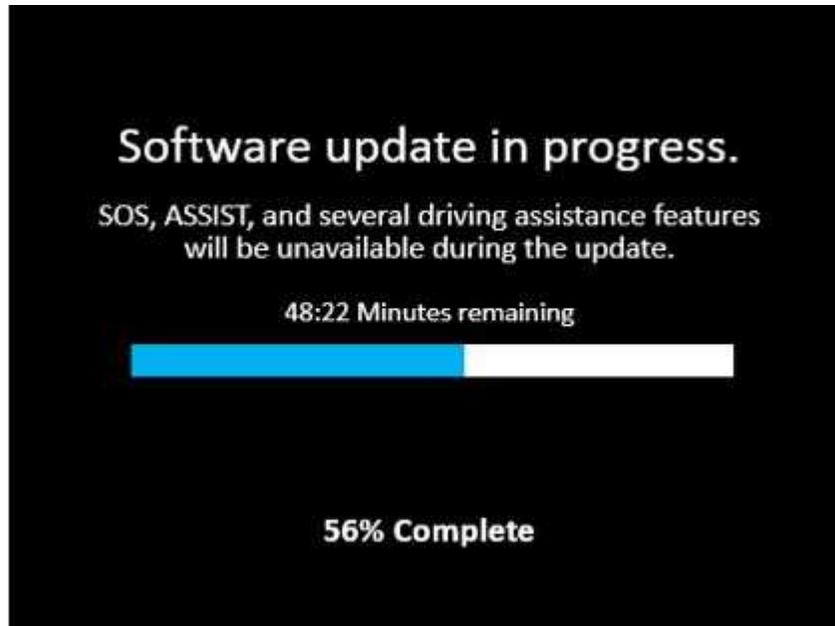
- Whether the customer selects “Update Now” or “Schedule Update” and sets a time, they can shut off the vehicle and leave. The update will be completed automatically (Fig. 3) .

NOTE: This phase may take several minutes to complete.

Fig. 3
Update In Progress Screen

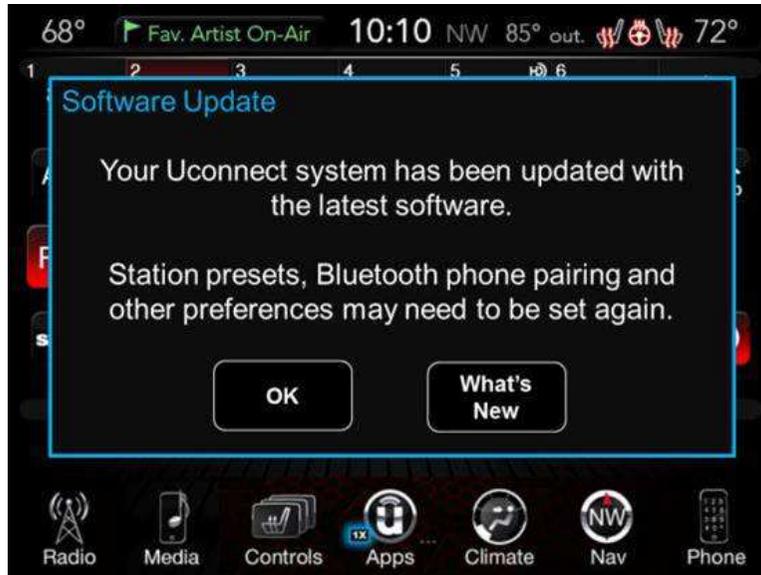
- Upon completion of update, the radio will display a confirmation message (Fig. 4) .

Fig. 4
Confirmation Screen
