Updating HVAC ECU Software to Fix Front HVAC Evaporator Freezing and Improve Espar Heater Cool Down

54-338

**Freightliner
Service Bulletin**

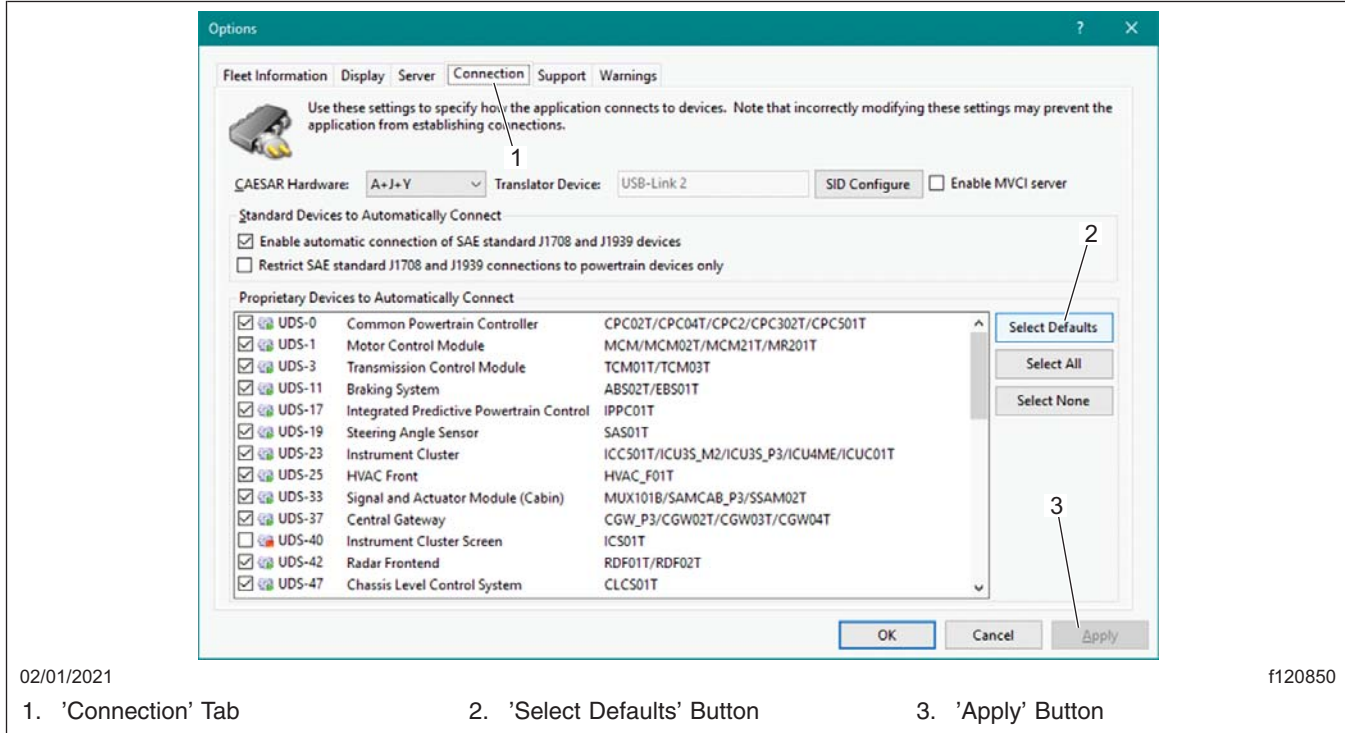
Fig. 2, Configuring DiagnosticLink to Connect to Default ECUs

2.1 When programming, we recommend configuring DiagnosticLink to connect only to 'Default' ECUs.

- Select 'Tools' from the top menu, and then select 'Options' from the drop down menu.
- Find and select the 'Connection' tab. See [Fig. 2](#).
- Select the 'Select Defaults' button on the right side of the window, then select 'Apply.'

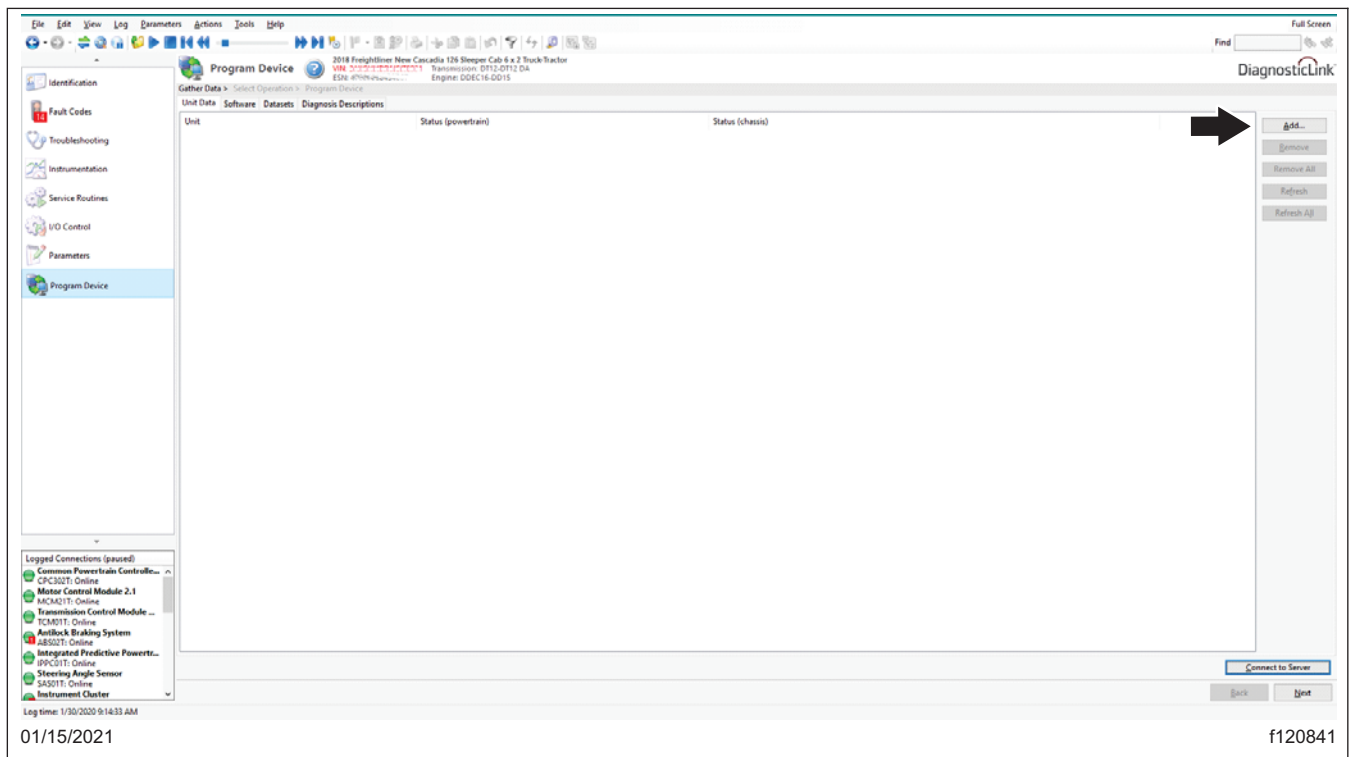
Fig. 5, Adding the VIN to Download Updated Server Data

- Use your DTNACconnect information to connect to the server. Your sign-in to the server will remain active until DiagnosticLink is closed.
- Select 'Add' to add a download request for the vehicle by entering the vehicle identification number (VIN). See Fig.5.

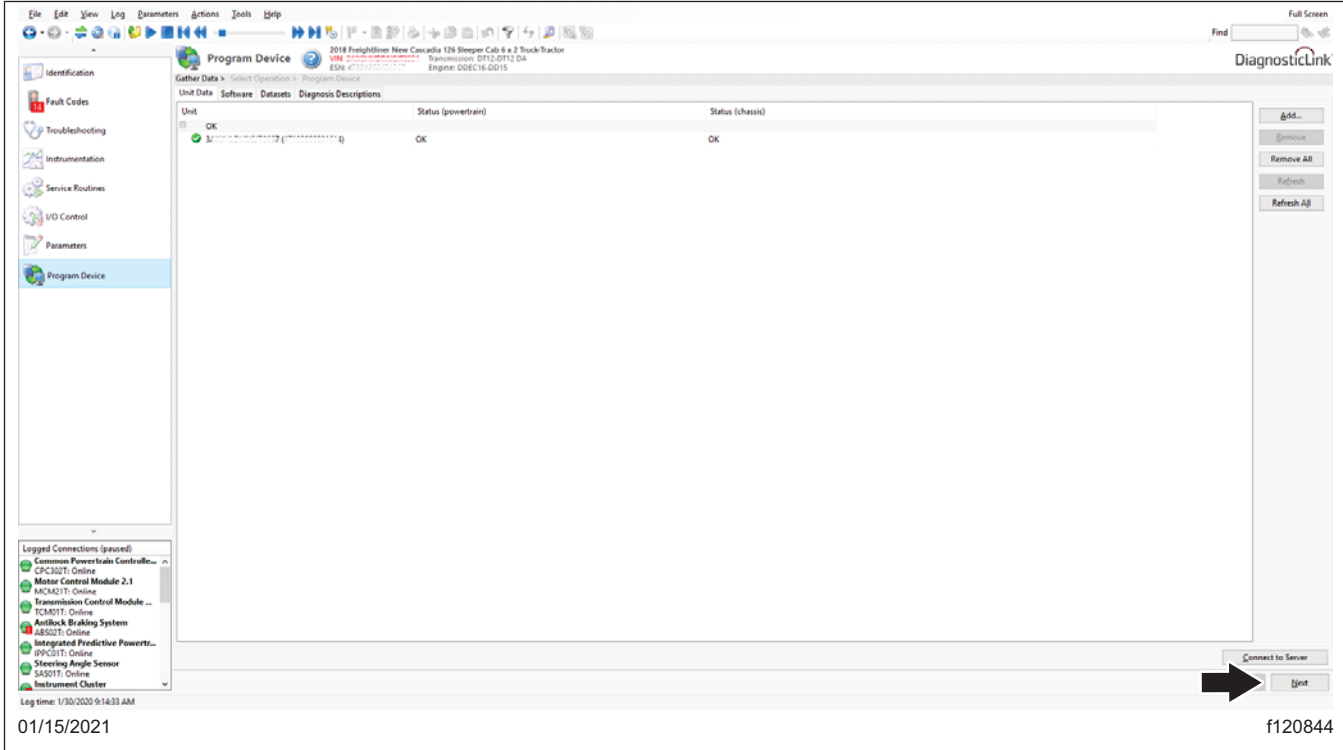
Fig. 8, Selecting Next

10. Once the data has been downloaded, select 'Next.' See Fig. 8.

NOTE: 'Latest' is the last service record (may be older software) and 'Newest' is the most up to date software available for the installed hardware. If the last service record is the most up to date software available, no 'Newest' record will be provided.

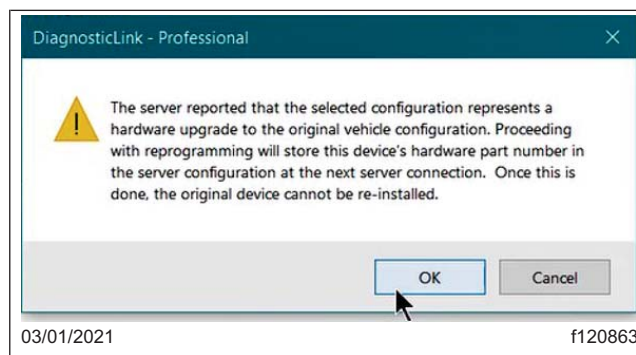
Fig. 10, Device (ECU) a Different Part Number Pop-Up

12. If the ECU currently installed has a different part number than what is stored on the server, the pop-up note shown in **Fig. 10** may appear. If this happens, select OK and continue to the next step.
