June 2021
SF622A

Subject: Cascadia/49X ABS MBSP+ Controller Software Update

Models Affected: Specific Model Year 2019-2022 Freightliner Cascadia, and Western Star 49X vehicles, manufactured September 12, 2018, through March 10, 2021.

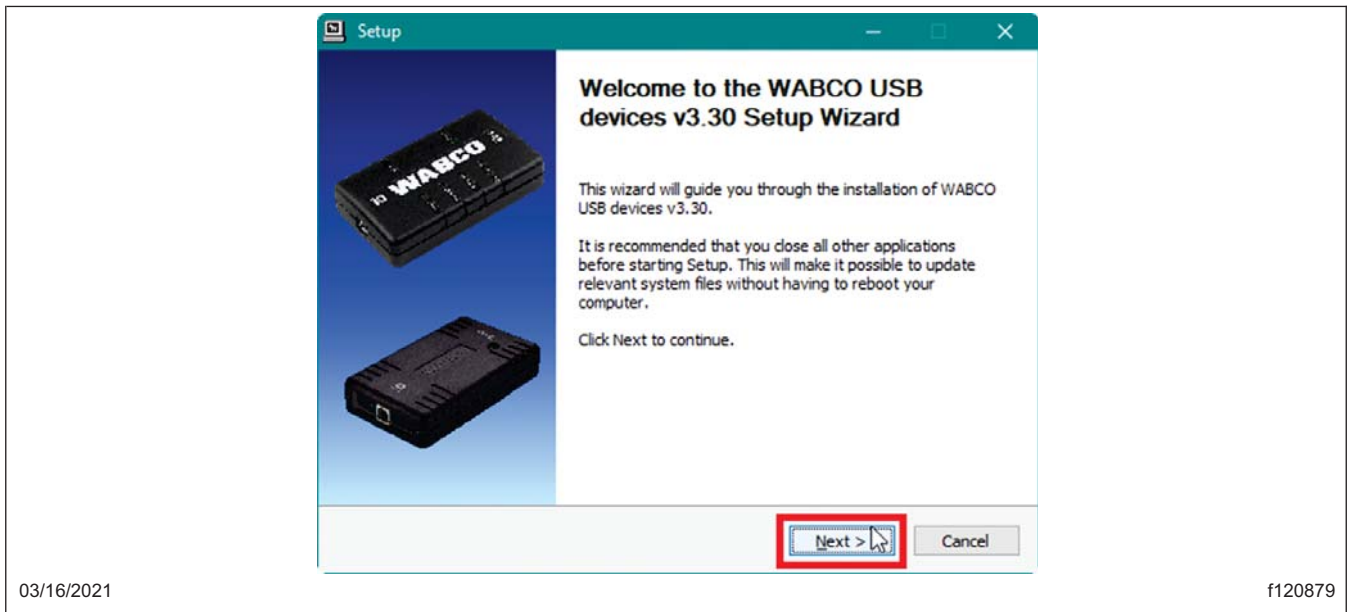
- 7.13 The setup program will install the mBSP Flash tool. At the 'Welcome to the WABCO USB devices Setup Wizard' window, select 'Next.'
See [Fig. 19](#).

Fig. 19, WABCO USB Devices Setup Window

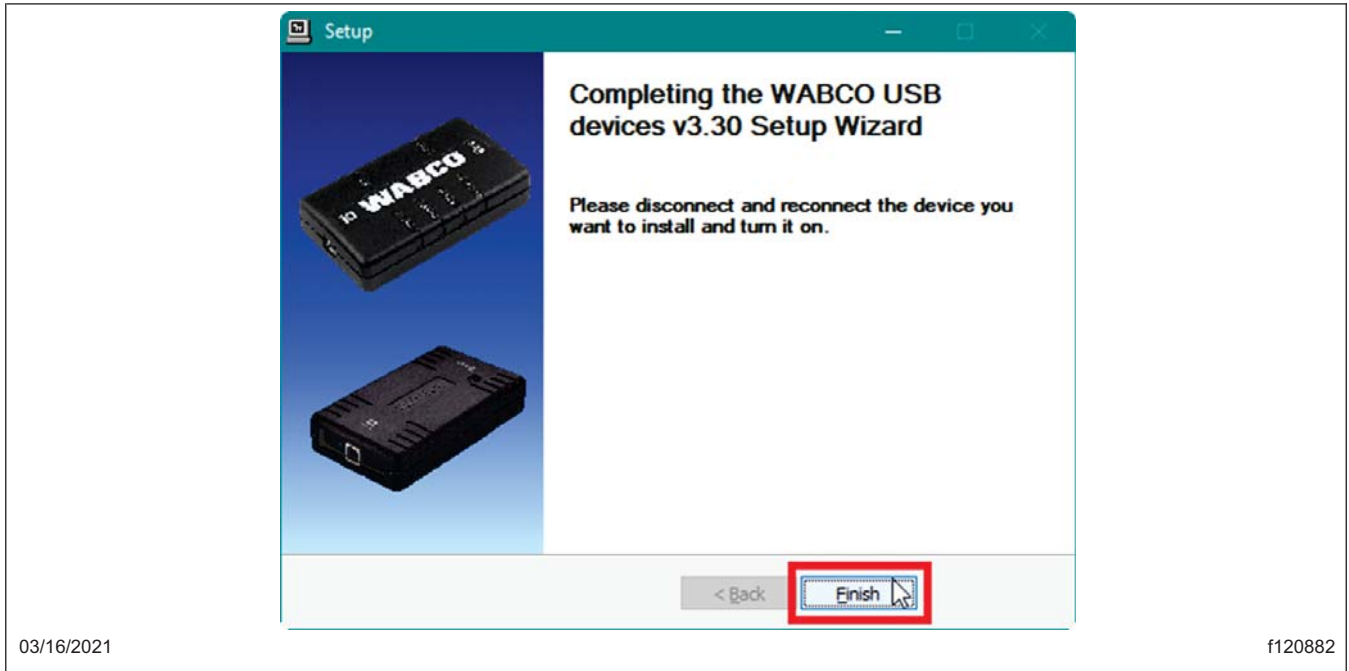
- 7.16 At the next window: 'Completing the WABCO USB devices Setup Wizard,' select 'Finish.'
See [Fig. 22](#).

Fig. 22, Completing the WABCO USB Setup Wizard

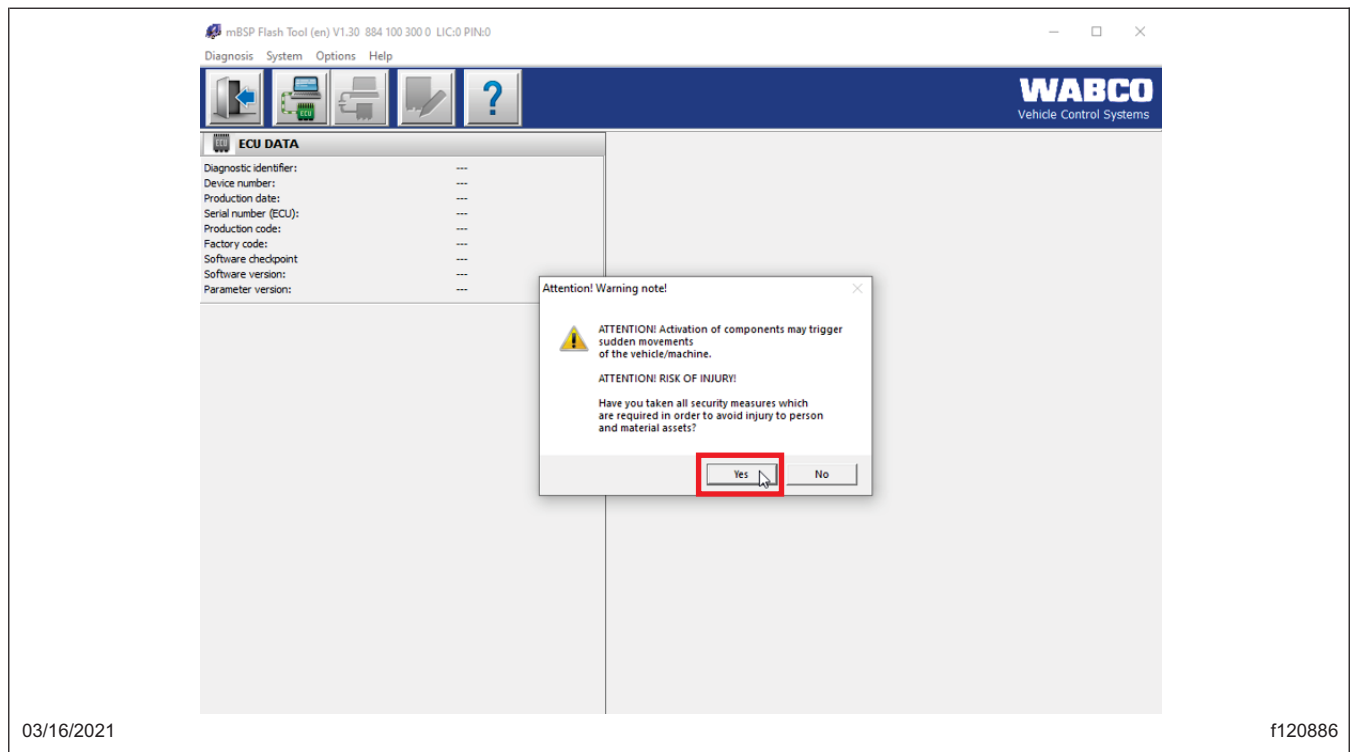
11. The program will open with a warning note. See [Fig. 26](#). Read the warning note. If the vehicle is secure, select 'Yes'.

Fig. 26, Accepting the Warning

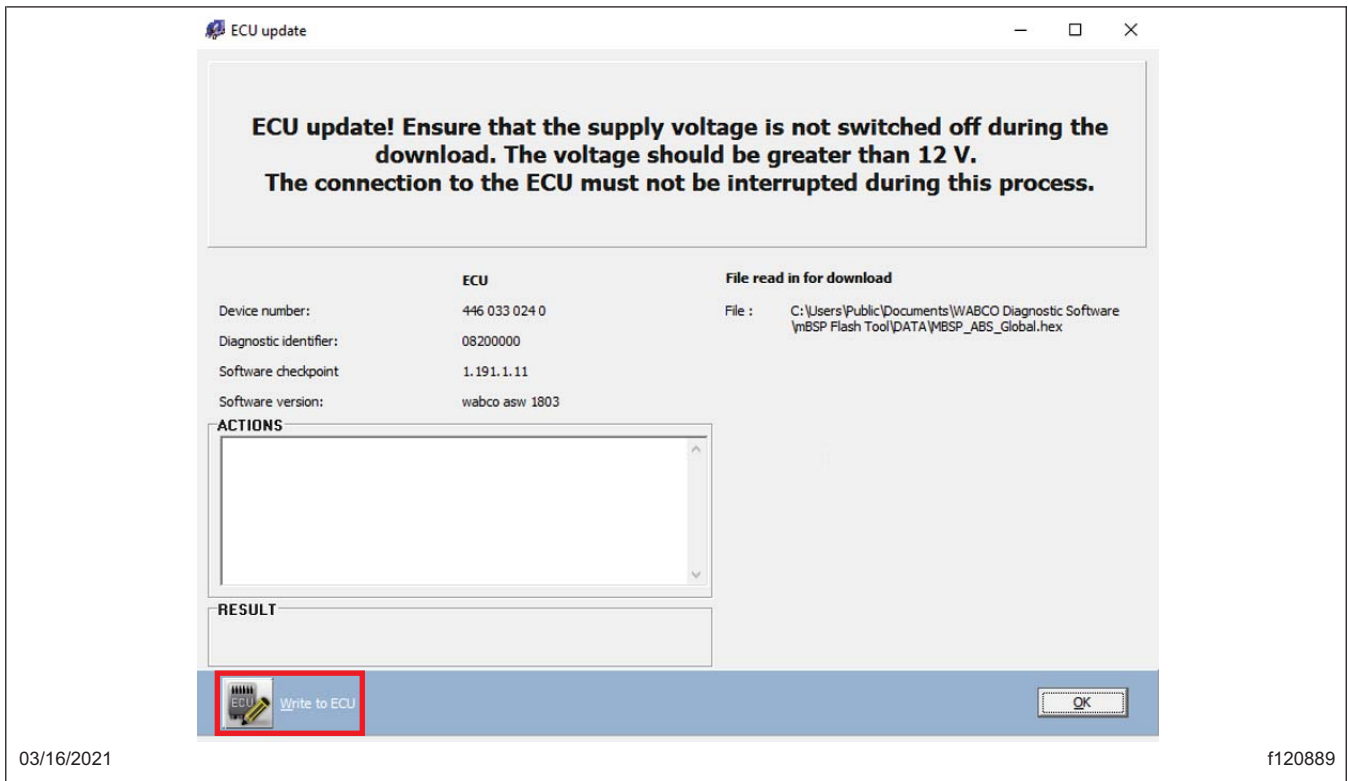
14. When the 'ECU update' window appears, select "Write to ECU" button to begin the ECU update.
See [Fig. 29](#).

The update may take several minutes. Do not disconnect the vehicle, turn the key to the OFF position, or allow the computer to go to sleep during this process.

Fig. 29, Starting the ECU Update

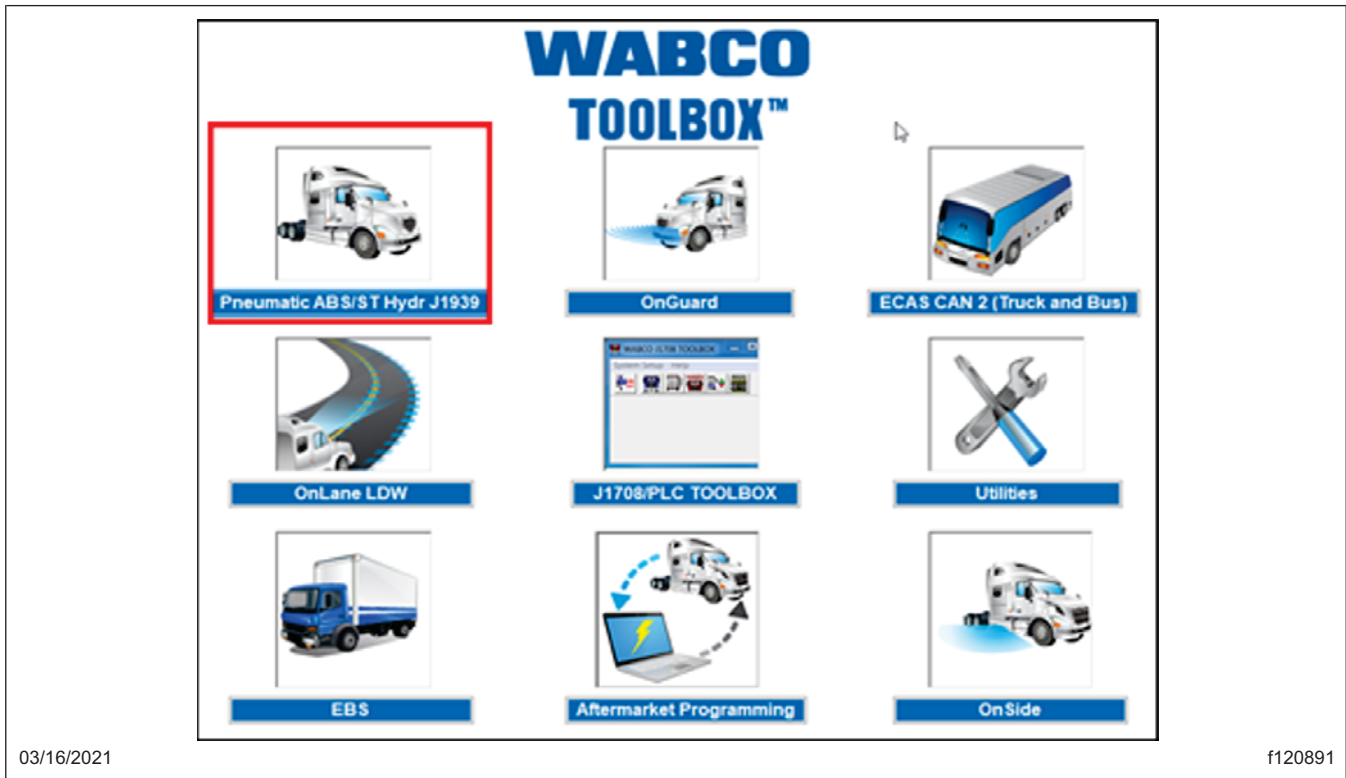
18. Save a parameter file from the ECU as proof that the parameter update was successfully completed and add it to the vehicle repair order. This can be done in WABCO Toolbox. Launch the Toolbox software and select 'Pneumatic ABS/ST Hydr J1939.' See [Fig. 31](#).

Fig. 31, WABCO TOOLBOX Options
