SERVICE BULLETIN

APPLICABILITY: 2016-18MY Legacy/Outback
 2016-18MY Impreza
 2016-18MY Crosstrek
 2016-18MY Forester
 2017-18MY WRX

NUMBER: 15-280-21R

SUBJECT: Gen1 Telematics Reprogramming for 3G Sunset

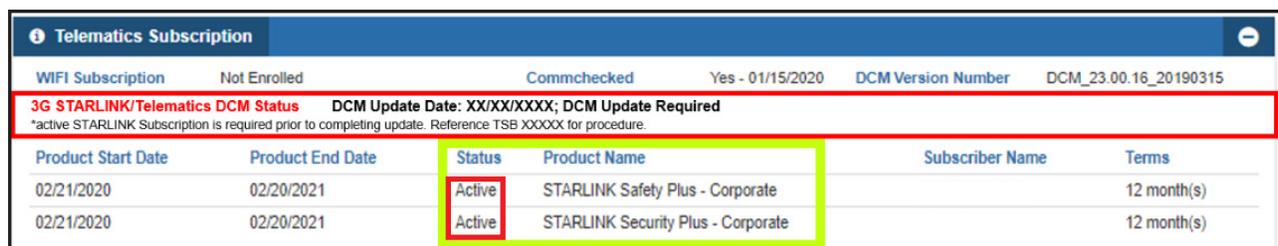
The screenshot example below shows the Telematics Subscription portion of the Vehicle Coverage Inquiry page. Here, the subscription can be confirmed as "Active" and also confirm the need to complete the DCM update procedure. The red outlined box highlights additional STARLINK information now included in this section of Vehicle Coverage Inquiry.

The screenshot shows a web interface for 'Telematics Subscription'. At the top, it displays 'WIFI Subscription Not Enrolled', 'Commchecked Yes - 01/15/2020', and 'DCM Version Number DCM_23.00.16_20190315'. Below this is a red-bordered box with the text: '3G STARLINK/Telematics DCM Status DCM Update Date: XX/XX/XXXX; DCM Update Required *active STARLINK Subscription is required prior to completing update. Reference TSB XXXXX for procedure.' The main table has columns for Product Start Date, Product End Date, Status, Product Name, Subscriber Name, and Terms. Two rows are shown, both with 'Active' status and 'STARLINK Safety Plus - Corporate' and 'STARLINK Security Plus - Corporate' product names. A red box highlights the 'Status' column, and a yellow box highlights the 'Product Name' column.

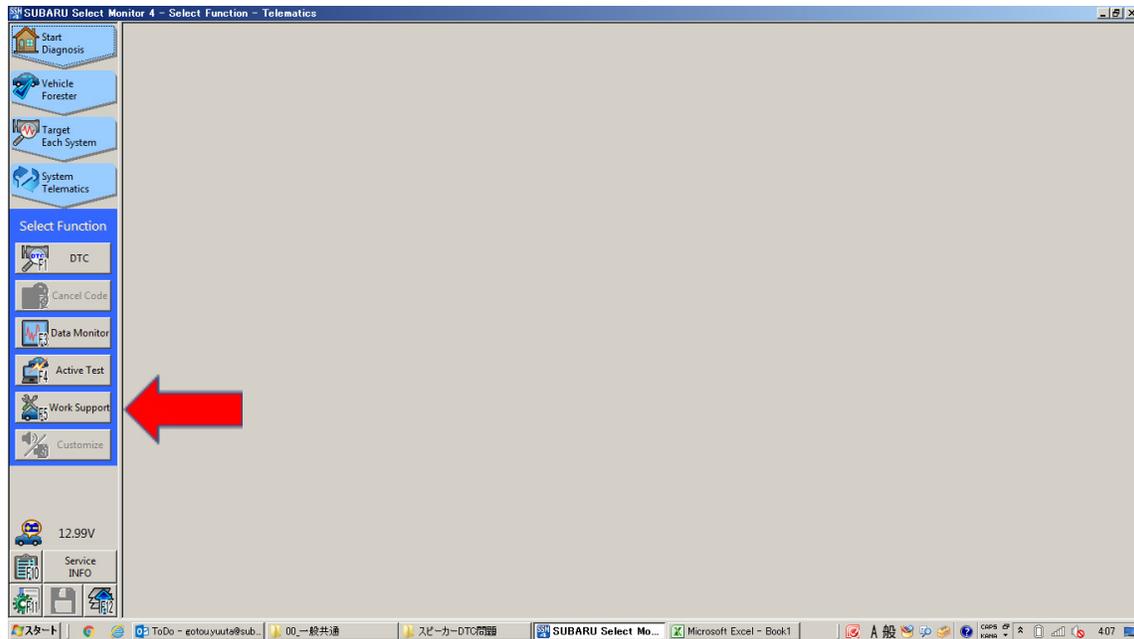
c. Click “Work Support” on the left-hand menu.

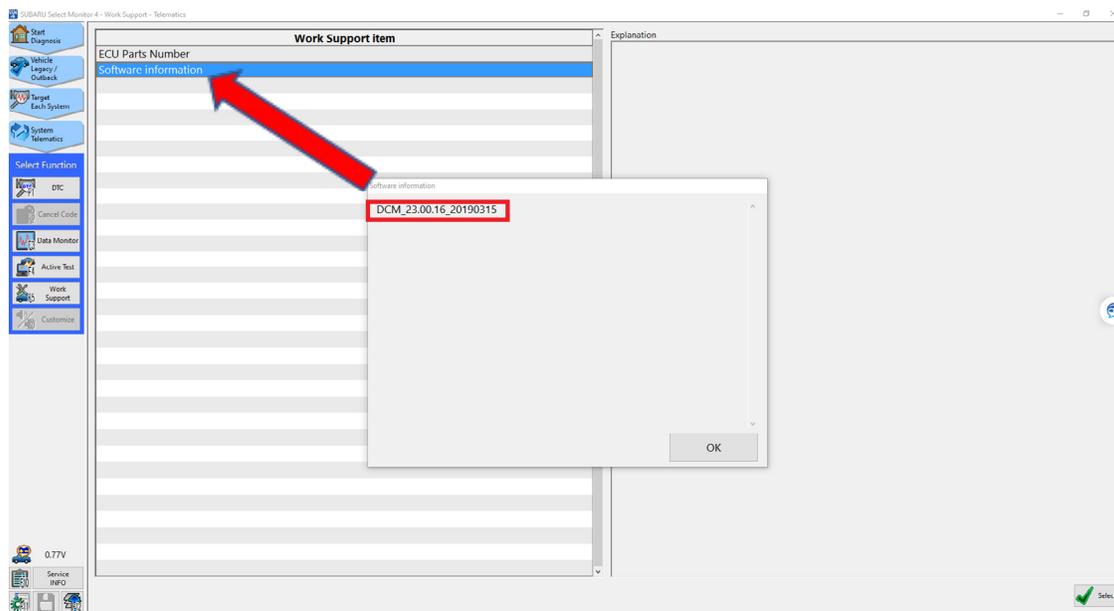
d. Select “Software Information” from the Work Support Items list.

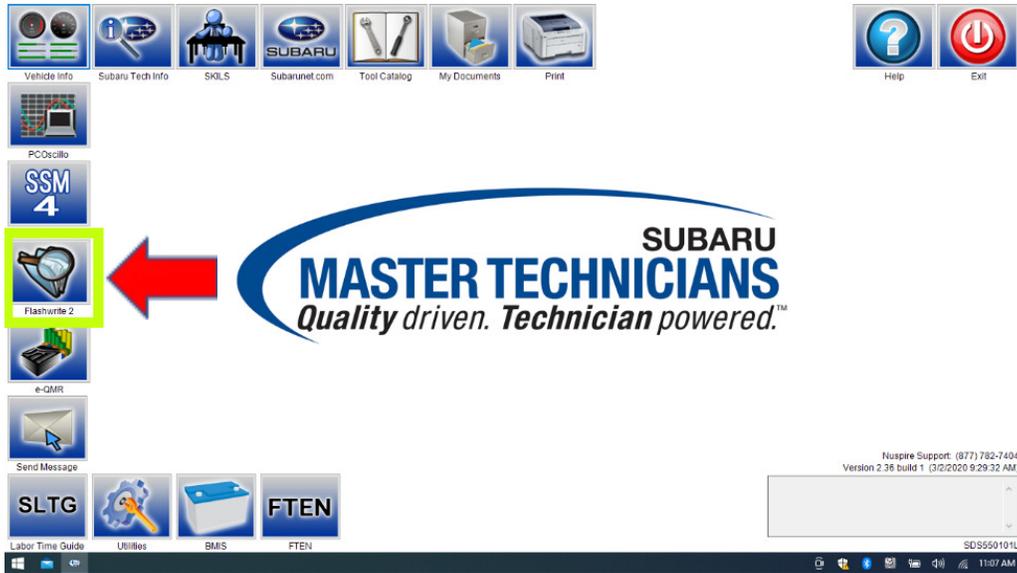
1. Connect the SDS Notebook and DSTi. Select **FlashWrite2** from the SDS Notebook GUI screen.

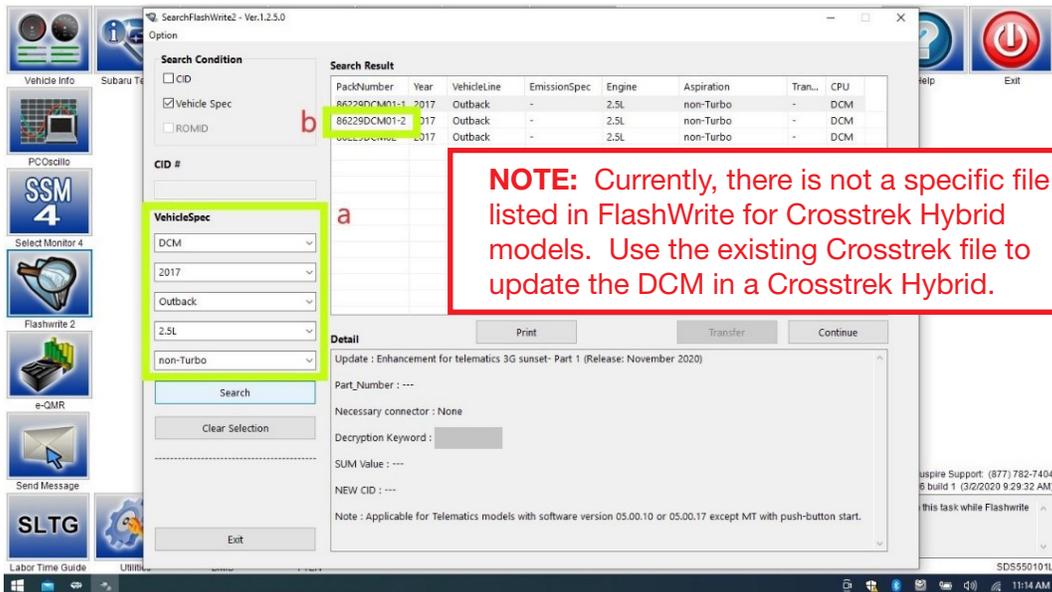
2. Once FlashWrite 2 opens, select DCM from the VehicleSpec drop down.
 - a) Complete entering the Vehicle Spec information.
 - b) Click and select the PK2 file **86229DCM01-2.pk2** intermediate image in FlashWrite.

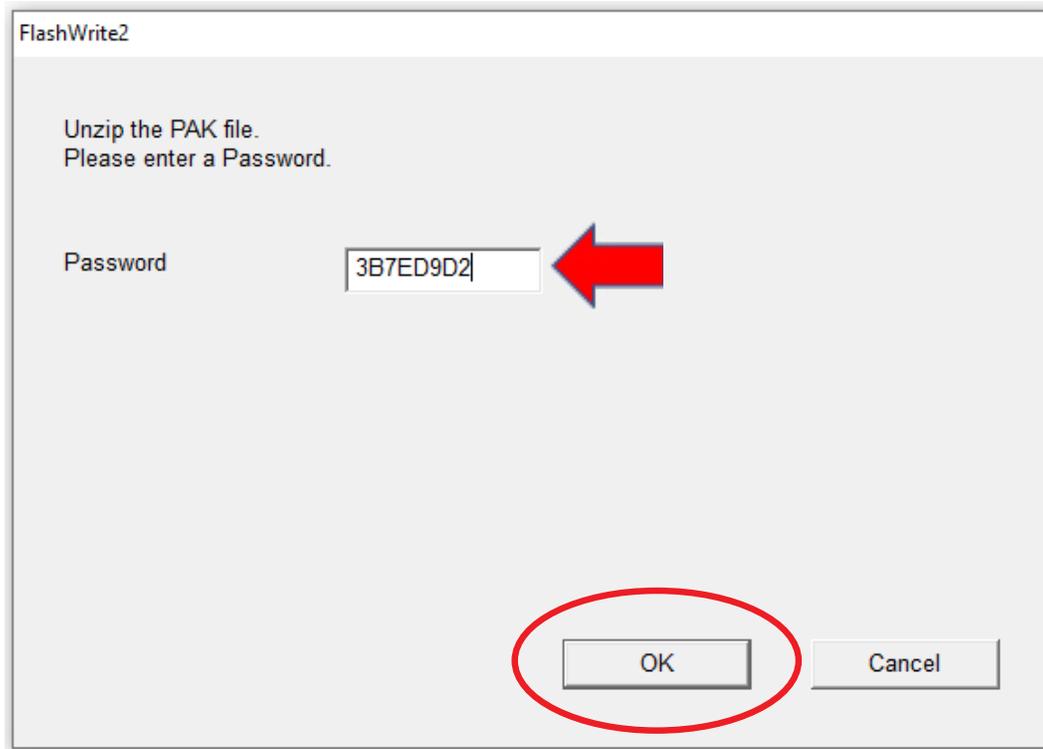
3. Enter the Decryption Keyword from the table above (3B7ED9D2) and click “**OK**.”

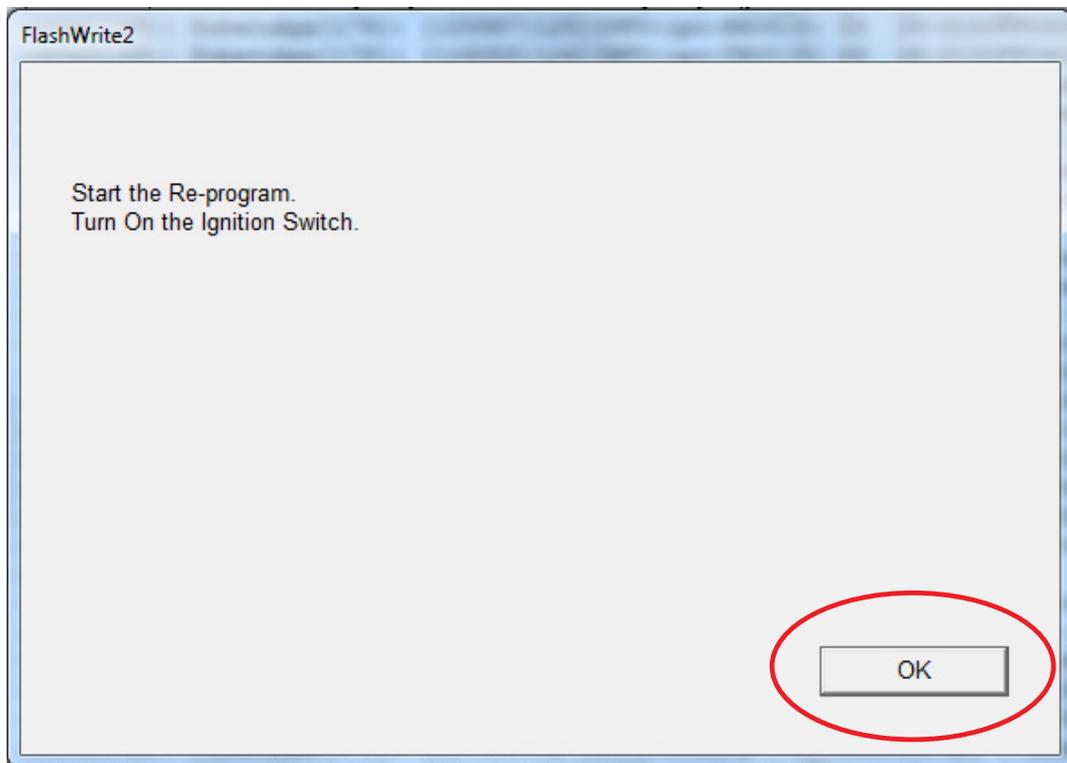
4. Turn the ignition ON and Click on ‘**OK**’ to start the reprogram.

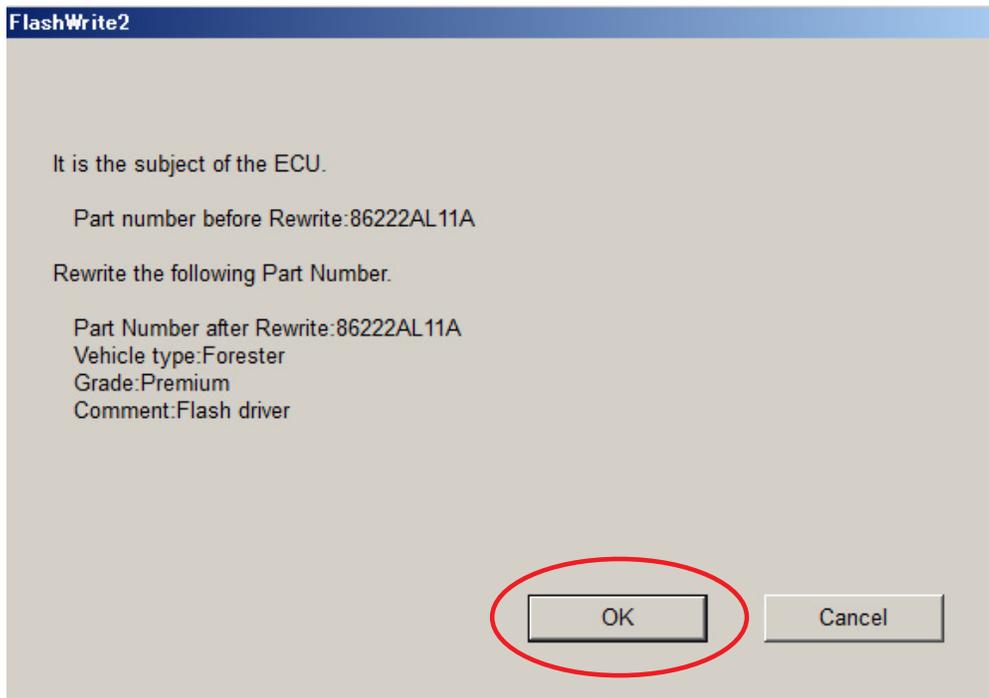
- a) Part number before and after reflash will be displayed. Click 'OK'.

(NOTE: This screen image is an EXAMPLE and may not represent the installed part number. These values will be the same before and after reflashing. The Screen will always indicate “Forester” no matter what model or model year is being reflashed.)

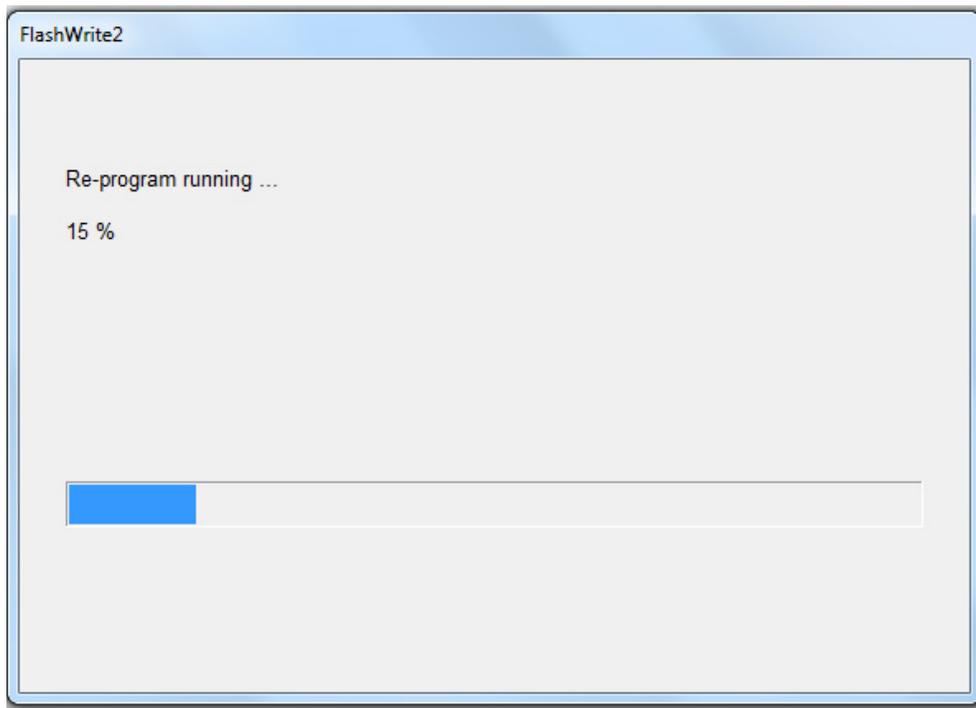
- b) A CAN flashing progression bar will appear and start incrementing toward 100%. The update may take up to 60 minutes to complete.

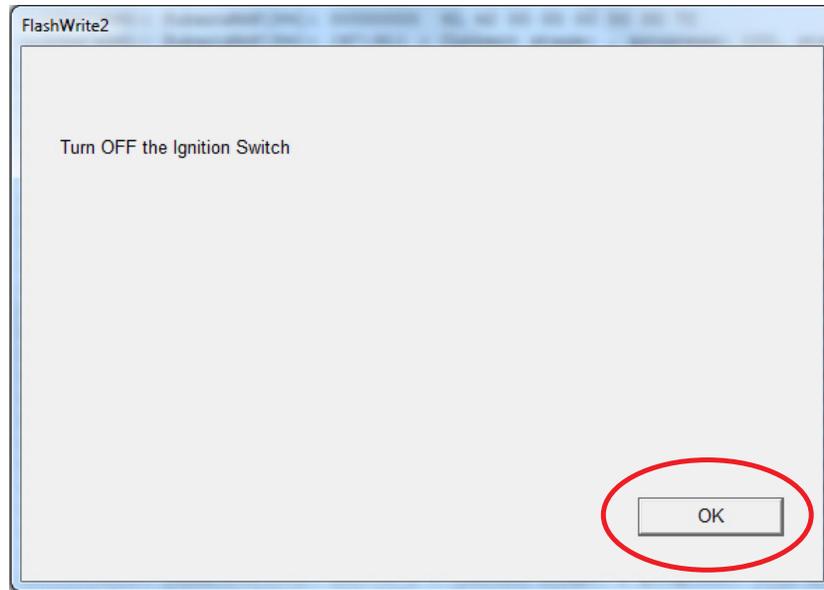
- c) **CRITICAL STEP:** After the reprogramming is finished, always put a CVT equipped vehicle in PARK and ensure the ignition is turned OFF. A prompt to switch the ignition OFF will be displayed. **DO NOT CLICK OK UNTIL THE VEHICLE IS IN PARK AND IGNITION IS SWITCHED OFF.**

- **WITHOUT TOUCHING THE BRAKE PEDAL,** push the start button (once).
- Move the selector into Park.
- Push the start button again to switch the vehicle OFF.
- **WAIT 30 SECONDS** and click OK.

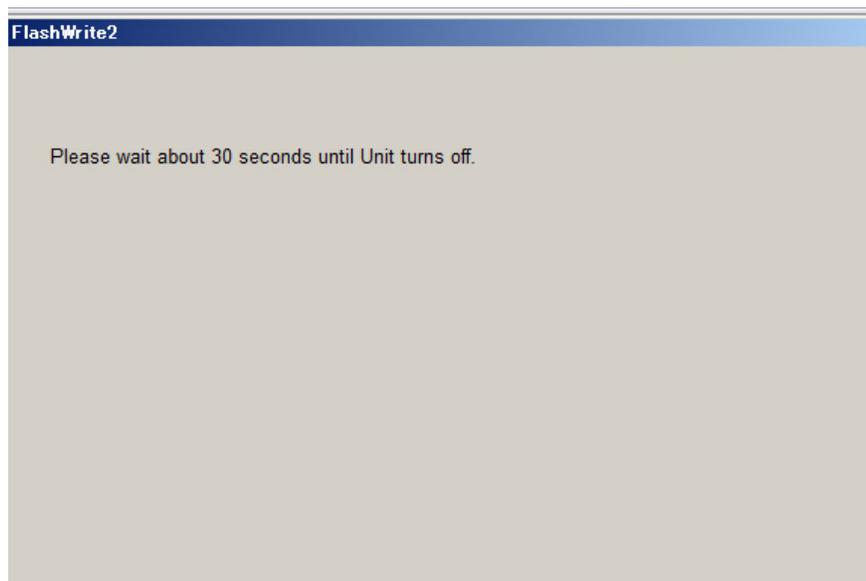
- d) **CRITICAL STEP:** FlashWrite will display the banner message “Please wait about 30 seconds until Unit turns off”. This banner page has a timer built in and will NOT continue until 30 seconds have passed and the DCM has safely shutdown. There is no way to verify the DCM has shutdown except waiting to ensure the full 30 seconds has passed. The next screen, e) shown below will display automatically.

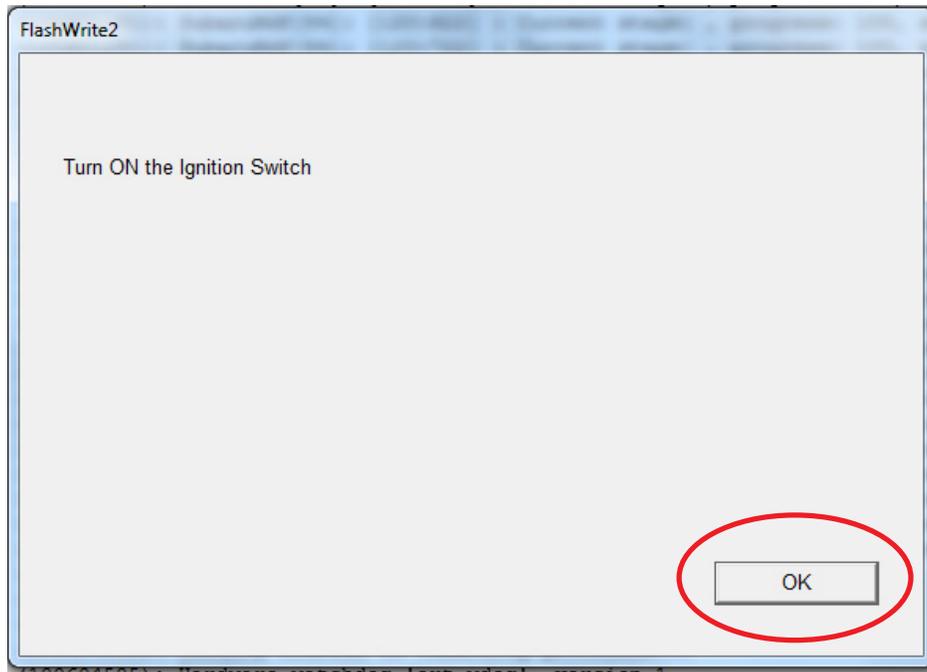
- e) A prompt for toggling ignition to ON will be displayed. Click on 'OK'

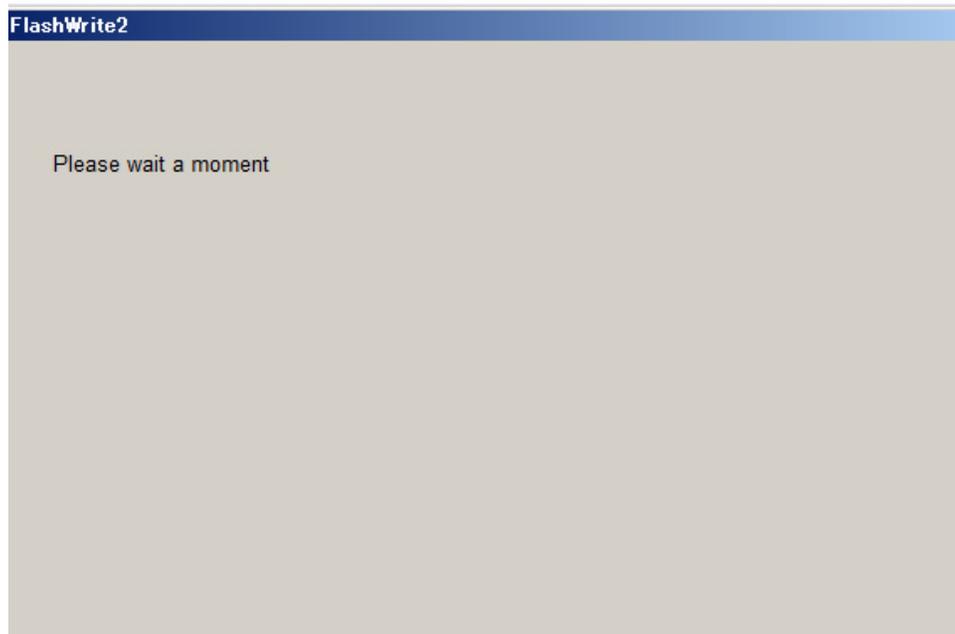
- f) FlashWrite will display the banner message "Please wait a moment."

CRITICAL: WAIT AT LEAST A FULL 5 MINUTES BEFORE PROCEEDING FROM THIS POINT. DURING THIS WAITING PERIOD, "REPARTITIONING" IS TAKING PLACE IN THE DCM AND CANNOT BE INTERRUPTED. DO NOT ATTEMPT ANY OTHER FUNCTIONS DURING THIS TIME (E.G. SWITCHING THE IGNITION OFF, STARTING ANOTHER UPDATE, USING THE SSM TO CHECK DCM STATUS, OPENING THE DOOR(S), ETC.).

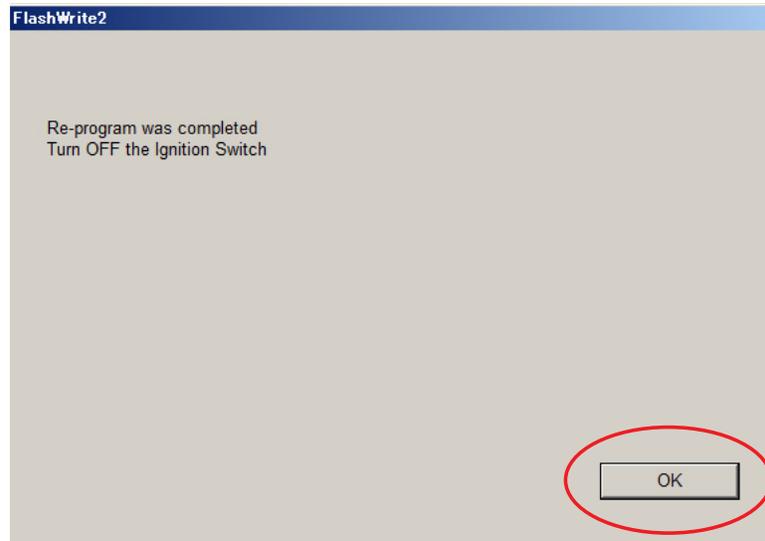
- g) FlashWrite will display the banner message “Re-program was completed. Turn OFF the Ignition Switch.”

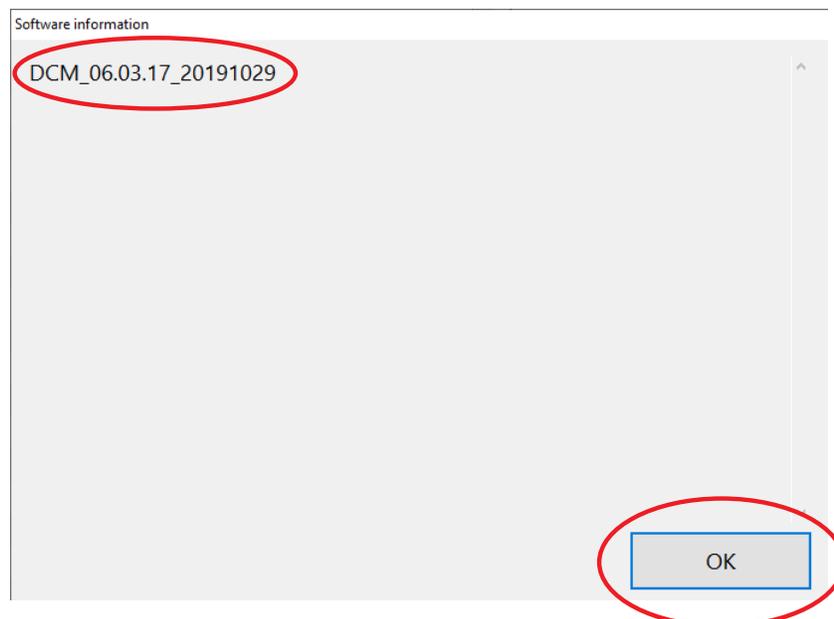
5. Verify the new DCM software version:

- a) Confirm SSM4 and DCM communication by retrieving the current software version.
- b) Click “Each System” on the left-hand menu.
- c) Select “Telematics” from the Systems List.
- d) Click “Work Support” on the left-hand menu.
- e) Select “Software Information” from the Work Support Items List.
- f) Record the current version of software on the RO for reference.
 - i. Successful retrieval of DCM software version? Proceed to **Step 6 below**.
 - ii. If SSM4 cannot communicate with DCM, DCM has current DTC(s), or the DCM software version cannot be retrieved, contact Techline for assistance before proceeding.

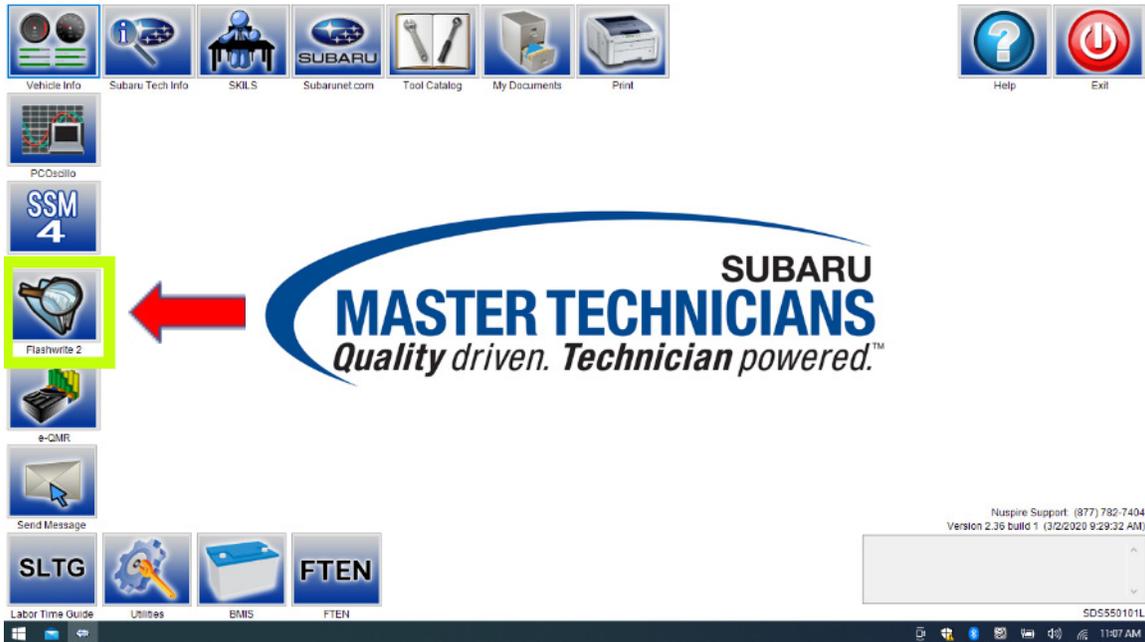
1. Connect the SDS Notebook and DSTi. Select **FlashWrite2** from the SDS Notebook GUI screen.

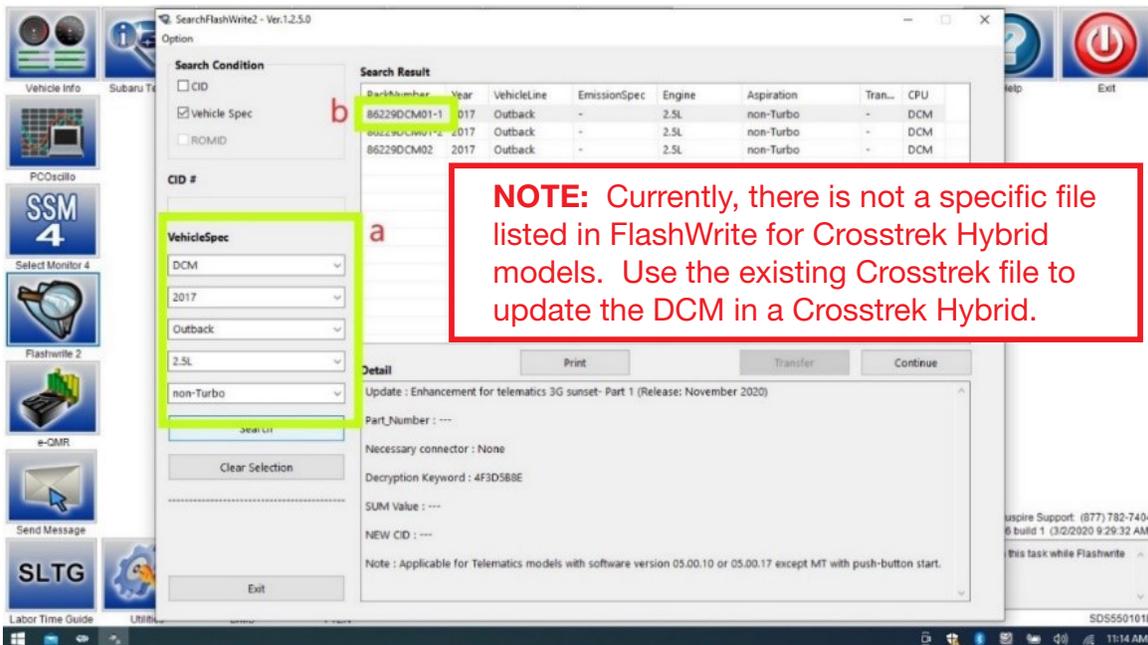
2. Once FlashWrite 2 opens, select DCM from the VehicleSpec drop down.
 - a) Complete entering the Vehicle Spec information.
 - b) Click and select the Pak file **86229DCM01-1.pak** intermediate image in FlashWrite.

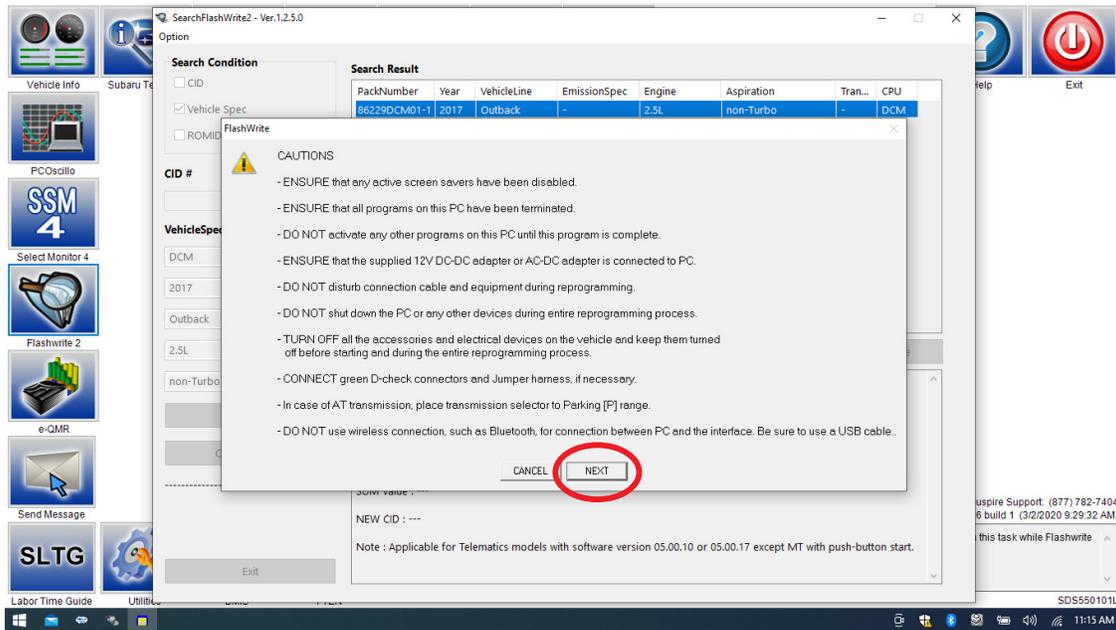
3. CAUTIONS will be displayed. Check the notices and click on “NEXT.”

WARNING: In the screenshot above, the on-screen directions indicate to leave the vehicle in PARK, doing this will cause the reflash procedure to FAIL. The vehicle **MUST BE LEFT IN NEUTRAL** for the entire reflash procedure. Reference **Step 1** above for all the vehicle conditions required for reprogramming.

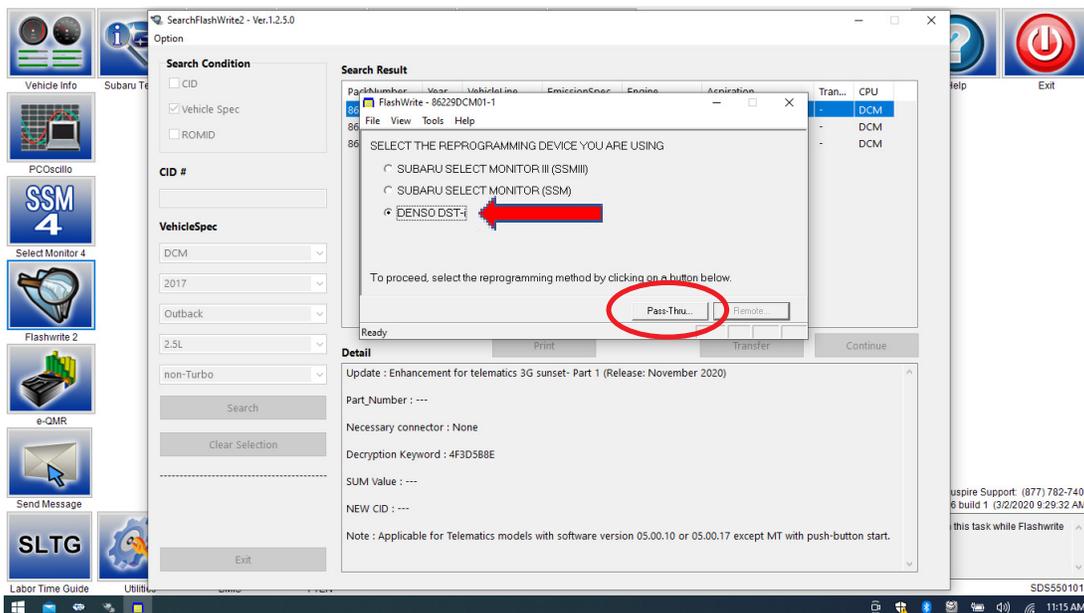
4. Select the reprogramming device and click “OK”.

5. Click on “Pass Thru.”

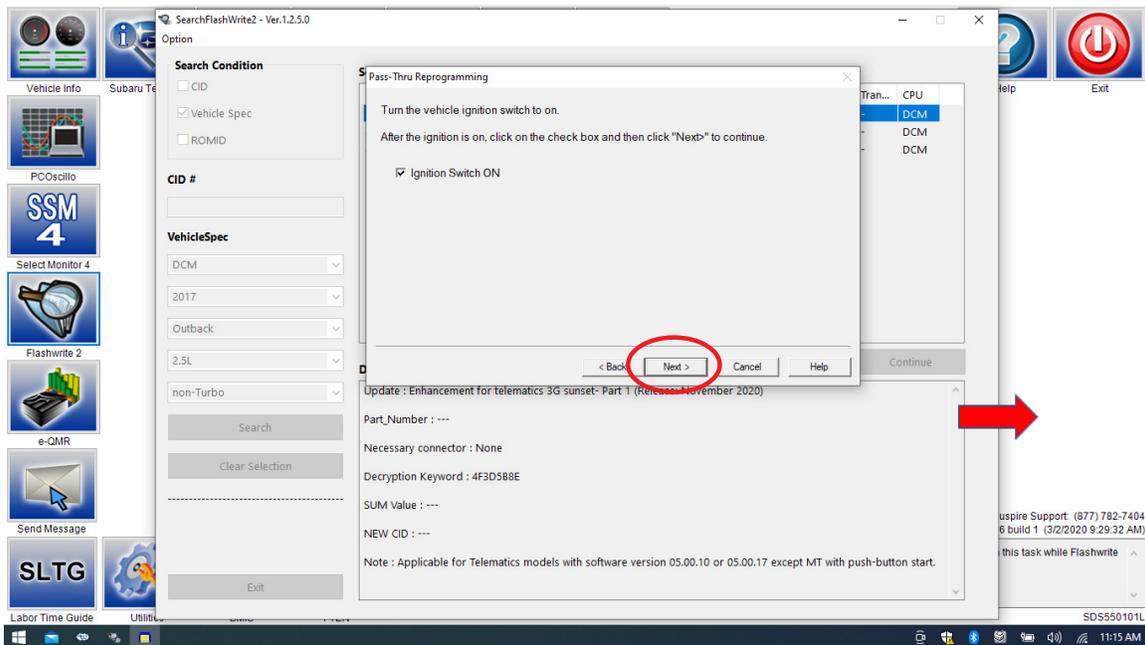
a) Turn on the ignition switch and click on ‘Next’.

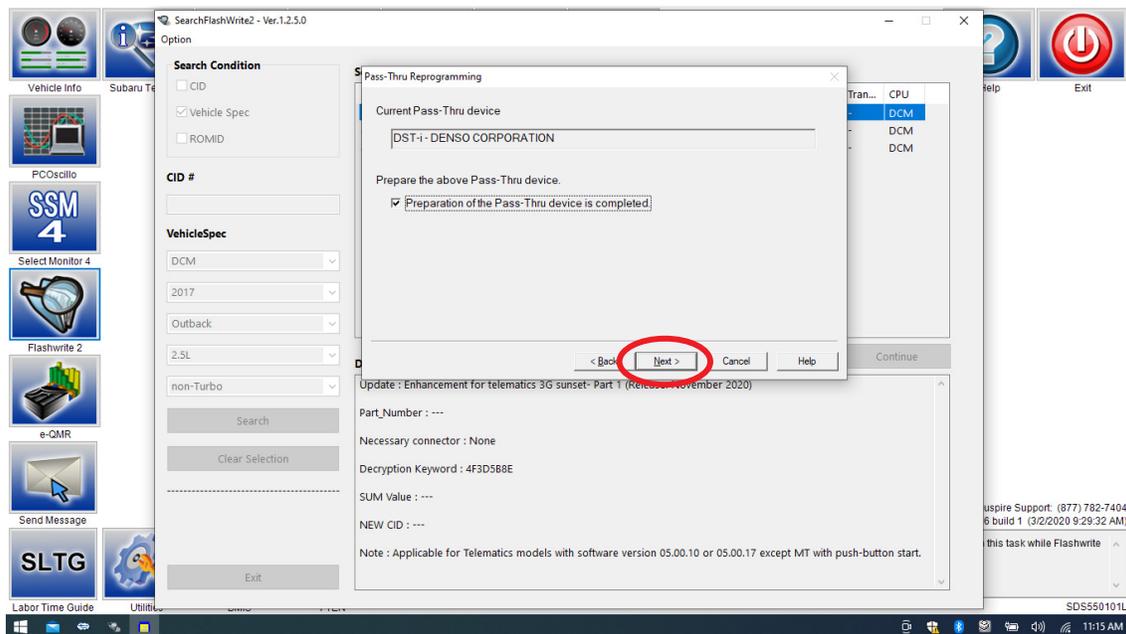
b) Pass-Thru preparation completed, click on Next to continue.

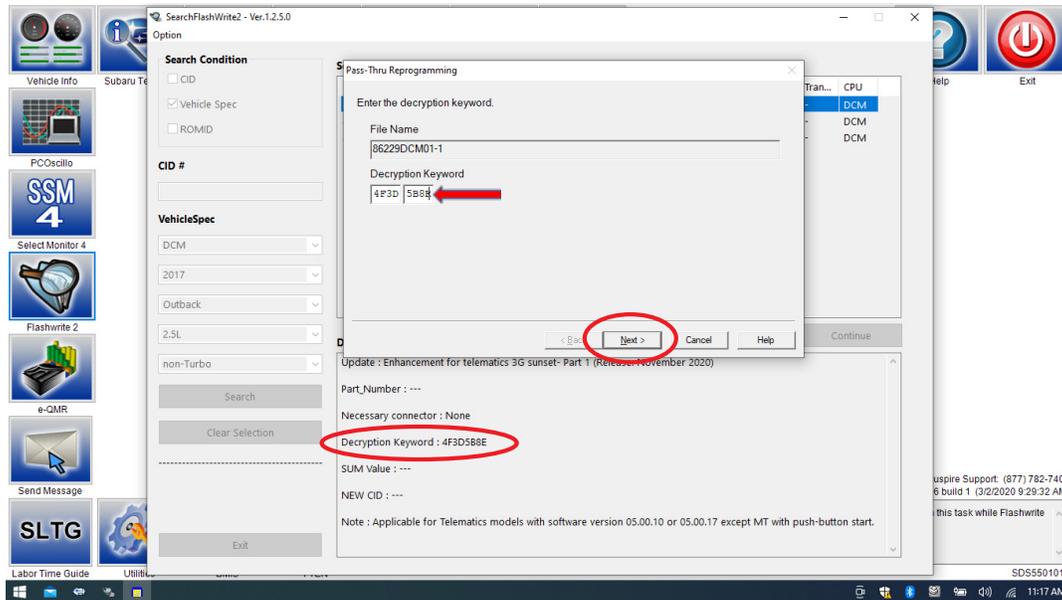
7. Enter the Decryption Keyword from the table above (4F3D5B8E) and click on “Next”.

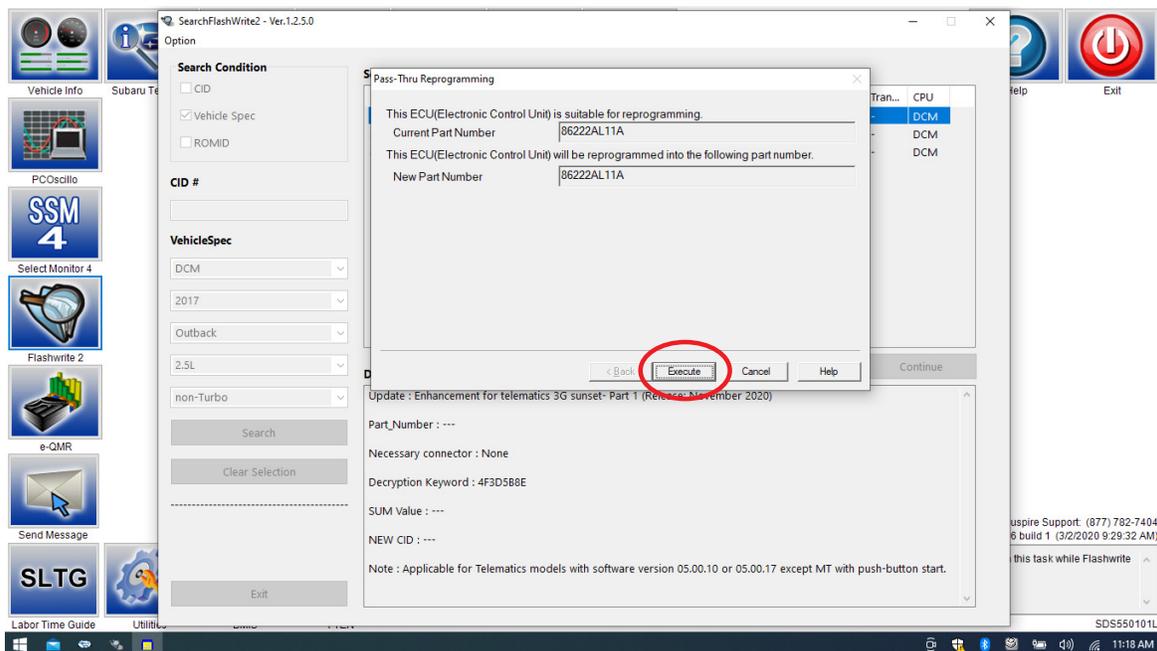
8. Click on “Execute.”

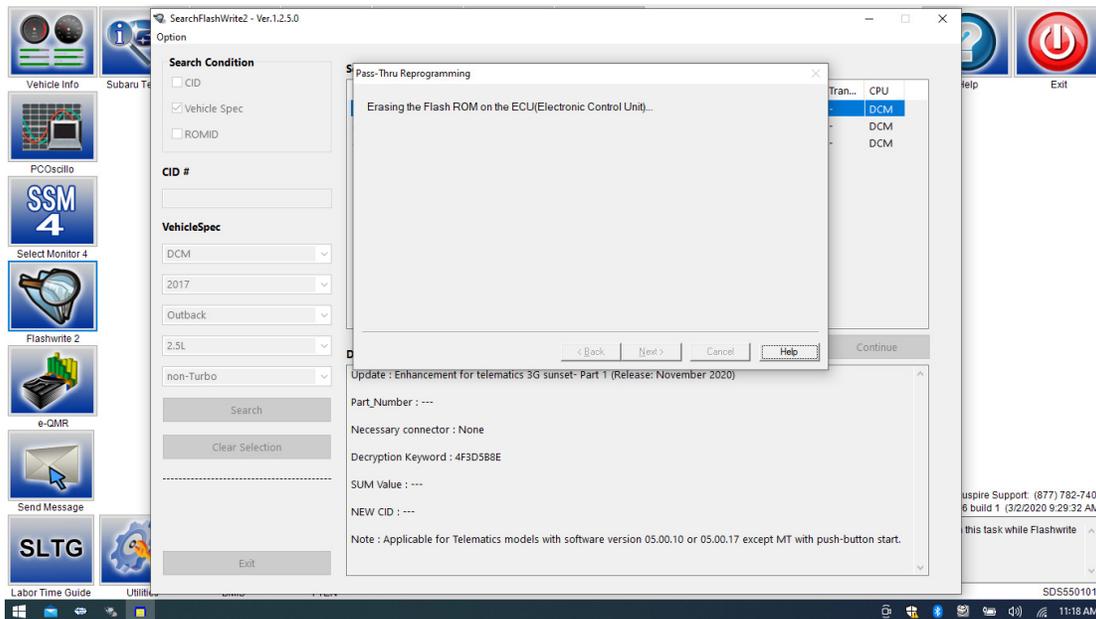
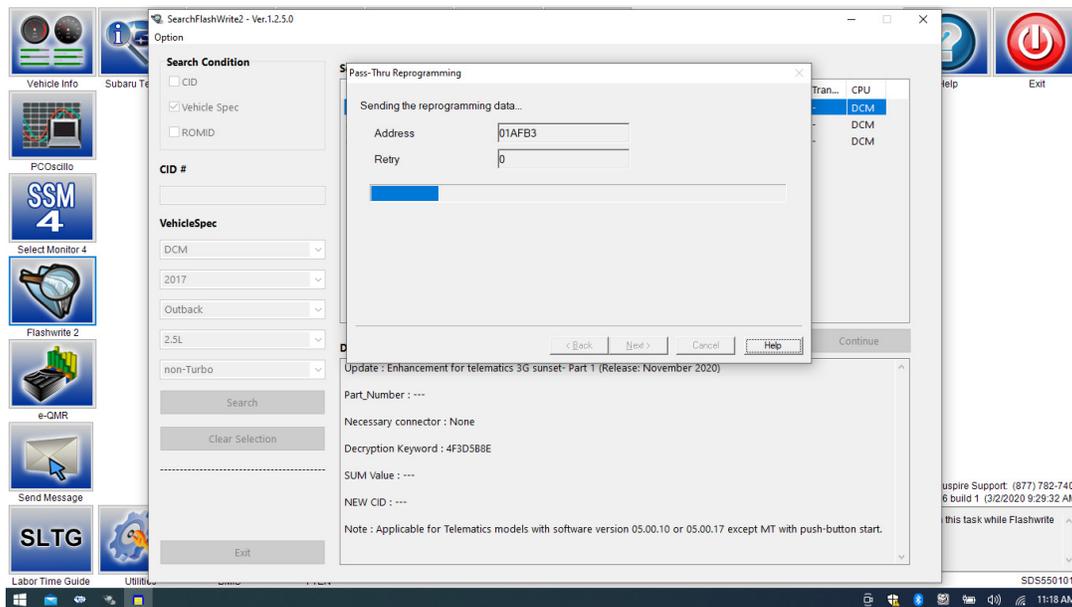
9. Reprogramming will begin. Please wait.

NOTE: Pay close attention to the start of the status bar progression. Failures may occur at the beginning of the procedure. Once progress is at 5%, reprogramming should continue trouble-free until 100% complete. The update may take up to 60 minutes to complete.

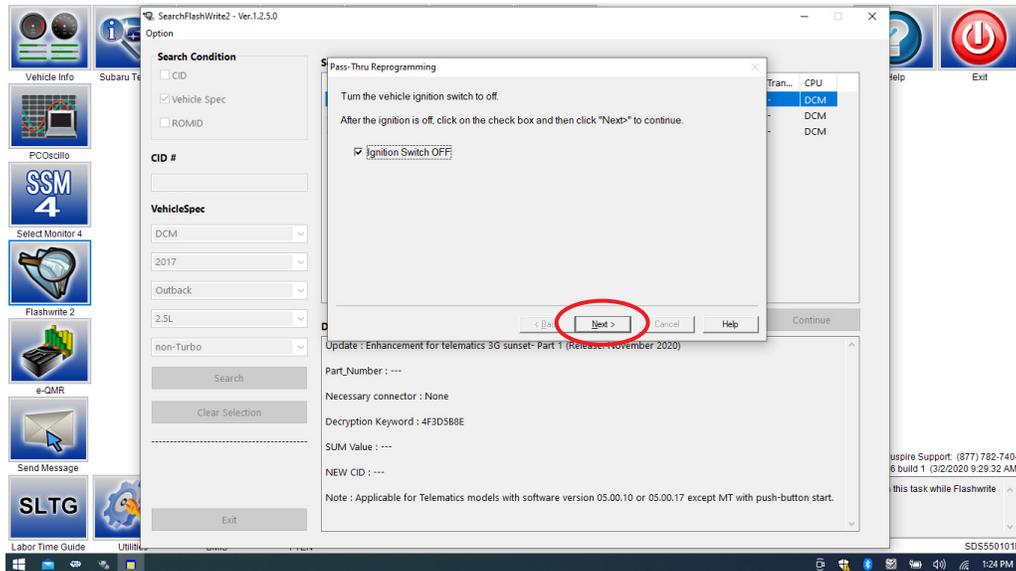
10. **CRITICAL STEP:** After the reprogramming is finished, always put a CVT equipped vehicle in PARK and ensure the ignition is turned OFF. A prompt to switch the ignition OFF will be displayed. DO NOT CLICK OK UNTIL THE VEHICLE IS IN PARK AND IGNITION IS SWITCHED OFF.

- **WITHOUT TOUCHING THE BRAKE PEDAL**, push the start button (once).
- Move the selector into Park.
- Push the start button again to switch the vehicle OFF.
- **WAIT 30 SECONDS** and click OK.

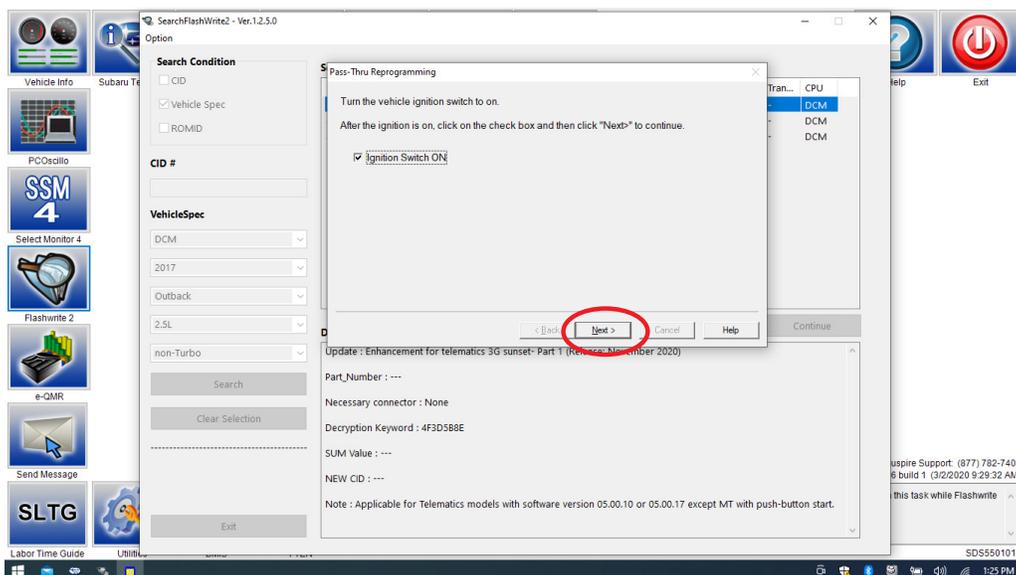
11. CRITICAL STEP: WAIT 30 seconds, cycle the ignition key or push-button start from OFF to ON then click “Next.”

CRITICAL: WAIT AT LEAST A FULL 5 MINUTES BEFORE PROCEEDING FROM THIS POINT. DURING THIS WAITING PERIOD, “REPARTITIONING” IS TAKING PLACE IN THE DCM AND CANNOT BE INTERRUPTED. DO NOT ATTEMPT ANY OTHER FUNCTIONS DURING THIS TIME (E.G. SWITCHING THE IGNITION OFF, STARTING ANOTHER UPDATE, USING THE SSM TO CHECK DCM STATUS, OPENING THE DOOR(S), ETC.).

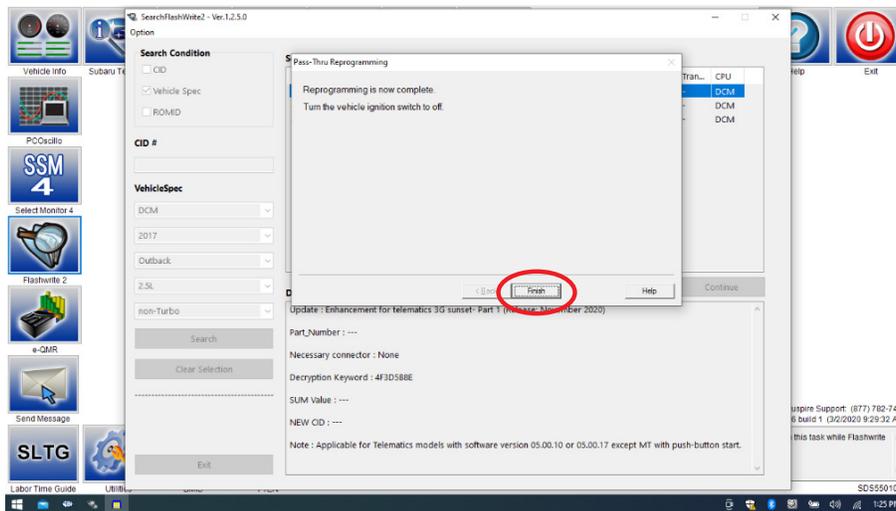
12. “Reprogramming is now complete” is displayed. Click on “Finish”.

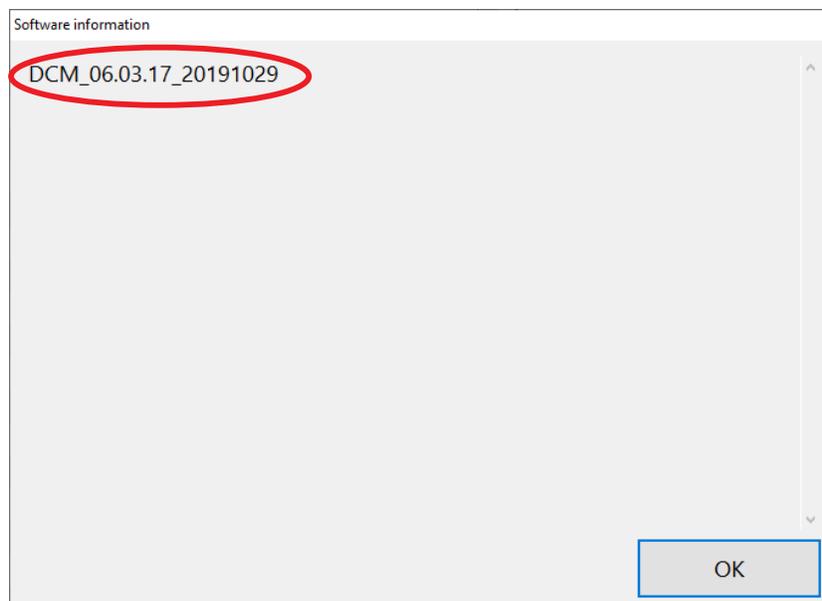
- a) Confirm SSM4 and DCM communication by retrieving the current software version.
- b) Click “Each System” on the left-hand menu.
- c) Select “Telematics” from the Systems List.
- d) Click “Work Support” on the left-hand menu.
- e) Select “Software Information” from the Work Support Items List.
- f) Record the current version of software on RO for reference.
 - i. After successful retrieval of the software version, proceed to **Step 14**.

NOTE: If SSM4 cannot communicate with DCM, DCM DTCs are current, or the DCM software version cannot be retrieved, contact Techline for assistance before proceeding.

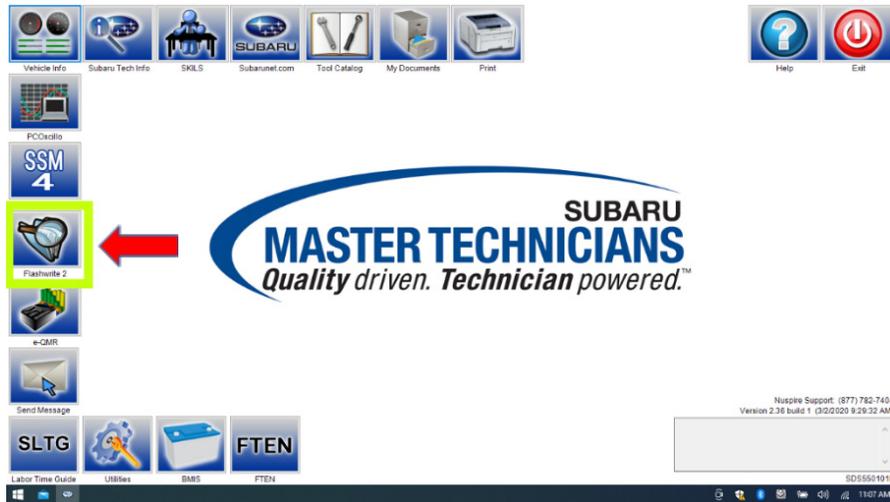
1. Connect SDS Notebook and DSTi. Select **FlashWrite2** from the SDS Notebook GUI screen.

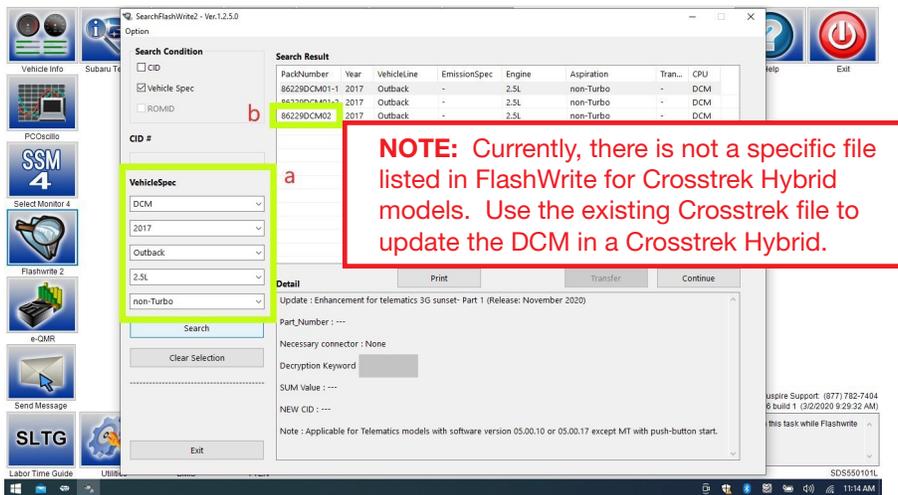
2. Once FlashWrite 2 opens, select DCM from the VehicleSpec drop down.

b) Click and select the PK2 file **86229DCM02.pk2** intermediate image in FlashWrite.

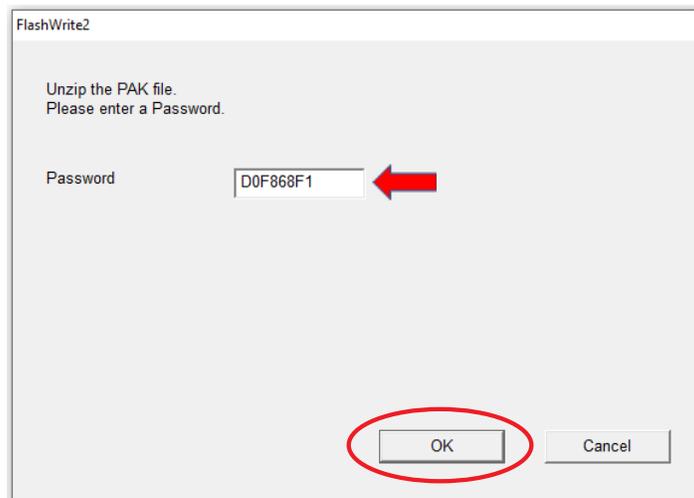
3. Enter the Decryption Keyword from the table above (D0F868F1) and click “OK”.

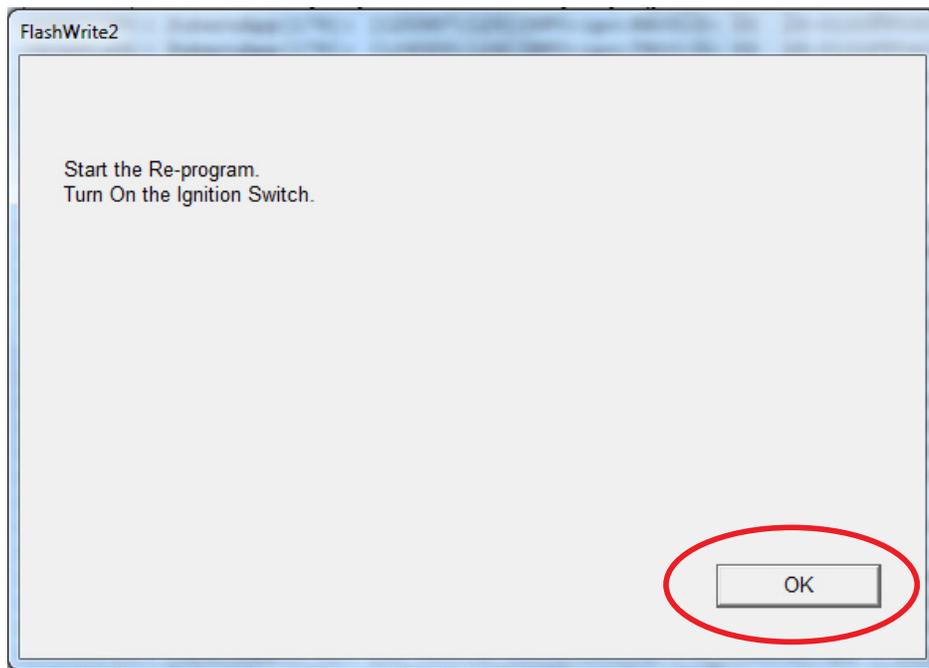
- a) Turn the ignition switch ON and Click on 'OK' to start the reprogram.

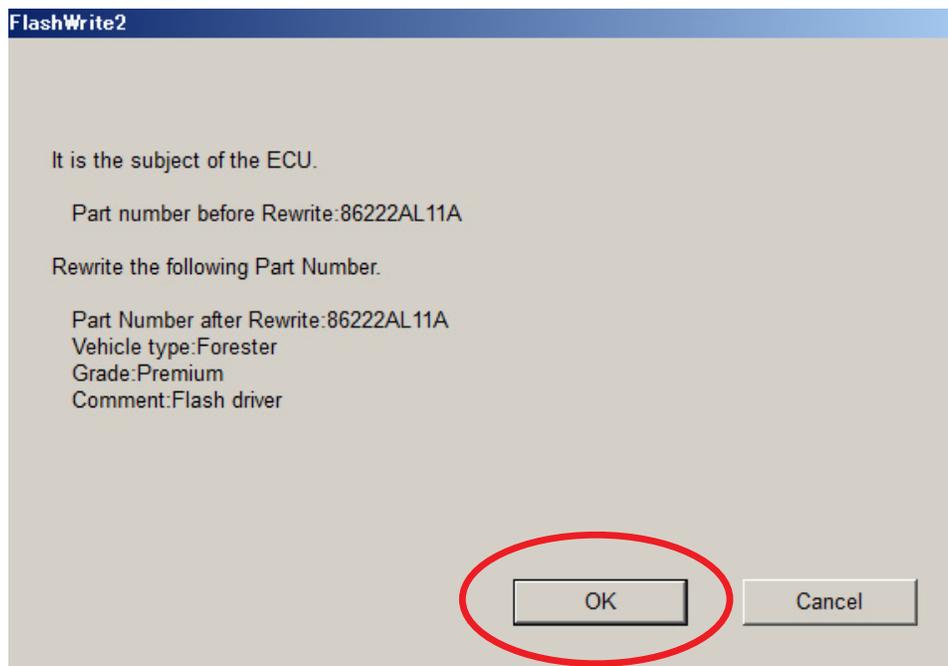
- b) Part numbers before and after reflash will be displayed. Click 'OK'.

(NOTE: This screen image is an EXAMPLE and may not represent the installed part number. These values will be the same before and after reflashing. The Screen will always indicate “Forester” no matter what model or model year is being reflashed.)
