SERVICE BULLETIN

APPLICABILITY: 2016-18MY Legacy/Outback
 2016-18MY Impreza
 2016-18MY Crosstrek
 2016-18MY Forester
 2017-18MY WRX

NUMBER: 15-280-21R

SUBJECT: Gen1 Telematics Reprogramming for 3G Sunset

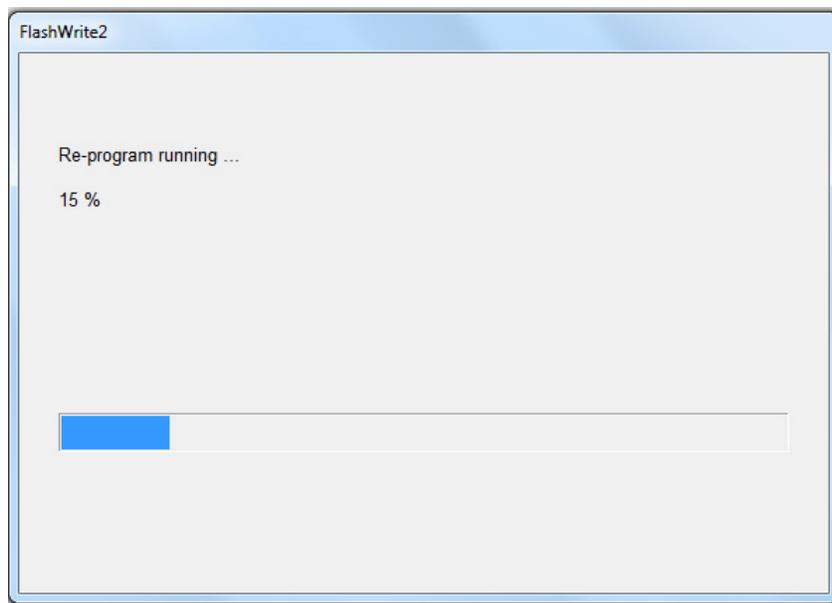
A CAN flashing progression bar will appear and start incrementing toward 100%. The update may take up to 60 minutes to complete.

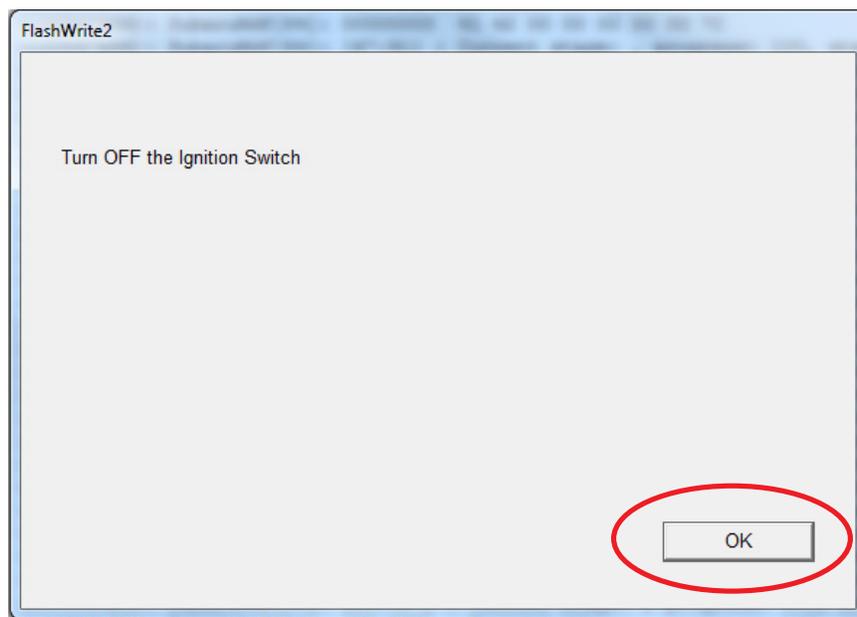
- c) **CRITICAL STEP:** After the reprogramming is finished, always put a CVT equipped vehicle in PARK and ensure the ignition is turned OFF. A prompt to switch the ignition OFF will be displayed. **DO NOT CLICK OK UNTIL THE VEHICLE IS IN PARK AND IGNITION IS SWITCHED OFF.**

- **WITHOUT TOUCHING THE BRAKE PEDAL**, push the start button (once).
- Move the selector into Park.
- Push the start button again to switch the vehicle OFF.
- **WAIT 30 SECONDS** and click OK.

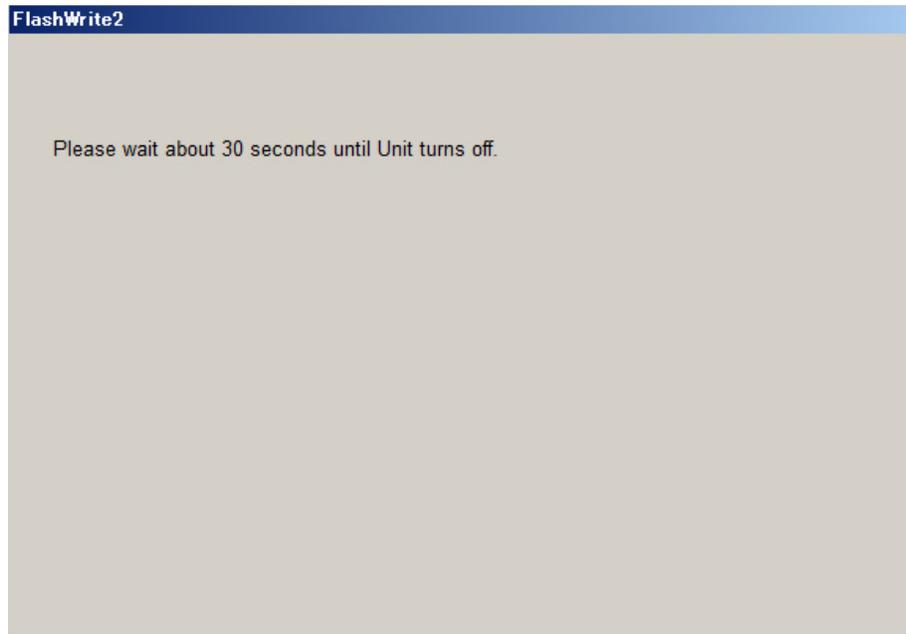
- d) **CRITICAL STEP:** FlashWrite will display the banner message “Please wait about 30 seconds until Unit turns off”. This banner page has a timer built in and will NOT continue until 30 seconds have passed and the DCM has safely shutdown. There is no way to verify the DCM has shutdown except **waiting to ensure the full 30 seconds has passed**. The next screen, e) shown below will display automatically.

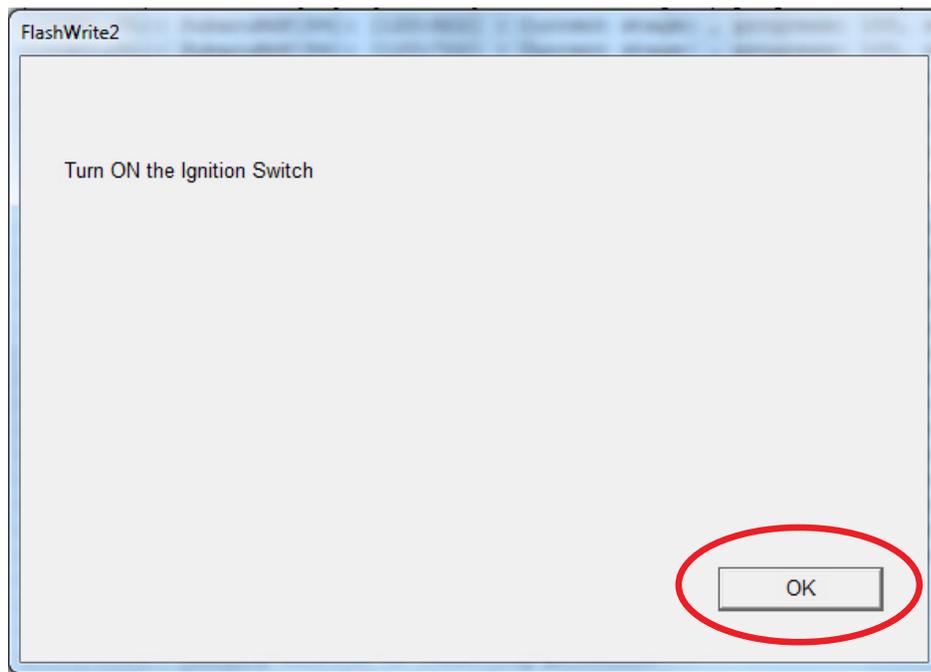
- e) The prompt for **switching the** ignition to ON will be displayed. Click on ‘OK.’

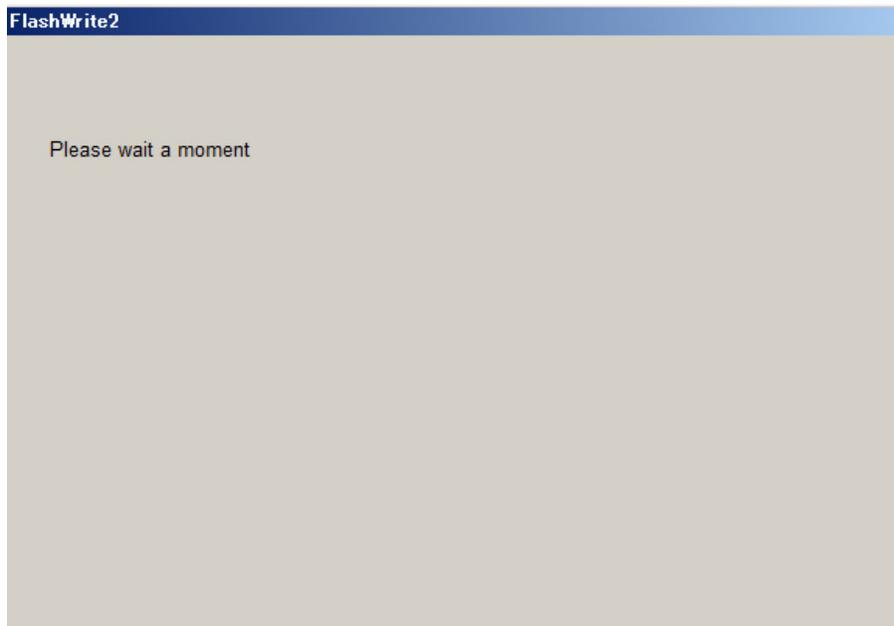
- f) FlashWrite will display the banner message “Please wait a moment.”

CRITICAL: WAIT at least a FULL 5 MINUTES before proceeding from this point. During this waiting period, “Repartitioning” is taking place in the DCM and CANNOT be interrupted. DO NOT attempt any other functions during this time (e.g. switching the ignition off, starting another update, using the SSM to check DCM status, opening the door(s), etc.).

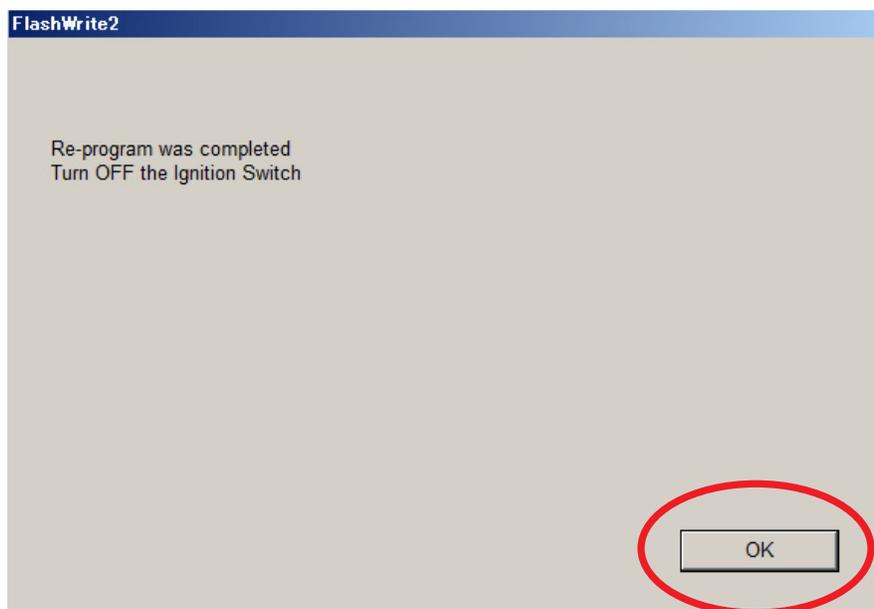
- g) FlashWrite will display the banner message “Re-program was completed. Turn OFF the Ignition Switch.”

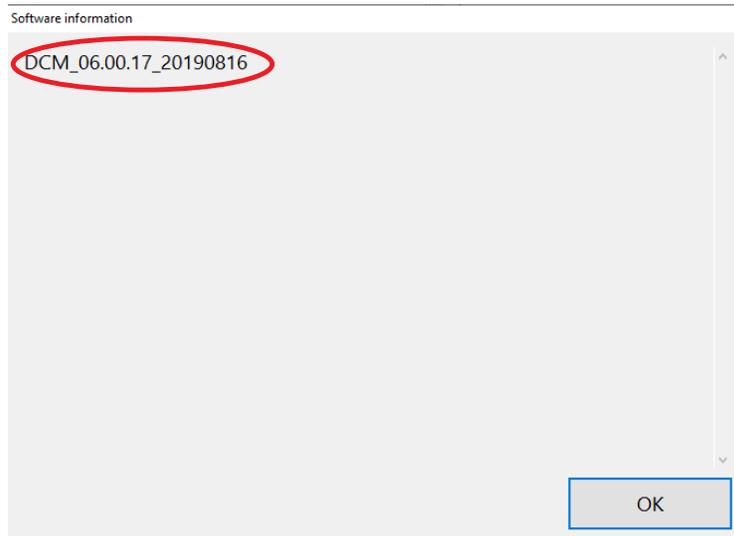
- b) Select “Telematics” from the Systems List.
- c) Click “Work Support” on the left-hand menu.
- d) Select “Software Information” from the Work Support Items List.
- e) Record the current version of software on the RO for reference.
 - i. The final version of DCM software should be **DCM_06.00.17_20190816**.
 - 1. If the final version is correct, proceed to **Step 5**.
 - 2. If the final version is not correct, record the DCM software version and contact Techline.

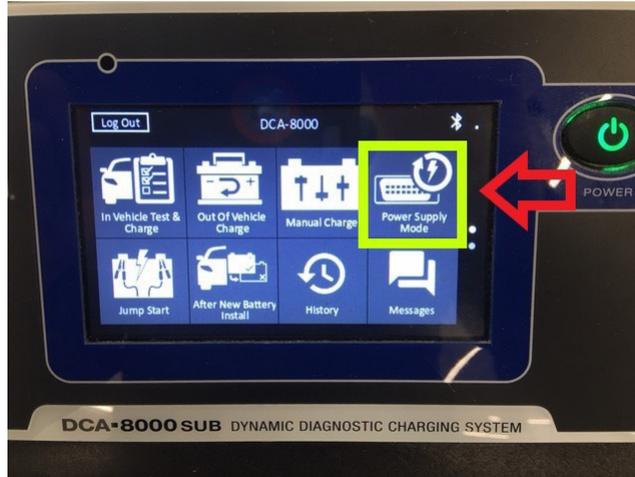
- **NEVER** connect the DST-i until the Power Supply Mode function has completed its battery test mode and the Charging Voltage has dropped to a steady 13.5 Volts on the display.
- Once Power Supply Mode reaches a steady 13.5 volts, connect the DST-i to the OBD connector.
- **If the battery voltage rises above 14V while the reprogramming is in process, the procedure will abort.** Charging voltage above 14V can indicate a need to test or charge the vehicle battery before any further reprogramming attempt is made.

CRITICAL: Power Supply Mode voltage must be stabilized at **13.5** Volts before proceeding.
