# Service Bulletin

Bulletin No.: 20-NA-106

**Subject: Unable to Change Camera View, Stuck in Rear Camera View or Video Processing Module (VPM) Not Responding**

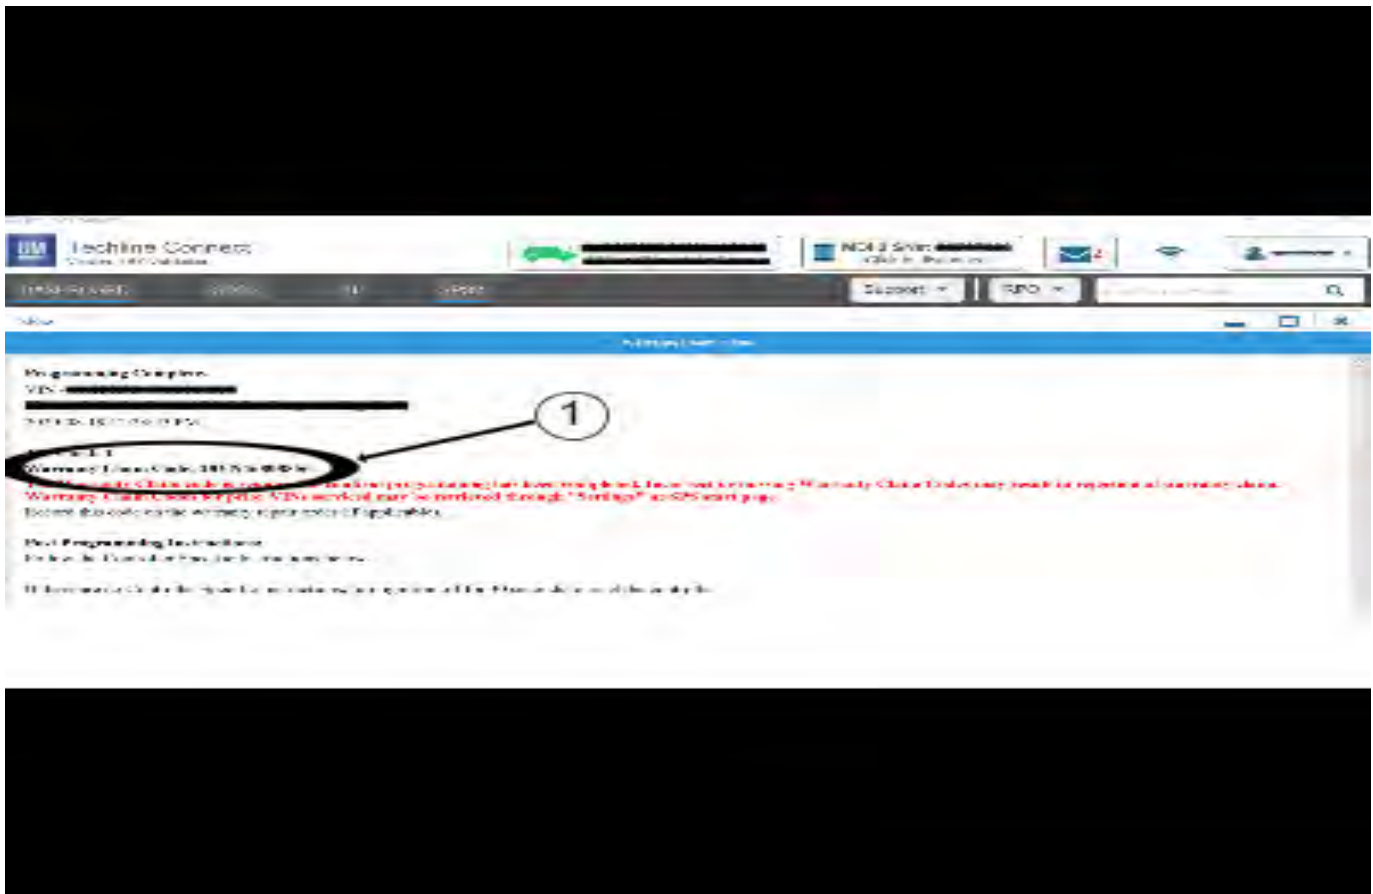
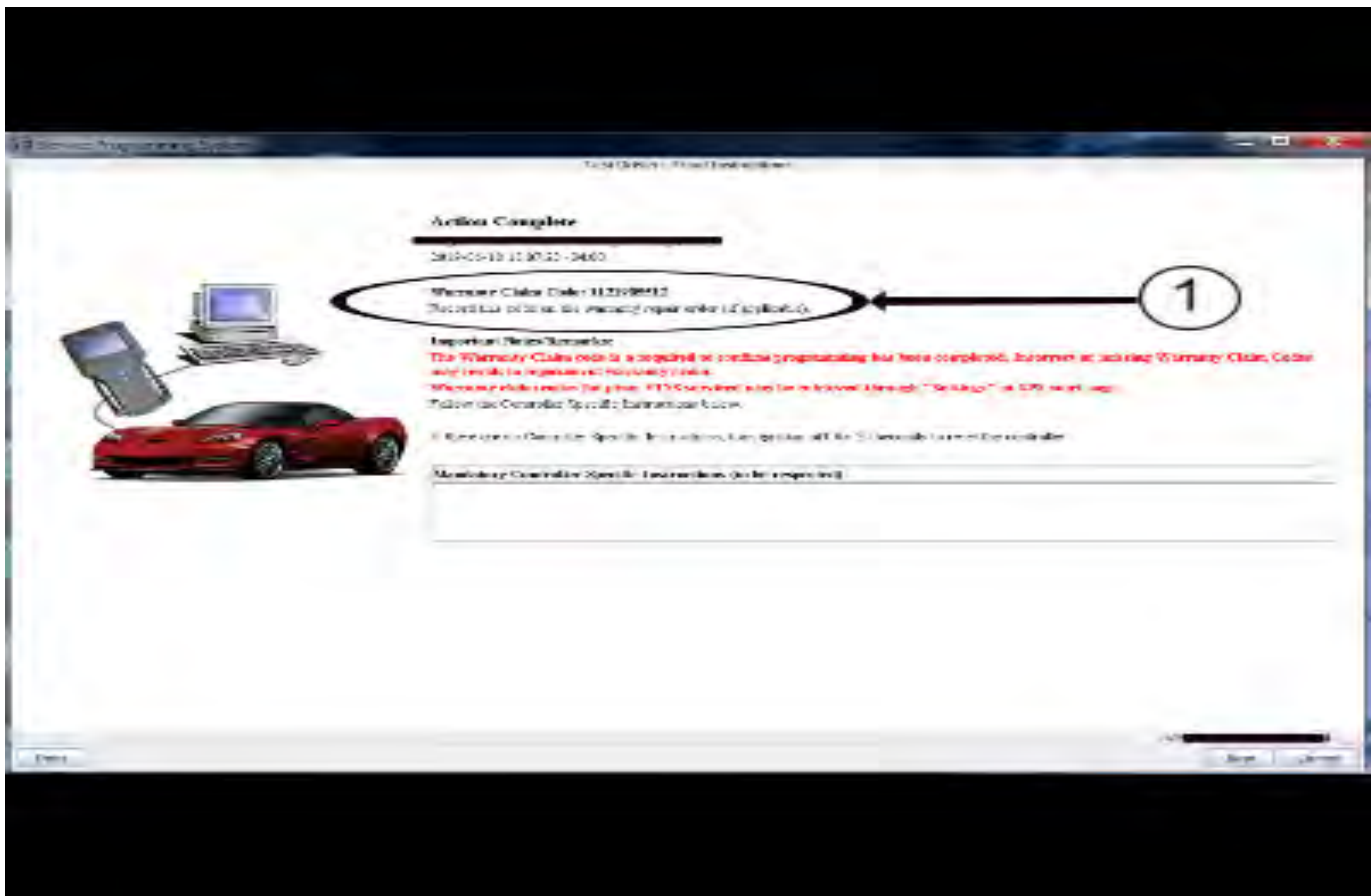
5431209

**Note:** The screenshots above are an example of module programming and may not be indicative of the specific module that is being programmed. Module selection and VIN information have been blacked out.

1. Reprogram the Video Processing Module. Refer to *K157 Video Processing Module: Programming and Setup* in SI.
