# TECHNICAL TOPICS

### Intermittent Passive Entry Operation

20-21MY L663 Defender

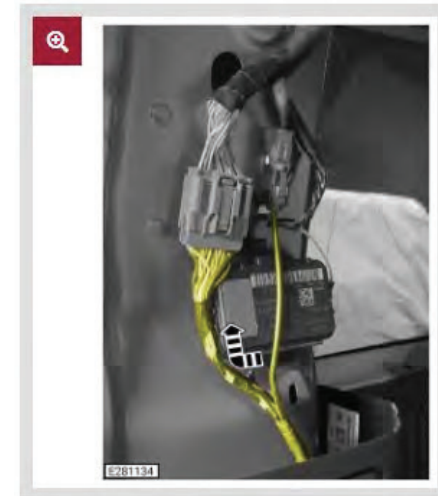
- JLRTB02076NAS1 will provide instructions to relocate a new RF Receiver behind the left D-pillar trim.
- Prior to installation a link lead will need to be assembled, please refer to TOPIx Workshop Manual section 418-02: Wiring Harnesses – Description & Operation Wiring Harness to review JLR approved wiring harness repair methods.
- **Publication of JLRTB02076NAS1 has been delayed due to part availability.**
- Please raise a TA until the bulletin is published.
