# QUALITY ACTION

# CAMPAIGN BULLETIN

## Audio Control Unit Reprogram Dealer Inventory

Reference: PM984

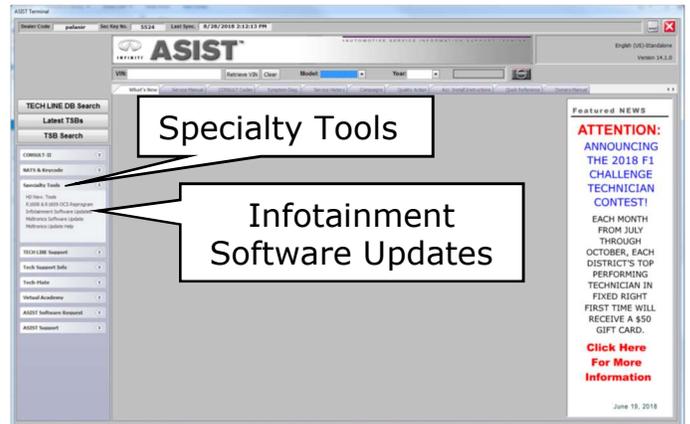
Figure 2

2. Open Infotainment downloader tool.  
(Figure 2)

- Open ASIST
- Select Specialty Tools
- Select Infotainment Software Updates

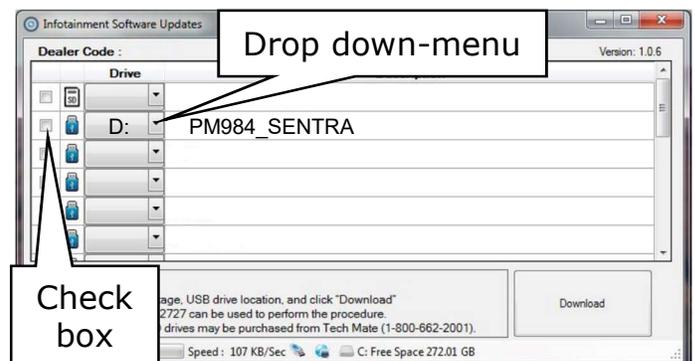
Figure 3

3. Select the check box next to the item titled **PM984\_SENTRA**.(Figure 3)

- Use the drop-down menu and select the location of the USB drive
- Select Download, and then wait for the download to complete
- The update is estimated to take 10-15 minutes to download to the USB drive

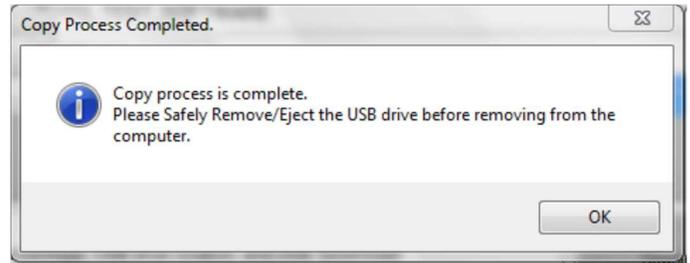
4. When the data download/transfer is completed, the message in Figure 4 will display.

- Select **OK**

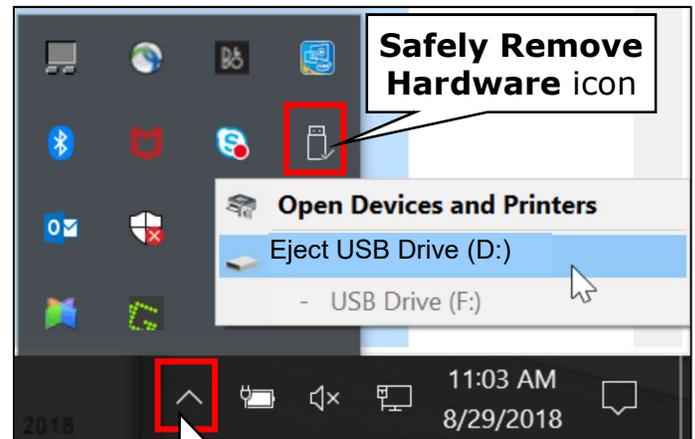
Figure 5

5. Once the transfer is complete, safely remove the USB drive from the ASIST Station. (Figure 5)

- From the PC toolbar, select the Safely Remove Hardware icon
- Select the USB drive to be removed
- Wait for message to appear that states, It is safe to remove hardware
- Remove the USB drive from the ASIST station

Follow the steps to safely remove the USB drive. If not followed, the USB drive may corrupt the update software.

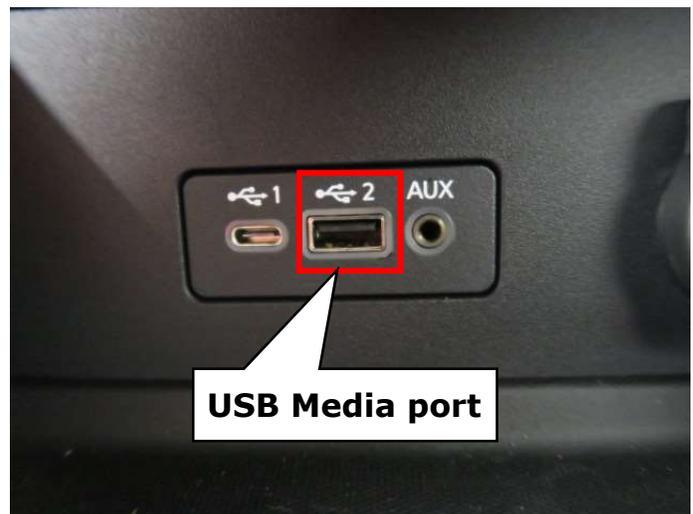
Figure 6

### 7. Insert the USB drive with infotainment software update into the vehicle's USB media port. (Figure 6)

**DO NOT** remove the USB drive during the software update until instructed.

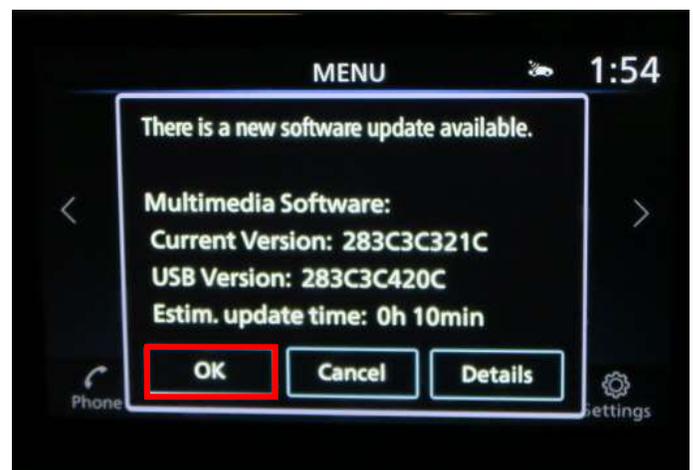
### 8. Wait approximately 10-30 seconds for the screen in Figure 7 to appear.

- Select "OK"

Reprogramming is not needed, if the following message is shown "Unable to update the software since the available version is the same or older than the current version".

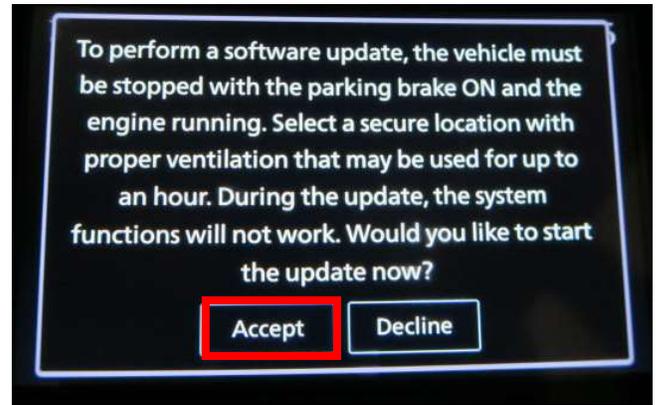
9. Review the programming requirements shown in Figure 8 and select "Accept" to start the reprogramming.

The software update will take approximately 10 minutes to complete.

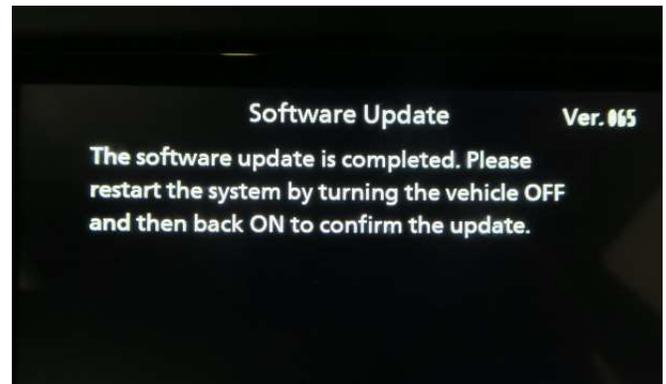
10. Once the software update is complete, the message shown in Figure 9 will display.

- Remove the USB drive from the USB port
- Turn the ignition off
- Open and close the driver's door
- Restart the engine

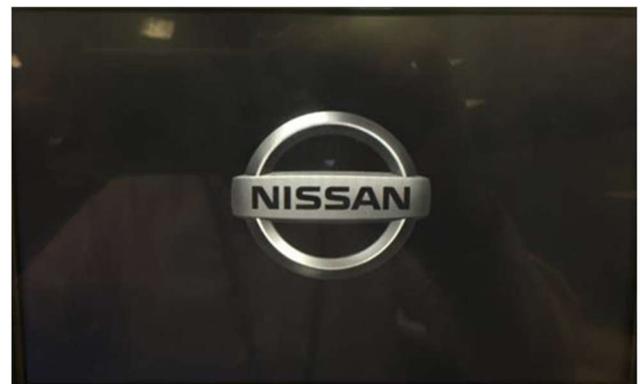
Figure 10

11. Allow the system to boot up completely (approximately 30 seconds).

- The Nissan logo will be displayed during the reboot (Figure 10)

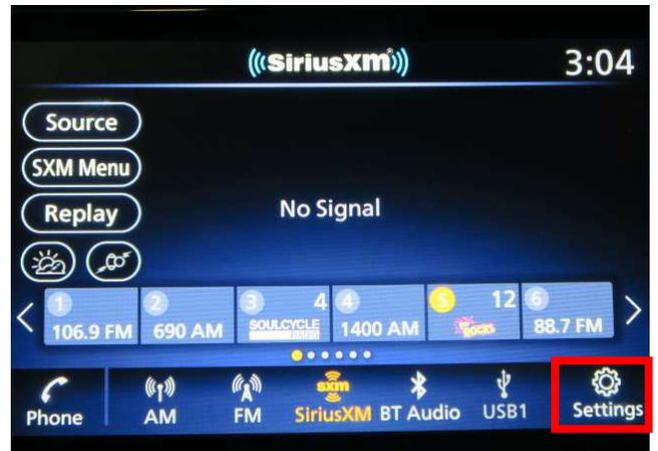
Figure 11

12. Select "Settings" located in the lower RH corner of the AV unit display. (Figure 11)

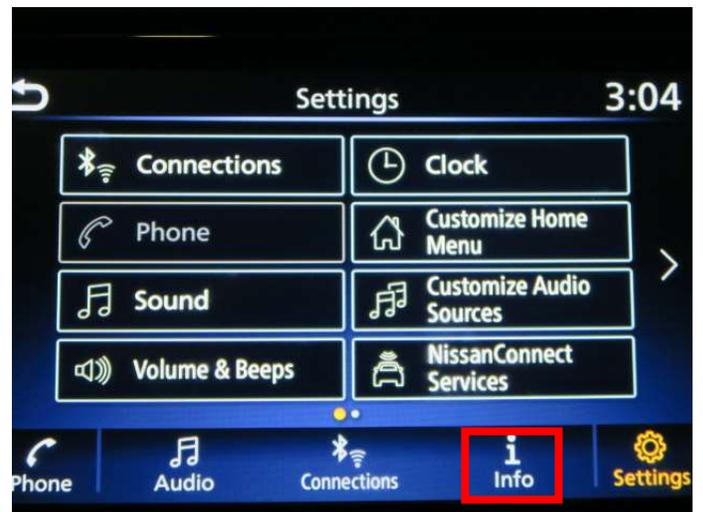
Figure 12

13. Select "Info" located at the lower part of the AV unit display. (Figure 12)

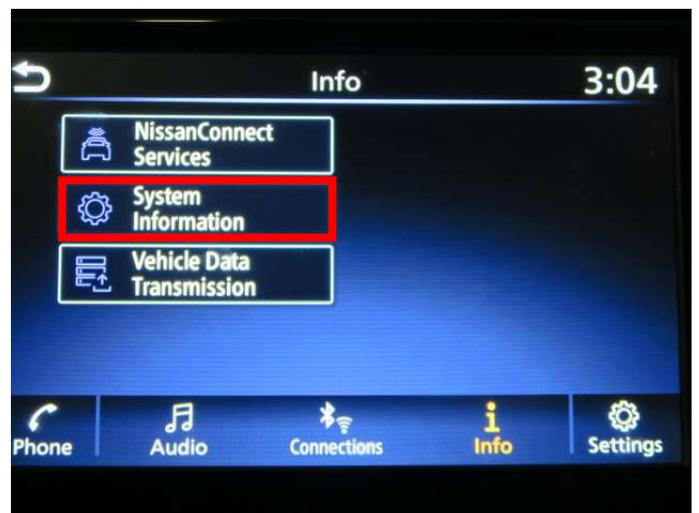
Figure 13

14. Select "System Information". (Figure 13)

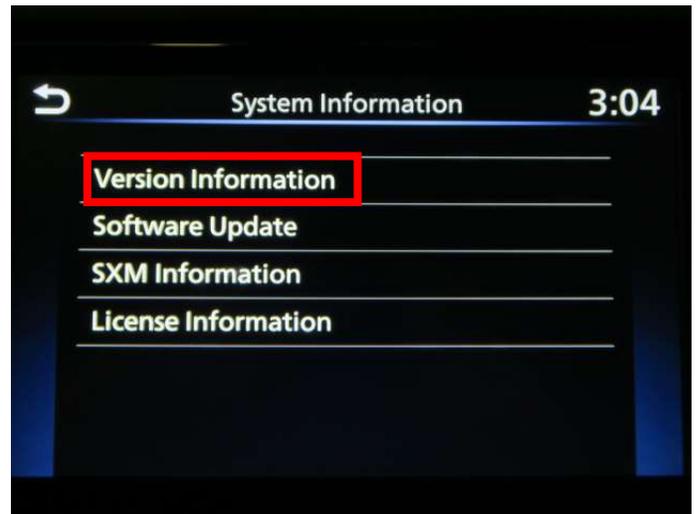
Figure 14

15. Select "**Version Information**".  
(Figure 14)

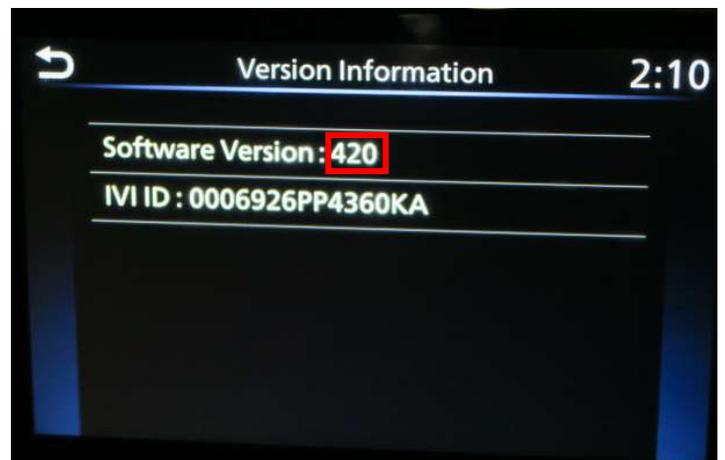
Figure 15

16. Verify Software Version is **420**.

- If software version is correct, procedure is complete, proceed to claims information
- If the software version is **NOT 420**, start this procedure over and verify the correct software shown in Step 3 is downloaded
