QUARANTINE NOTICE

Reference number:	QN-41-1510	Issued: 05 July, 2021
Subject:	Flash the Air Damping Module (ADM)	
Model(s):	DBX	
VIN Range:	Refer to the separately published list of affected Vehicle Identification Numbers (VINs)	
Applicable to:	All Dealers	
Distribute to:	After Sales Manager Executive Manager Service Manager Sales Manager	Warranty Staff Technician(s) Parts Staff

Reason for this Quarantine Notice

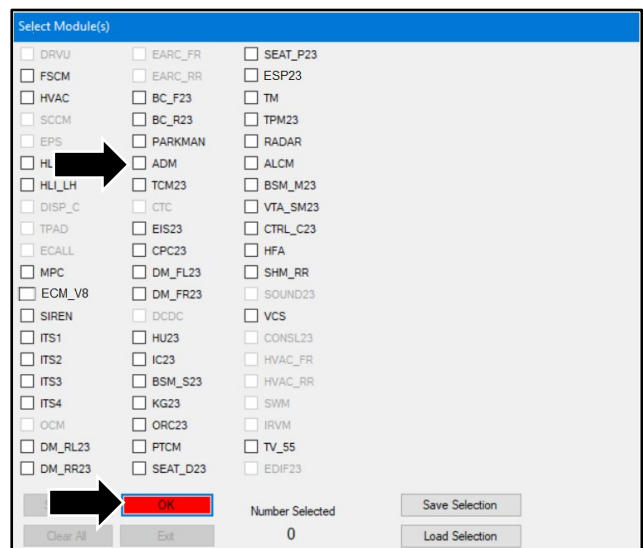
Figure 2

5. Select the "ADM" module then click "OK" (refer to Figure 2).

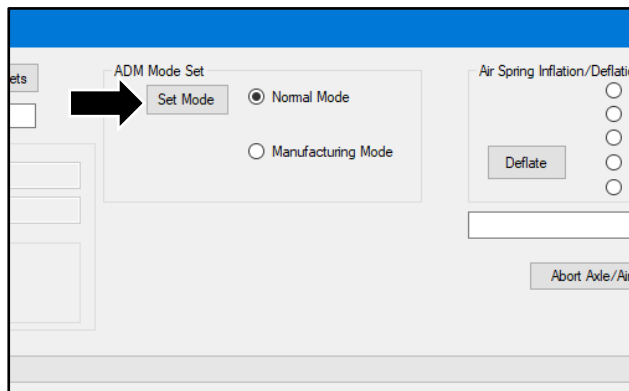
Figure 5

Note: If the suspension modes do not function correctly, click the “Set Mode” button with “Normal Mode” selected in AMDS – Special Apps - ADM (refer to Figure 5).
