GROUP	MODEL
Product Improvement	2014-2016MY Optima Hybrid (TF HEV) w/2.4L MPI
NUMBER	DATE
PI2104	July 2021

SUBJECT: **THETA 2.4L MPI - KNOCK SENSOR DETECTION SYSTEM  
(KSDS) ECU LOGIC IMPROVEMENT (PI2104)**

This bulletin provides information related to a software update to the Engine Control Unit (ECU) to install the Knock Sensor Detection System (KSDS), in order to protect the engine from excessive connecting rod bearing damage. This update is for certain 2014-2016MY Optima Hybrid (TF HEV) vehicles equipped with Theta 2.4L MPI engines, produced from December 11, 2013 through July 22, 2015.

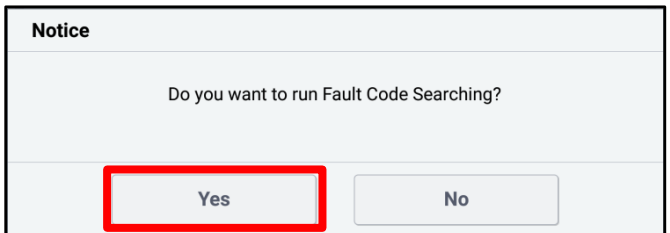
- When prompted, select 'YES' to check for Diagnostic Trouble Codes (DTC) and erase any DTCs stored such as EPS, ESC, and TPMS that may have been set during the upgrade.
