Emissions Service Action

Code: 24GW

Subject Engine Control Module (ECM) Software

Update Engine Control module (ECM) software.

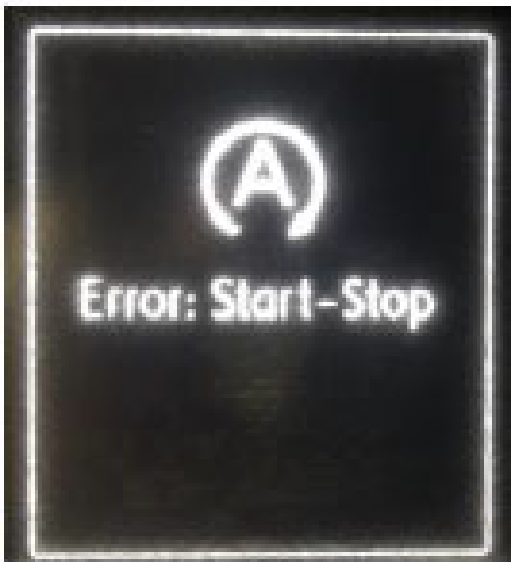
- If the message shown is displayed on the instrument cluster after the flash and it was not present prior to the flash, the ECM adaptation channel for the start/stop activation may have to be changed from inactive to active.
- To change the adaptation channel, use Diagnosis Mode OBD and change the ECM adaptation channel, "*Activation of start/stop function [\$0927]*" from "not active" to "active".
- The adaptation will also change on its own after the vehicle is driven for 50 km (~32 miles). However, the message in the cluster might not disappear until the ignition is cycled after the vehicle has been driven for 50 km (~32 miles).
