Service Bulletin

19-049

Apple CarPlay[™] Will Not Launch

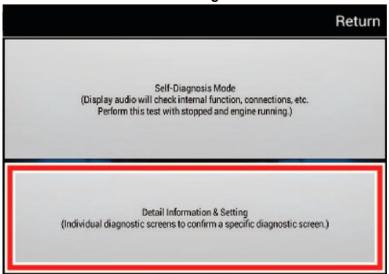
2. Select Detail Information & Setting.

3. From the **Detail Information & Setting** screen, press and hold the **MENU** icon for **5 seconds** until the display changes to the **Developer Diag** screen.

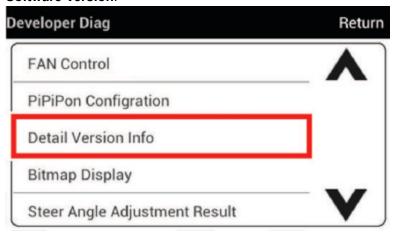
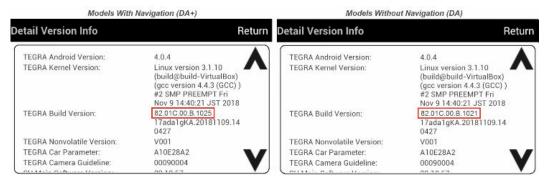
4. From the **Developer Diag** screen, select **Detail Version Info** and confirm the **TEGRA Build Version** and **SH Main Software Version**.

Software Details	New Software Versions	
	Models with Navigation	Models without Navigation
TEGRA Build Version	82.01C.00.B.1025	82.01C.00.B.1021
Touch Version	T5AR04	T5AR04
