**AMB5 - Re-Programming Power Electronics (Stop Delivery/Recall Campaign)**

Model Year: **2021**

Model Line: **Taycan (Y1A)**  
**Taycan Cross Turismo (Y1B)**

Concerns: **Power electronics and engine electronics (DME)**

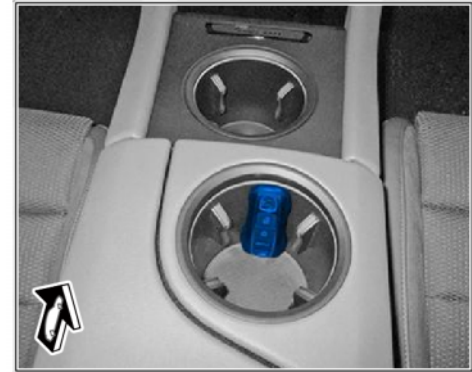
- 2 Position the **driver's key** with the back facing forward upright between the holding struts in the rear cupholder (**emergency start tray**) to guarantee a permanent radio link between the vehicle and remote control ⇒ *Emergency start tray*.
- 3 Connect **9900 - PIWIS Tester 3** to the vehicle communication module (VCI) via the **USB cable**. Then, connect the communication module to the vehicle and switch on the PIWIS Tester.  
**Operate the PIWIS Tester via the power supply unit** due to the long programming time.

*Emergency start tray*

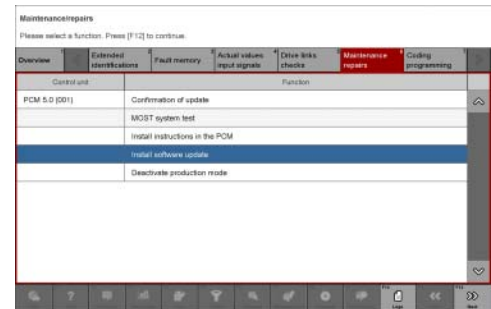
- 6.8 Select the '**Install software update**' function and press •F12" ('Next') to perform the software update ⇒ *Installing PCM 6.0 software update*.

*Installing PCM 6.0 software update*

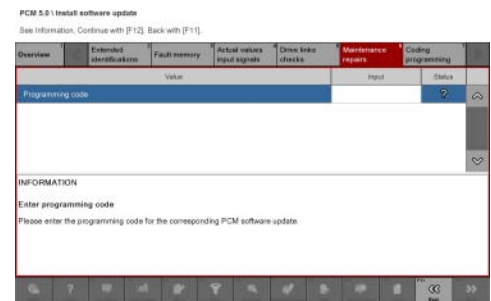
- 6.9 Confirm the information that is displayed by pressing •F12" ('Next').
- 6.10 After meeting the preconditions, confirm by ticking the 'Status' column. Then, press •F12" ('Next') to continue.
- 6.11 Enter the programming code **K4M4S** in the relevant column ⇒ *Entering PCM 6.0 programming code* and press •F12" ('Next') to confirm ⇒ *Entering PCM 6.0 programming code*.

*Entering PCM 6.0 programming code*

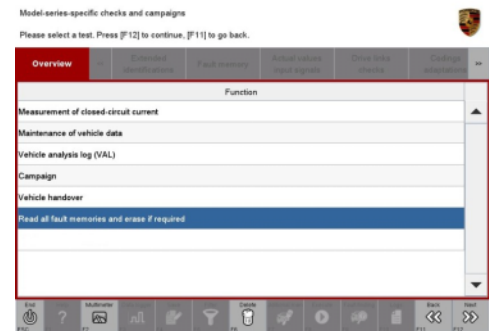
- 4.4 Press **•F8** to delete fault memory entries.
- 4.5 Press **•F12** ("Yes") in response to the question as to whether you really want to delete all fault memory entries.

The faults stored in the fault memories of the various control units are deleted.

*Erasing fault memories*

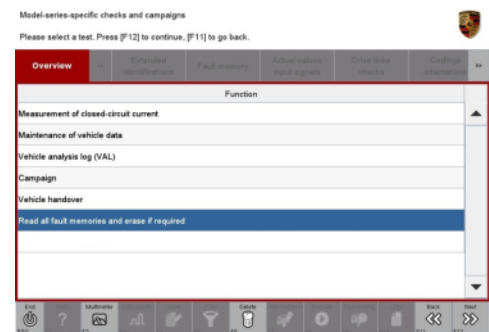
- 3.4 Press •F8" to delete fault memory entries.
- 3.5 Press •F12" ('Yes') in response to the question as to whether you really want to delete all fault memory entries.

The faults stored in the fault memories of the various control units are deleted.

*Erasing fault memories*
