# Emissions Service Action

## Code: 24Fi

<b>Subject</b>	Engine Control Module (ECM) Software				
<b>Release Date</b>	August 03, 2021				
<b>Affected Vehicles</b>	<b>Country</b>	<b>Beginning Model Year</b>	<b>Ending Model Year</b>	<b>Vehicle</b>	<b>Vehicle Count</b>
	USA	2019	2020	GOLF	9,782
	USA	2019	2019	GOLF SPORTWAGEN	2,742
	USA	2019	2020	JETTA	233,132
	CAN	2019	2020	GOLF	12,517
	CAN	2019	2019	GOLF SPORTWAGEN	574
	CAN	2019	2020	JETTA	39,452
		<p>Check Campaigns/Actions screen in Elsa on the day of repair to verify that a VIN qualifies for repair under this action. Elsa is the <u>only</u> valid campaign inquiry &amp; verification source.</p> <ul style="list-style-type: none"> <li>✓ Campaign status must show "open."</li> <li>✓ If Elsa shows other open action(s), inform your customer so that the work can also be completed at the same time the vehicle is in the workshop for this campaign.</li> </ul>			
<b>About this action</b>	Engine control software updates include improvements to diagnostics and monitoring to improve vehicle serviceability.

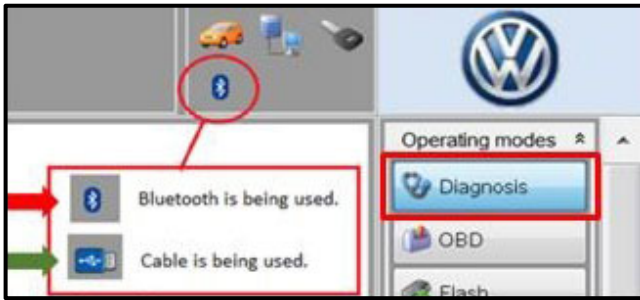
- Confirm that scan tool is communicating with the diagnostic head by USB <Green Arrow>.
  - If the Bluetooth symbol is shown <Red Arrow> then disconnect the diagnostic head from the vehicle and reconnect the USB cable to the diagnostic head and then reattach to the vehicle.
- Upon ODIS startup, verify the “Diagnosis” operating mode is selected <as shown>.
