DTC B2724-23 AND/OR C1B56-04 STORED, AND/OR RAB ERROR MESSAGE OR WARNING

APPLIED VEHICLES: 2020-2021 QX50 (J55)

APPLIED SYSTEM: Rear Automatic Braking

Sonar Control Unit Reprogramming

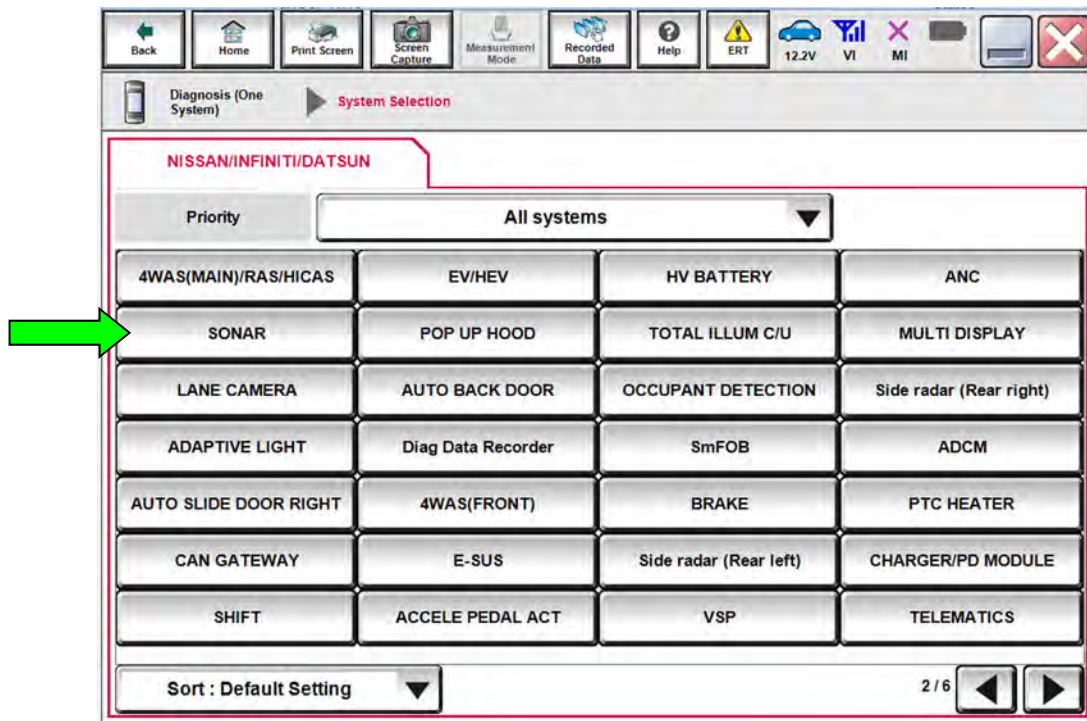
Figure 4

11. Select SONAR.

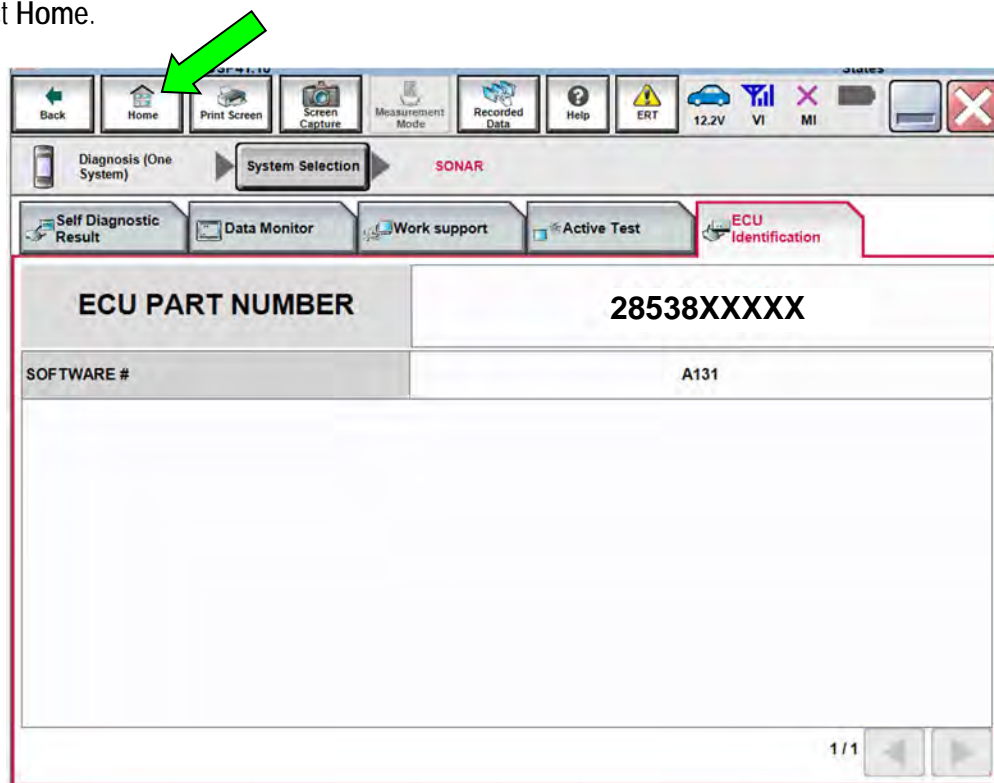
Figure 6

14. Select Home.

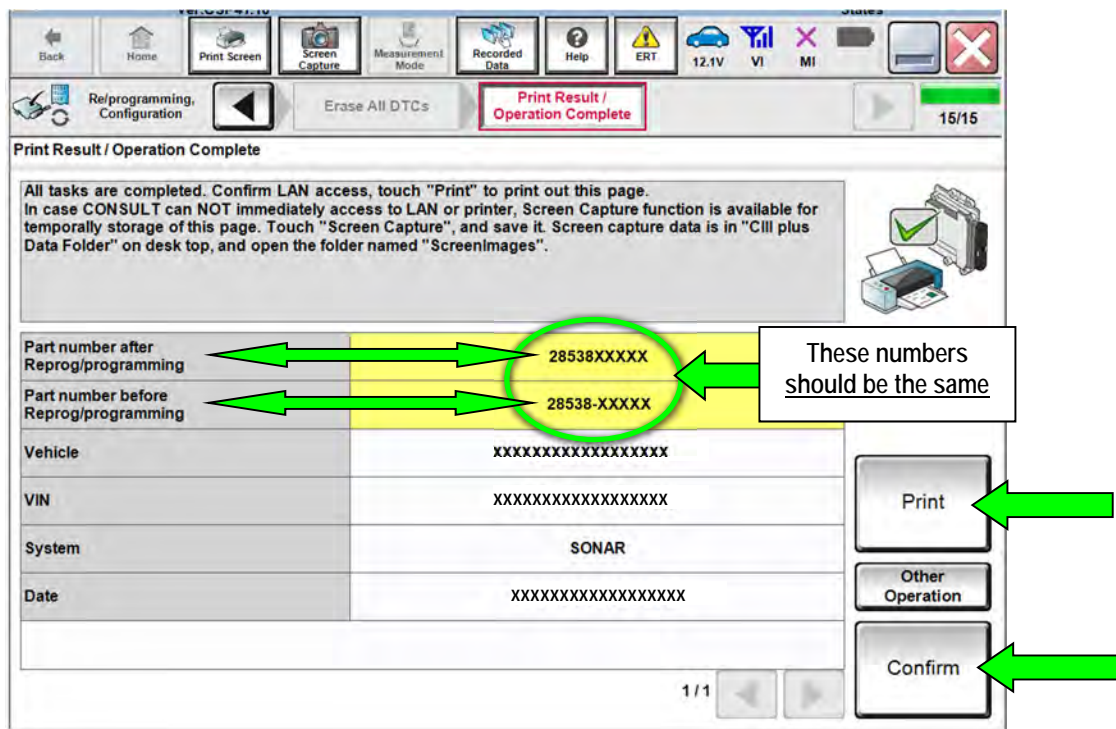
HINT: When the entire reprogramming process is complete, the screen in Figure 28 will display.

41. Verify the before and after part numbers are the same.

NOTE: For this reprogram, the before and after reprogramming part numbers should be the same. This is not an error.

42. Print a copy of the screen below (Figure 28) and attach it to the repair order for warranty documentation.

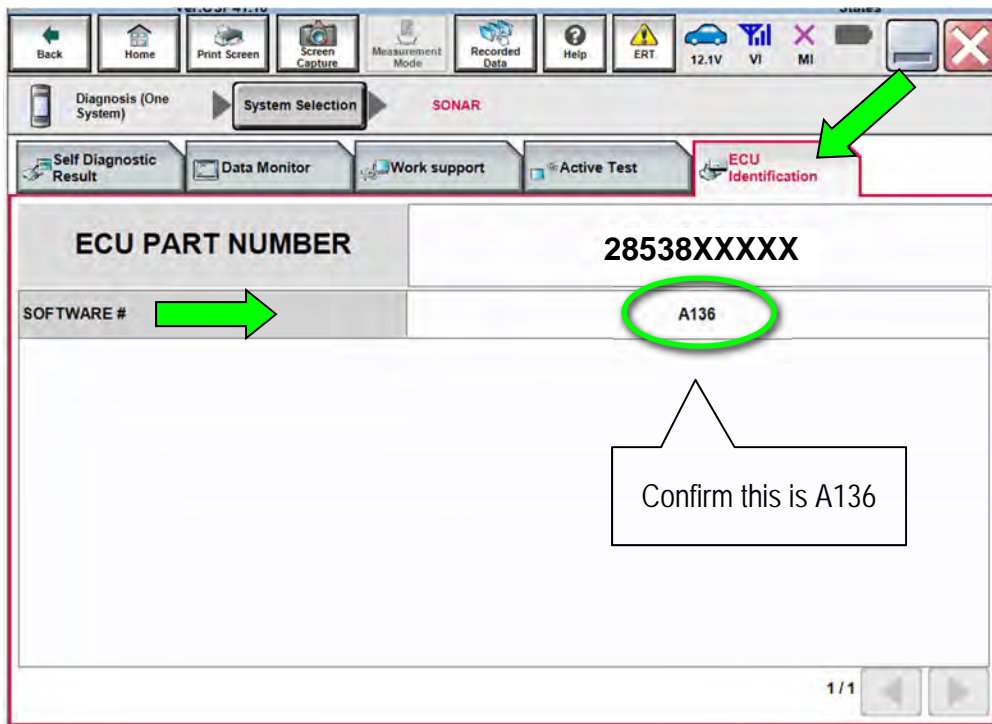
Figure 39

61. Select ECU Identification.

62. Confirm the SOFTWARE #. See Figure 39.

- If the SOFTWARE # is A136, proceed to step 63.
- If the SOFTWARE # is not A136, reprogramming did not successfully complete. Go back to step 15 on page 6 and perform the procedure again.
