Engine Control Module (ECM) Reprogram Dealer Inventory

Reference: PC816
Date: July 16, 2021

PC816 – 2022 PATHFINDER ISS ECM REPROGRAM

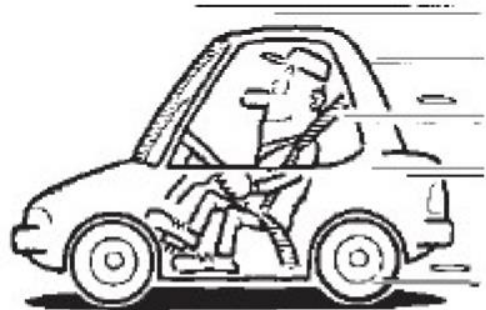
Figure A

- Most instructions for reprogramming with CONSULT-III plus (C-III plus) are displayed on the CONSULT PC screen
- Take the vehicle for a 10 minute drive in order to meet the following Idle Air Volume Learn (IAVL) conditions:
 - Engine coolant temperature: 70 -100°C (158 - 212°F)
 - Battery voltage: More than 12.9V (At idle)
 - Transmission: Warmed up
- After reprogramming is complete, you will be required to perform Throttle Valve Closed Position, Idle Air Volume Learn, Accelerator Closed Position, and DTC erase

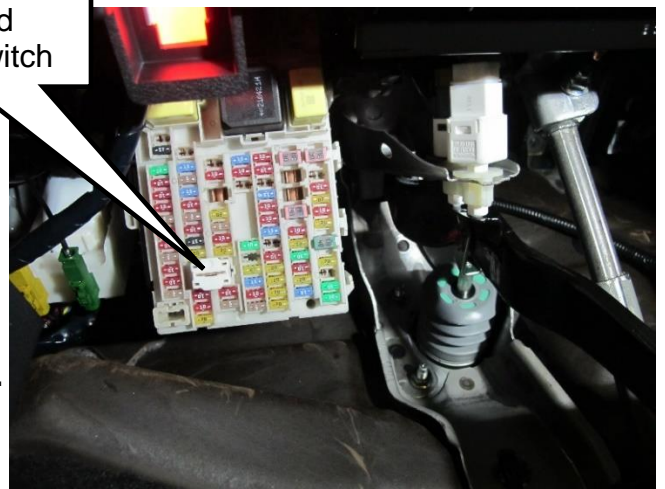
Figure 1

1. Verify the extended storage switch is pushed **IN** (Figure 1).

- a. Turn the ignition OFF.
- b. Open the driver door and leave it open.
- c. Locate the interior fuse panel under driver's side dash.
- d. Push the extended storage switch IN.
- e. Wait at least 2 seconds.
- f. Turn the ignition ON.
- g. Make sure the extended storage warning message is not displayed in the combination meter/display.

Extended
Storage Switch

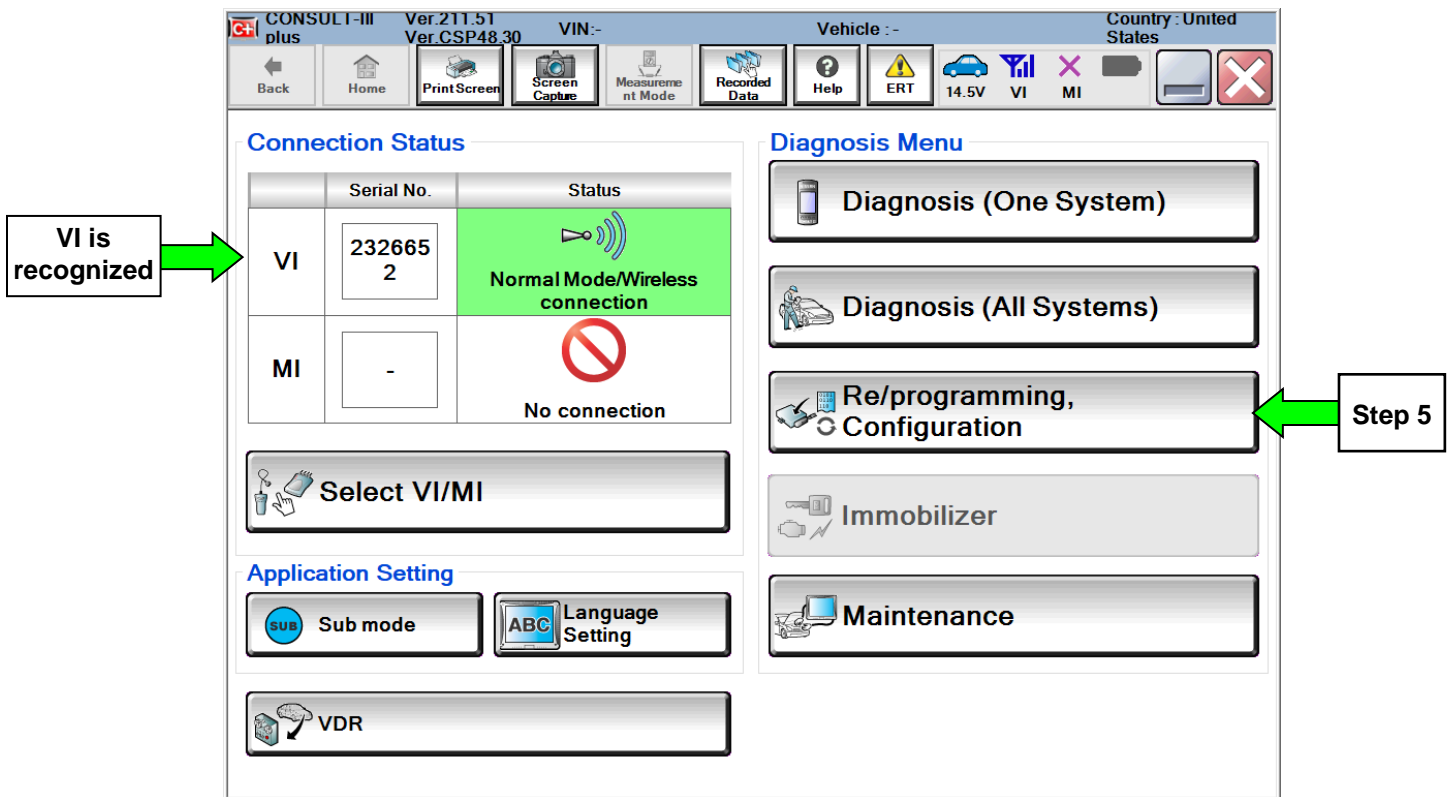
Figure 2

2. Connect the CONSULT PC to the vehicle to begin the reprogramming procedure.
3. Start C-III plus.
4. Wait for plus VI to be recognized/connected.
 - The serial number will display when the plus VI is recognized/connected
5. Select Re/programming, Configuration.

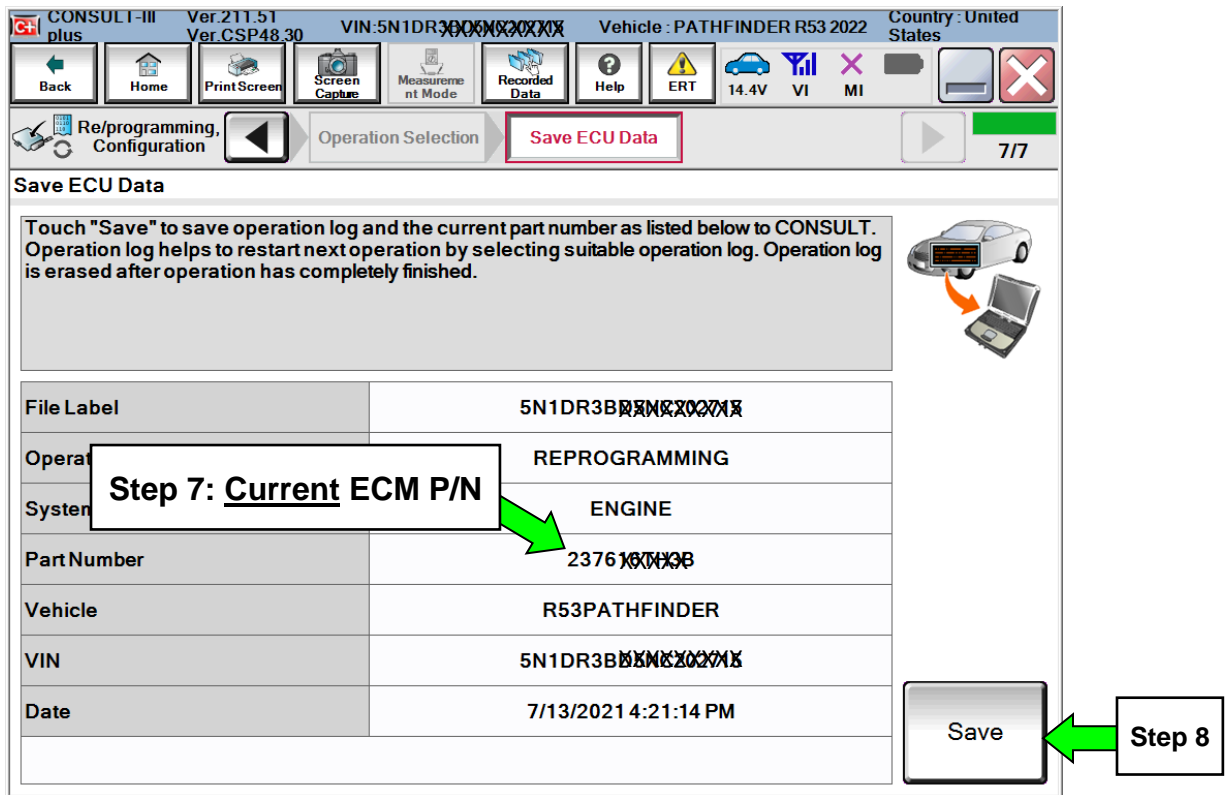
6. Follow the on-screen instructions and navigate the C-III plus to the screen in Figure 3.

7. Write the current ECM Part Number shown in Figure 3 on the Repair Order.

8. Compare the P/N you wrote down to the numbers in the Current ECM Part Number column in Table A, below.

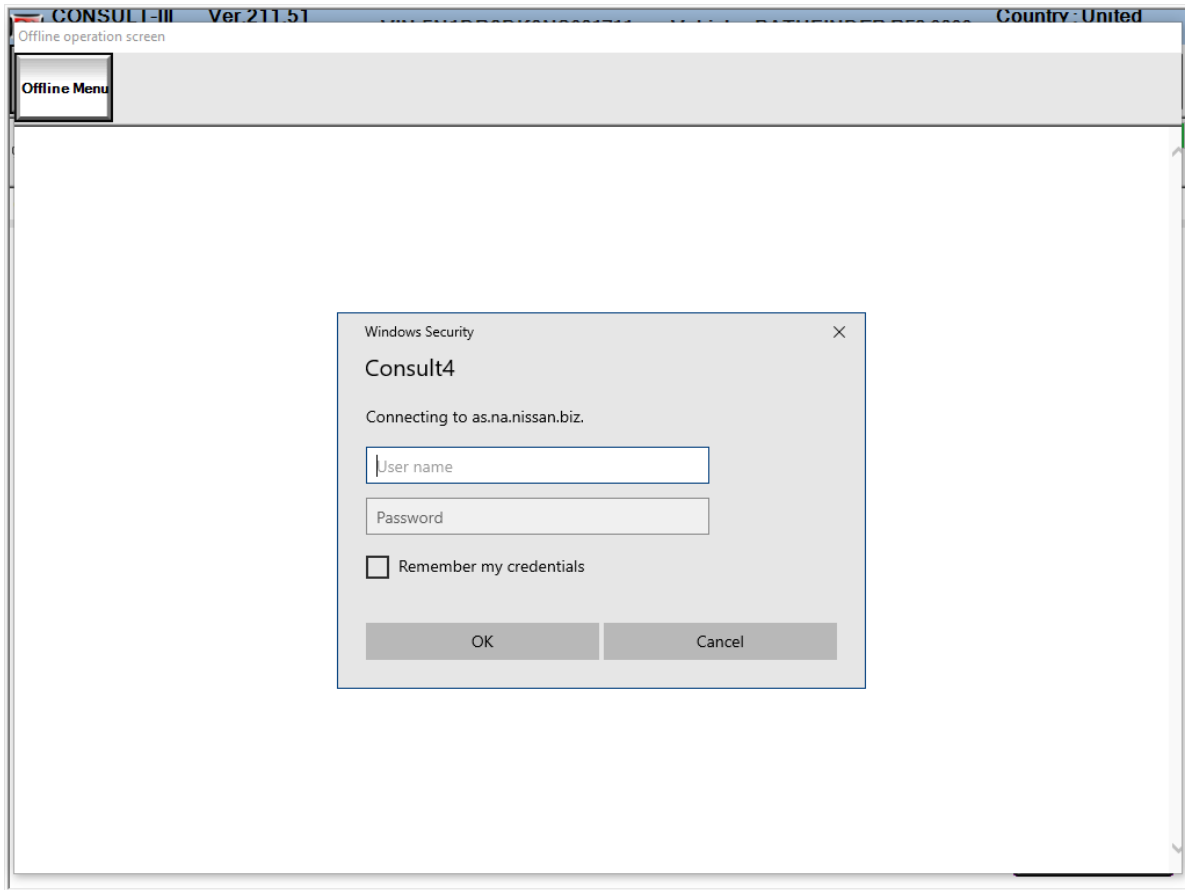
Figure 4

9. Follow the on-screen instructions to navigate C-III plus and reprogram the ECM.

- Before reprogramming will start, you will be required to enter your User Name and Password
 - The CONSULT PC must be connected to the Internet (Wi-Fi or cable)
 - If you do not know your User Name and Password, contact your Service Manager

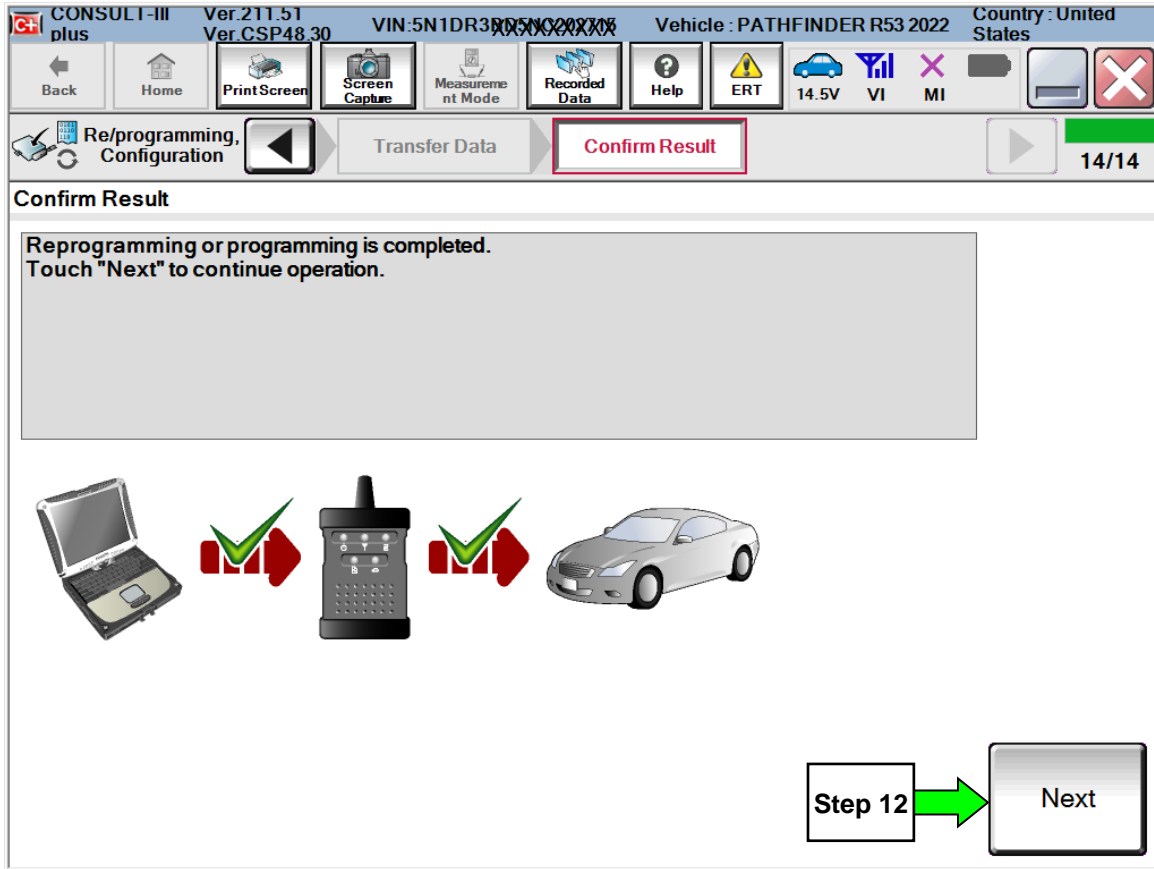
10. When the screen in Figure 5 displays, reprogramming is complete.

NOTE: If the screen in Figure 5 does **not** display (reprogramming did not complete), refer to the ECM Recovery information on Page 9.

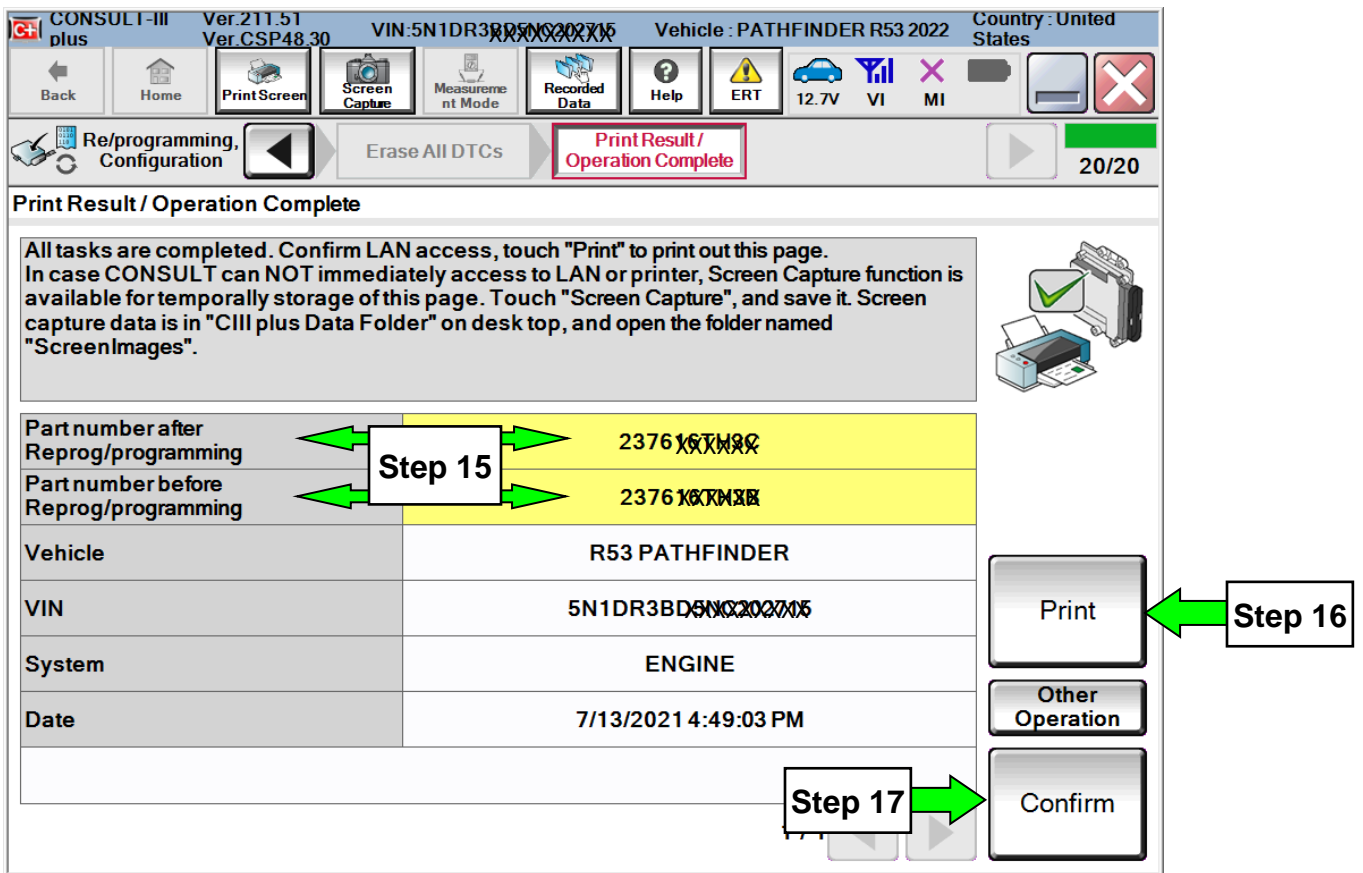
14. When the entire reprogramming process is complete, the screen Figure 6 will display.
15. Verify the before and after part numbers are different.
16. Print a copy of this screen (Figure 6) and attach it to the repair order for documentation.
17. Select Confirm, see claims information on Page 10.

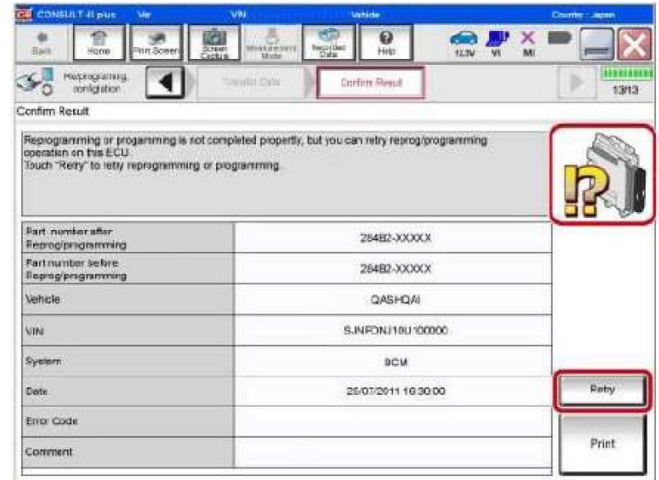
Figure 7

If reprogramming does not complete and the “!?” icon displays as shown in Figure 7:

- Check battery voltage (12.0–15.5 V)
- Ignition is ON, engine OFF
- External Bluetooth® devices are OFF
- All electrical loads are OFF
- **Select retry and follow the on screen instructions**
- “Retry” may not go through on first attempt and can be selected more than once

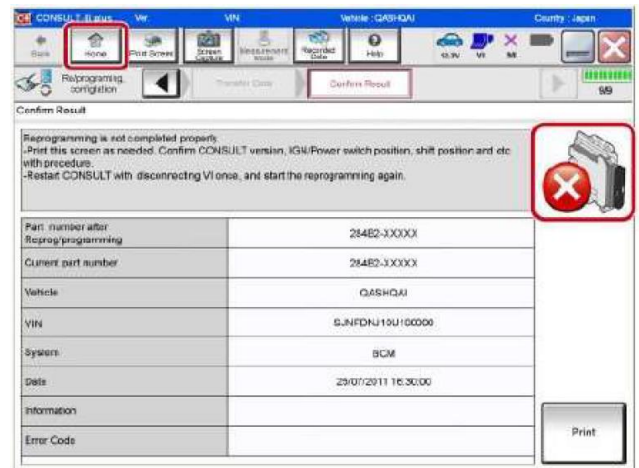
Figure 8

If reprogramming does not complete and the “X” icon displays as shown in Figure 8:

- Check battery voltage (12.0 – 15.5 V)
- CONSULT A/C adapter is plugged in
- Ignition is ON, engine OFF
- Transmission is in Park
- All C-III plus / VI cables are securely connected
- All C-III plus updates are installed
- **Select Home, and restart the reprogram procedure from the beginning**
