SIB 00 05 21

ISTA 4.28/4.29 CONNECTIVITY PROBLEMS WITH OLDER VEHICLES

2021-06-15

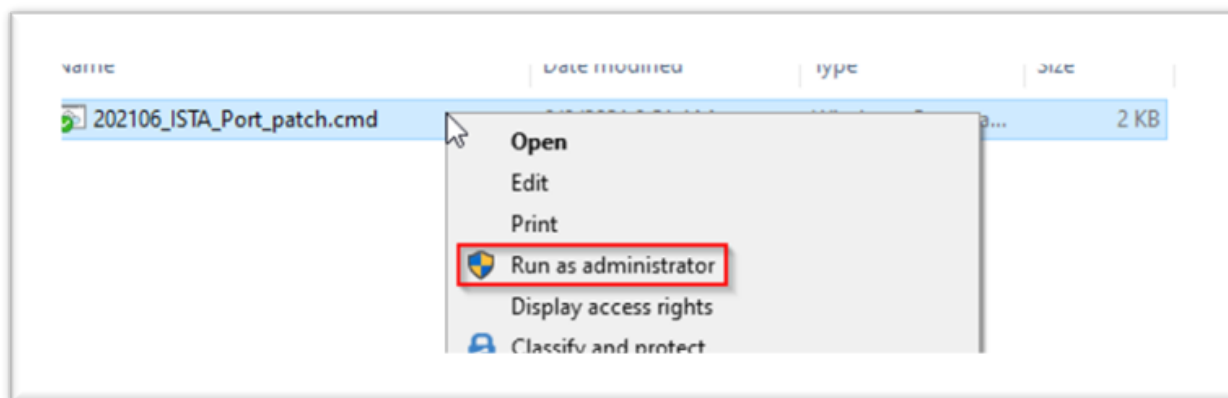
- Exit out of ISTA and confirm it's not running in the background by looking in the Windows Task Manager.
- Save the attached zip file "202106\_ISTA\_Port\_patch.zip" to any directory on the computer where ISTA is installed.
- Switch to the directory with the ZIP file.
- Unzip the 202106\_ISTA\_Port\_patch.zip ZIP file into the same folder.
- Start the patching process by running the .cmd file "202106\_ISTA\_Port\_patch.cmd" as an administrator:

- Once the script is finished, re-open ISTA and attempt connectivity to a BN2000 motorcycle.

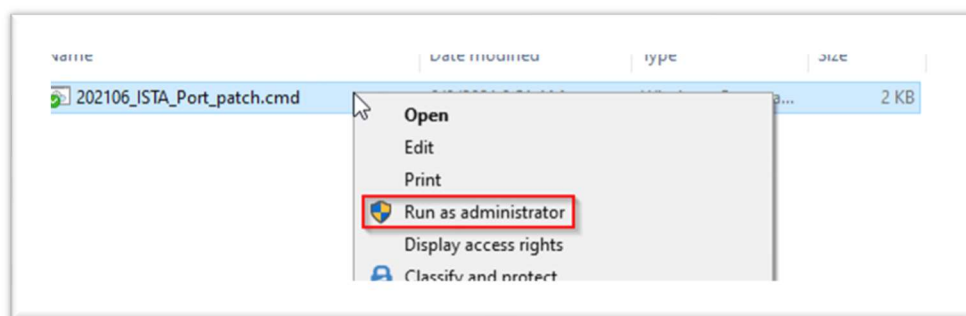
1. Exit out of ISTA and confirm it's not running in the background by looking in the Windows Task Manager.
2. Save the attached zip file "202106\_ISTA\_Port\_patch.zip" to any directory on the computer where ISTA is installed.
3. Switch to the directory with the ZIP file.
4. Unzip the 202106\_ISTA\_Port\_patch.zip ZIP file into the same folder.
5. Start the patching process by running the .cmd file "202106\_ISTA\_Port\_patch.cmd" **as an administrator**:

6. Once the script is finished, re-open ISTA and attempt connectivity to a BN2000 motorcycle.
