# Diagnostic Procedure

## Blue iQ® Fault Code 6963

| FC | SPN | FMI | Title |
|---|---|---|---|
| 6963 | 8241 | 0 | Fuel Storage Compartment 1 Temperature - Data Valid But Above Normal Operating Range - Most Severe Level |

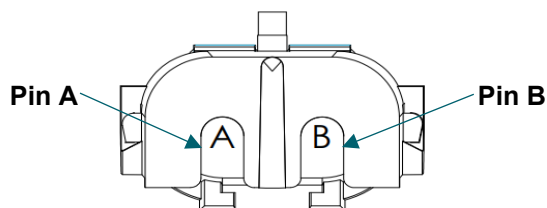
- Step 1**
- **Ignition Off.**
  - Unplug Thermistor 1 from Blue iQ harness.
  - Use a DMM and appropriate test leads to probe between **Pin A** and **Pin B** of Thermistor 1 to measure the resistance and **record the ohms reading**.

Thermistor connector end view

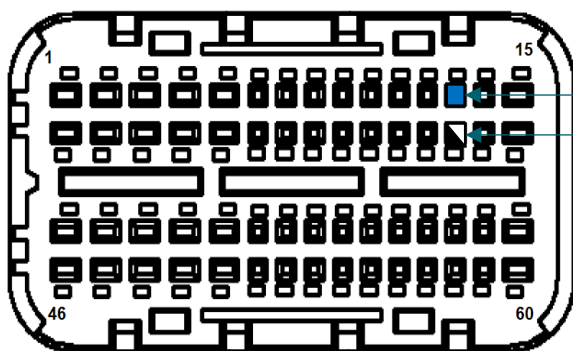
- Ignition Off.
- Unplug FSCM 60-pin connector.
- Inspect and **FSCM 60-pin connector** and **Thermistor 1 connector** and associated harness wires and for the following conditions:
  1. corrosion
  2. missing cavity plugs
  3. bad termination
  4. damaged or loose terminals

FSCM harness connector end view

Pin 13 –  
Blue wire

Pin 28 –  
Black/white  
wire

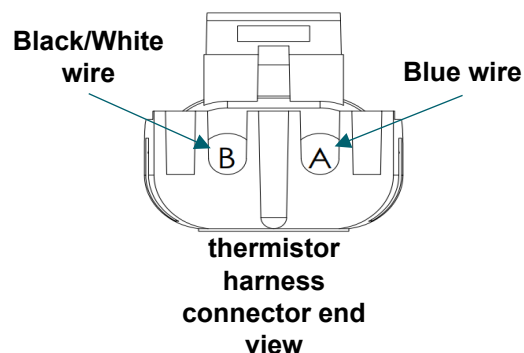
thermistor  
harness  
connector end  
view

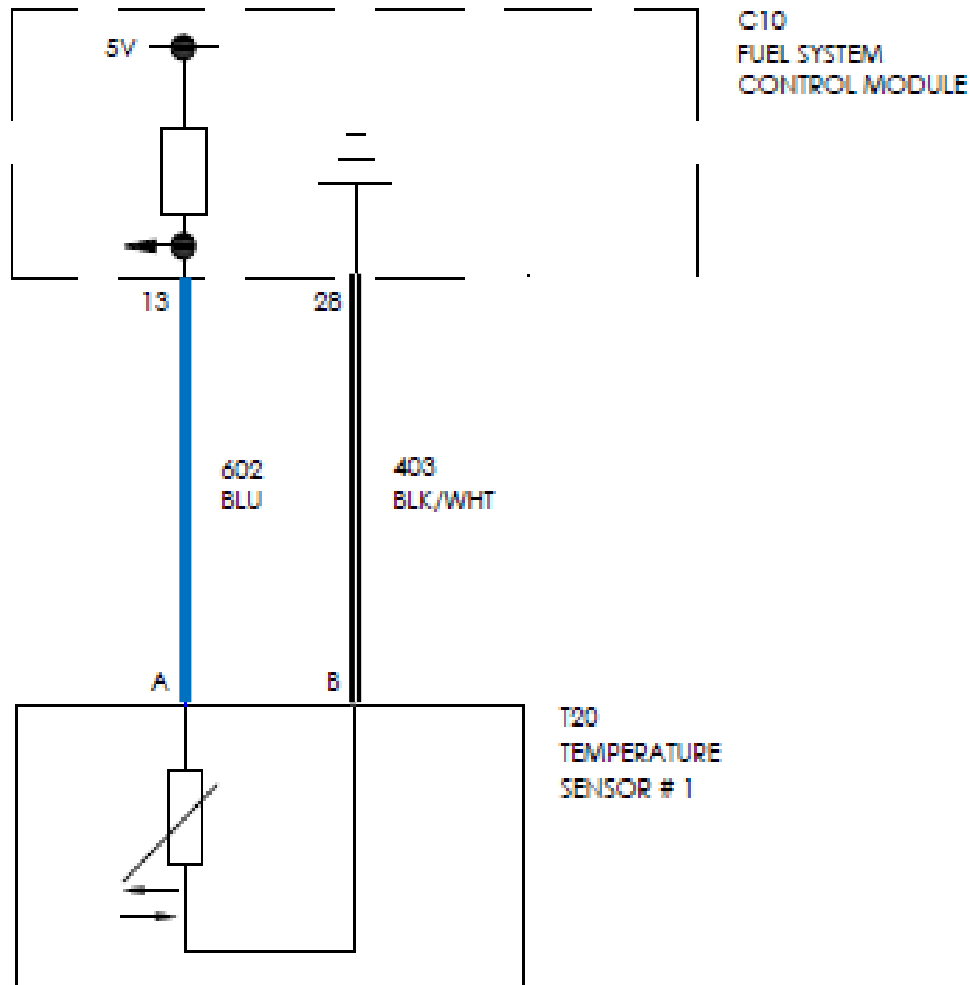
- **Ignition Off.**
- Use a DMM and appropriate test leads to perform a wire-to-wire resistance test on the following connectors using the diagram below:
  1. FSCM **Pin 13** to Thermistor 1 **Pin A** – Blue wire
  2. FSCM **Pin 28** to Thermistor 1 **Pin B** – Black/White wire

**Resistance between zero and 1 ohms?**
