GROUP	MODEL
Product Improvement	2016MY Forte, Forte Koup (YD) w/2.0L GDI
NUMBER	DATE
PI2105	August 2021

SUBJECT: **NU 2.0L GDI - KNOCK SENSOR DETECTION SYSTEM (KSDS) ECU LOGIC IMPROVEMENT (PI2105)**

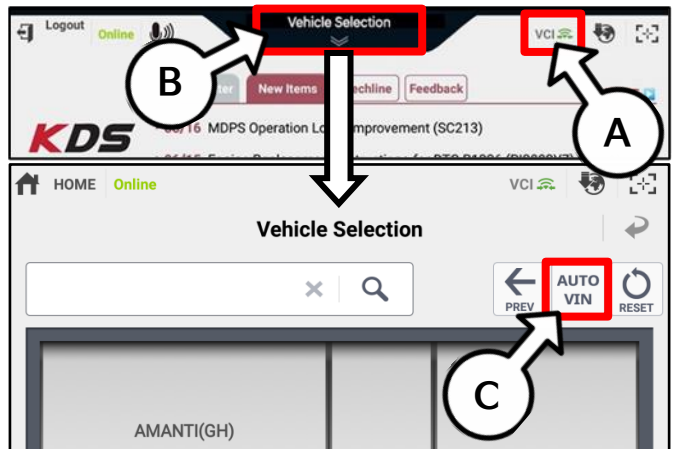
3. Confirm communication with VCI (A) and then configure the vehicle (B) using the 'AUTO VIN' (C) feature.

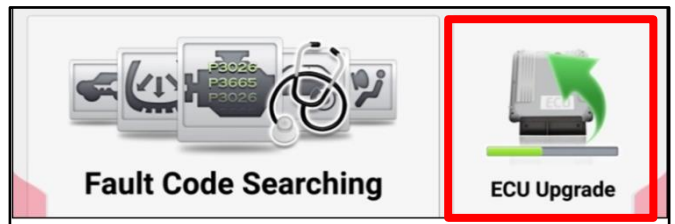
4. Select 'ECU Upgrade'.

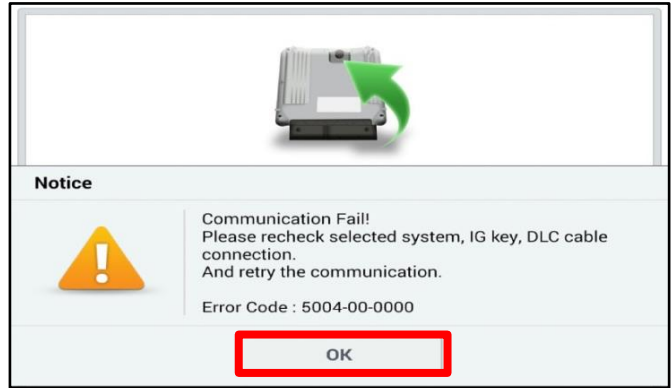
9. If a "Communication Fail" screen appears, verify that the VCI-II and KDS are communicating properly. Select 'OK' and restart the procedure from step 4.

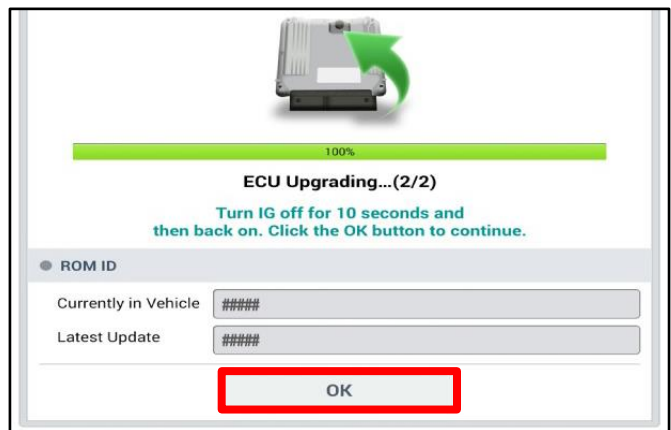
10. When instructed on the KDS, turn the ignition OFF for ten (10) seconds then back on. Select 'OK' to continue.

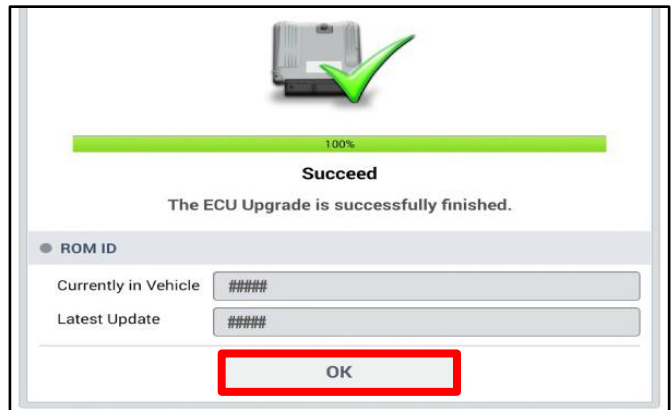
11. Once the upgrade is complete, select 'OK' to finalize the procedure.

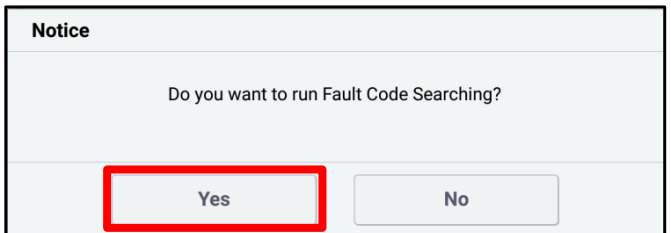
12. When prompted, select 'YES' to check for Diagnostic Trouble Codes (DTC) and erase any DTCs stored such as EPS, ESC, and TPMS that may have been set during the upgrade.
