91-21-02 MIB3 Composition & Discover Media Infotainment System Malfunctions

Technical Background

This procedure resolves the concern(s) specified above by updating the MIB3 Infotainment System software to the latest level **0805**.

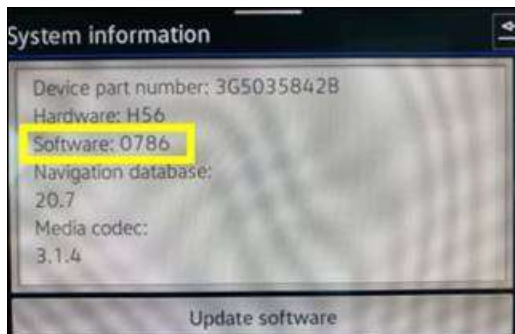
Figure 1.

- Connect Midtronics InCharge 940 (INC 940) or GRX3000VAS Tester/Charger to the vehicle's 12 volt battery.
- Switch the ignition to the ON position.
- Switch ON the Infotainment System.
- Check the Software Version by pressing the "Menu" button.
- Page over in the Infotainment menu and select "Settings" from the touchscreen menu.
- In "System Settings", scroll down to select "System Information" from the touchscreen menu (Figure 1).

If the current software level is lower than **0805**, proceed with this Technical Bulletin.

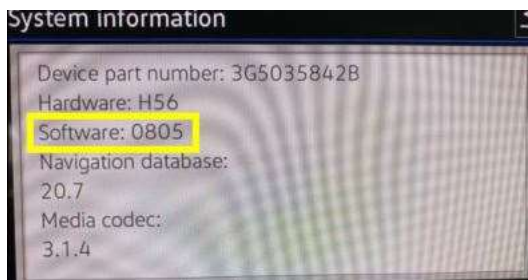
Figure 2.

Confirm that the software is updated to version **0805**. (Menu > Settings > System Information) (Figure 2).
