August 2021
SF622A
REVISED NOTICE

Subject: Cascadia/49X ABS MBSP+ Controller Software Update

Models Affected: Specific Model Year 2019-2022 Freightliner Cascadia, and Western Star 49X vehicles, manufactured September 12, 2018, through March 10, 2021.

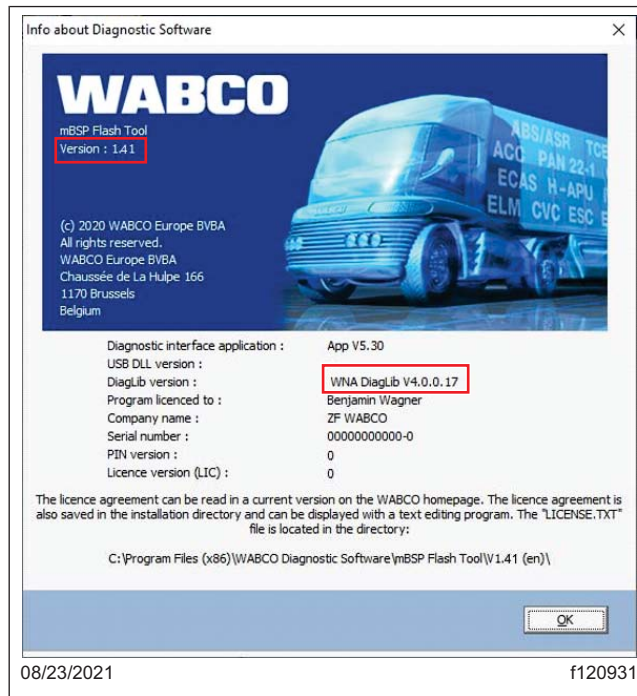
5. An mBSP flash tool software version 1.41 (See [Fig. 1](#)), WNA DiagLib Version **V4.0.0.17** is required to perform this ABS ECU software update procedure. If the mBSP flash tool software is already installed, check the mBSP flash tool software version; go to 'Help,' then select 'Info about....' See [Fig. 2](#) and [Fig. 3](#).

Fig. 3, Info about Diagnostic Software Window

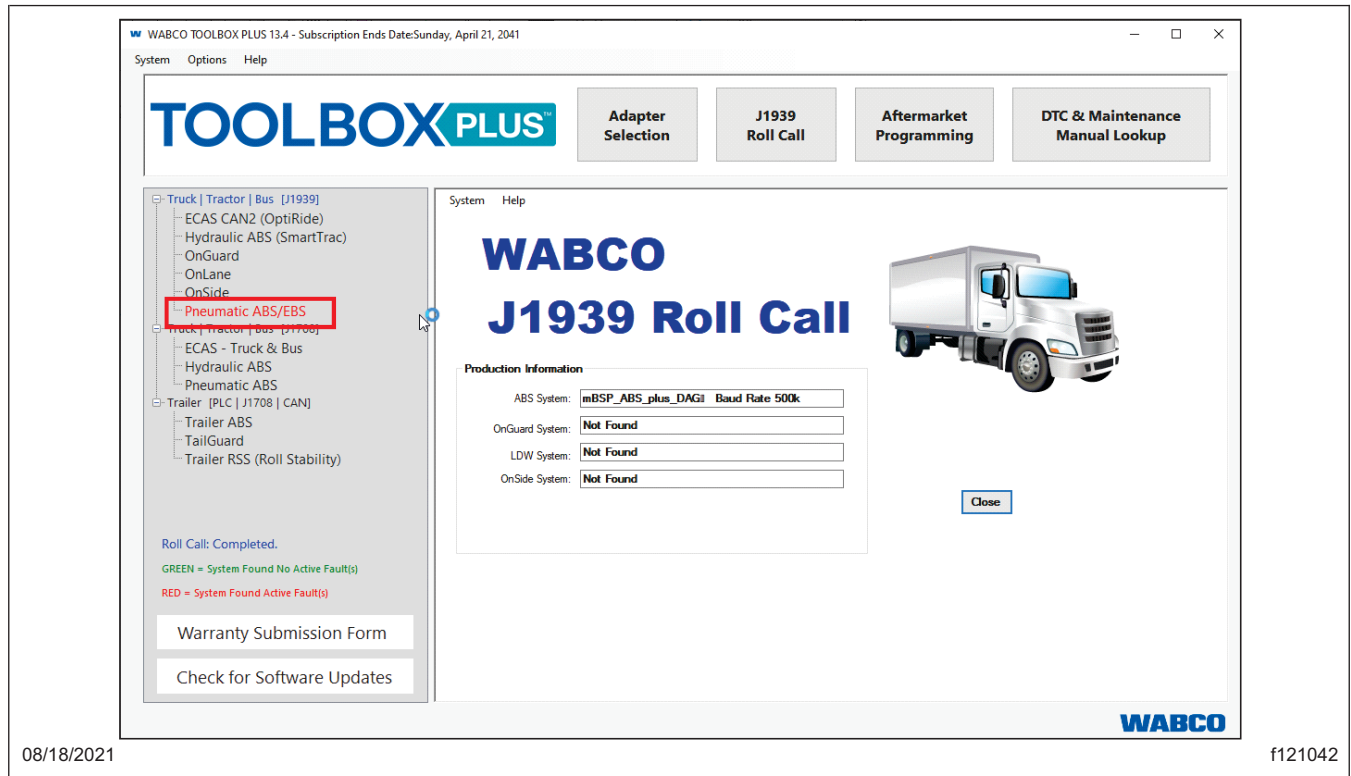
19. Save a parameter file from the ECU as proof that the parameter update was successfully completed, and add it to the vehicle repair order. This can be done in WABCO Toolbox. Launch the Toolbox software and select 'Pneumatic ABS/EBS.' See [Fig. 32](#).

Fig. 32, WABCO TOOLBOX Options
