WMHO - Re-Programming Various Control Units (Workshop Campaign)

Model Year: **As of 2020 up to 2021**

Model Line: **Taycan (Y1A)**
Taycan Cross Turismo (Y1B)

Concerns: **Re-programming various control units**

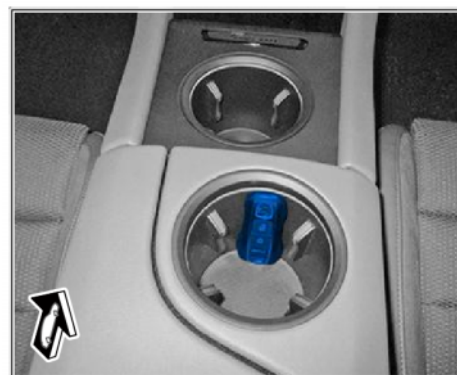
Emergency start tray

2 Position the **driver's key** with the back facing forward upright between the holding struts in the rear cupholder (**emergency start tray**) to guarantee a permanent radio link between the vehicle and remote control ⇒ *Emergency start tray*.

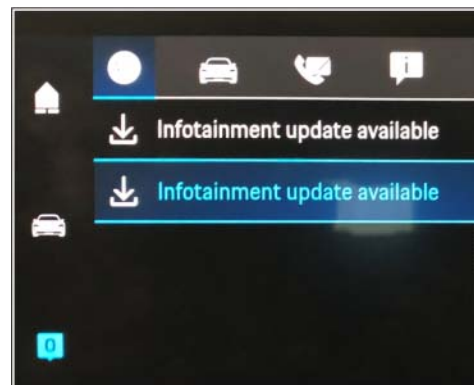
Infotainment update in central display

After carrying out the campaign, please inform customers that Infotainment updates are available via the central computer (PCM) and provide them with any help and support they need during installation ⇒ *Infotainment update in central display*.

These updates are only available if the customer has logged in on the vehicle using his/her main user credentials (Porsche ID). Several updates are available depending on equipment and these must be installed one after the other in steps. It can take several minutes to install these. New functions can only be used when all updates have been completed and the vehicle has established bus idle for at least 15 minutes.
