SERVICE BULLETIN

Classification: AN21-001A	Reference: NTB21-011A	Date: August 3, 2021
------------------------------	--------------------------	-------------------------

FALSE MAINTENANCE ALERT NOTIFICATION

APPLIED VEHICLES: 2020-2021 Titan/Titan XD (A61) – SV w/Convenience Package, SL, Platinum Reserve, PRO-4X

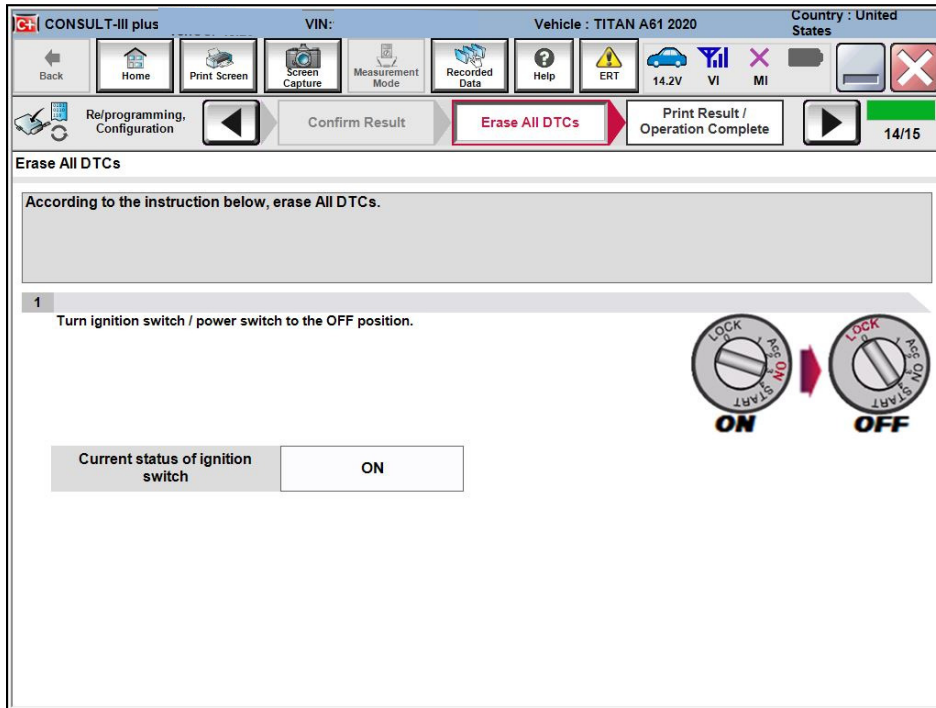
25. Erase all DTCs.

- Follow the on-screen instructions as shown in Figure 19 and Figure 20.

- Select **Next**.

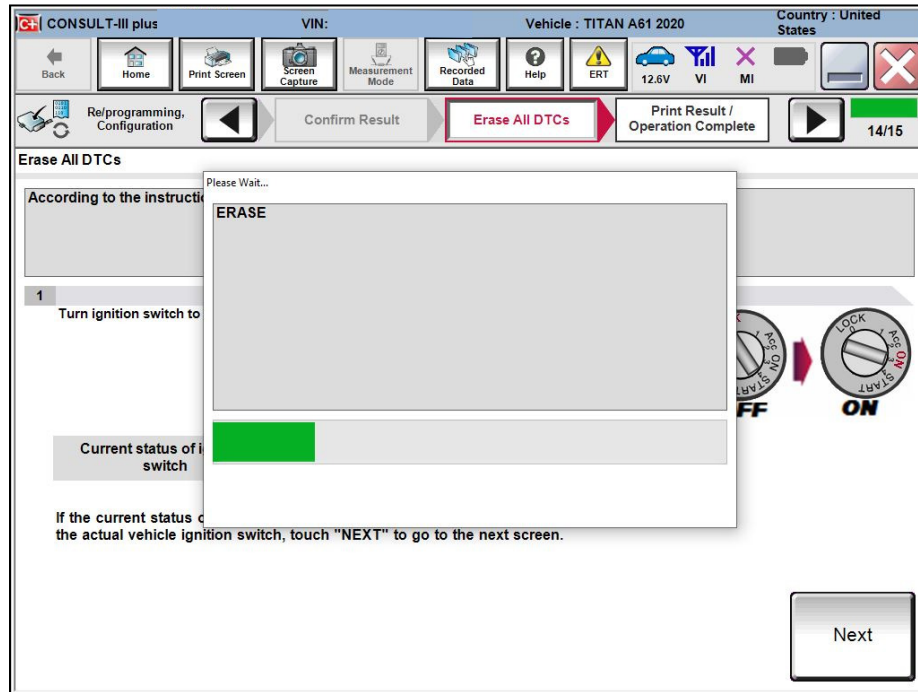
Figure 21

26. Allow **Erase All DTCs** to complete.
