SERVICE CAMPAIGN BULLETIN

VOLUNTARY SERVICE CAMPAIGN 2021 SENTRA; AUDIO CONTROL UNIT REPROGRAM

CAMPAIGN ID #: PM991
APPLIED VEHICLES: 2021 Sentra (B18) – SV and SR only

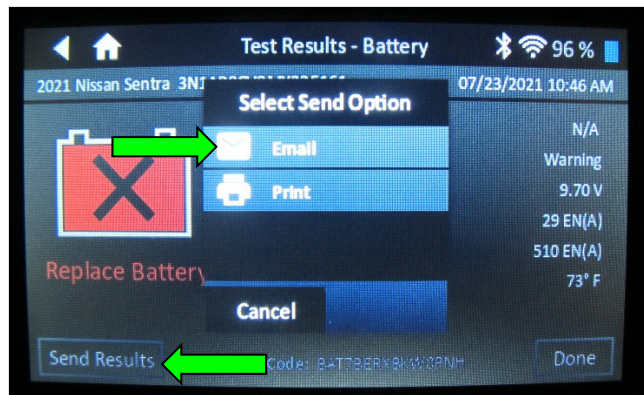
Figure 2

a. Select **Send Results**.

b. Select **Email**.

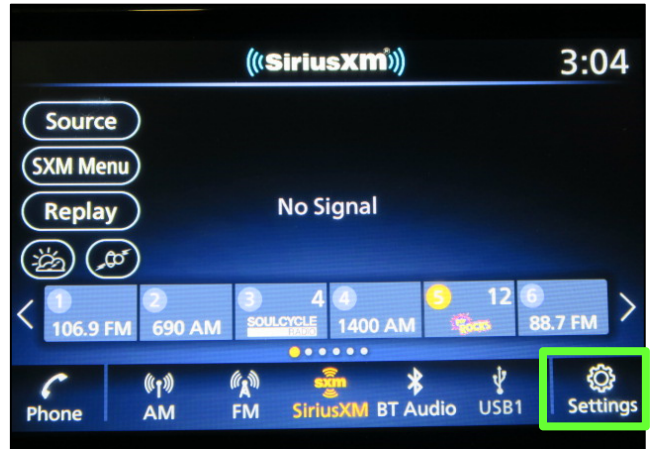
Figure 4

5. Select **Settings**, located in the lower right hand corner of the AV unit display shown in Figure 4.

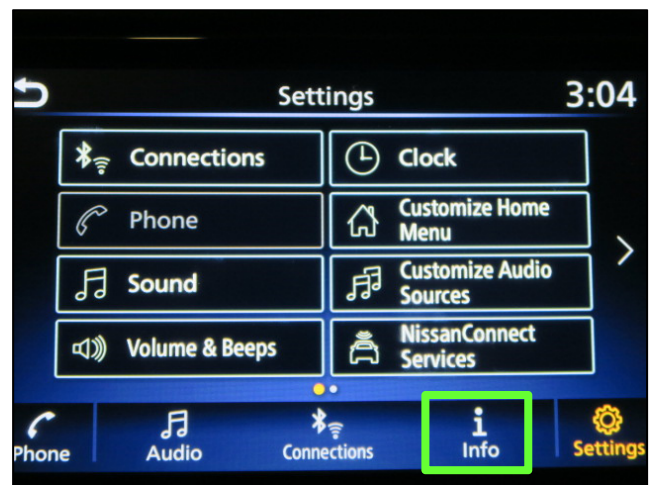
Figure 5

6. Select **Info**.

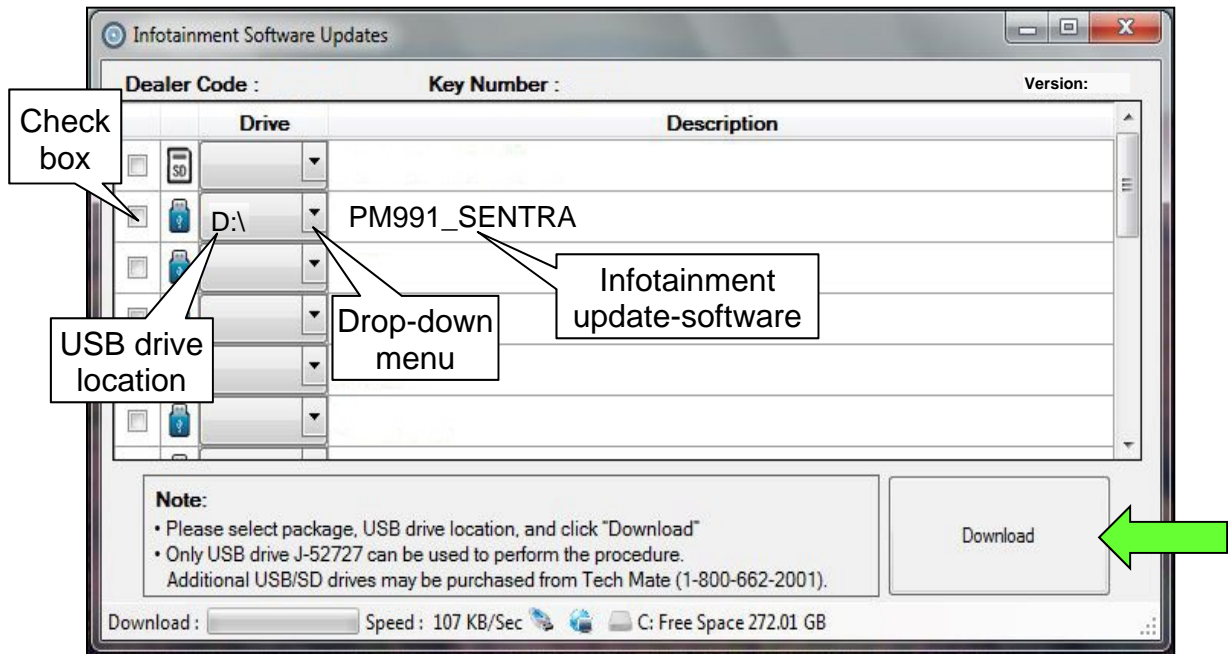
Figure 10

13. Select the check box next to infotainment update-software PM991_SENTRA (Figure 10).
14. Use the drop-down menu and select the location of the USB drive that was inserted in step 10.

- If the software version is NOT 423, start this procedure over and verify that the correct software shown in step 13 on page 9 is downloaded.
- If the software version is 423, the reprogramming is complete.

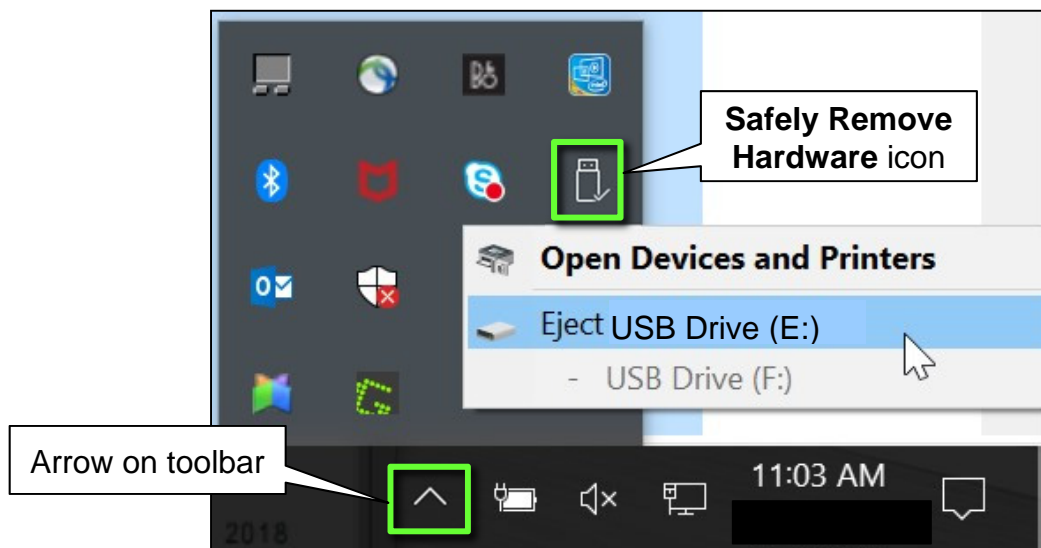
Figure 12

17. Once the transfer is complete, safely remove the USB drive from the CONSULT PC.
 - a. From the PC toolbar, select the **Safely Remove Hardware** icon.
 - The icon is on the toolbar, or can be found after selecting the arrow.
 - b. Select the USB drive to be removed, and then remove the USB drive from the CONSULT PC.

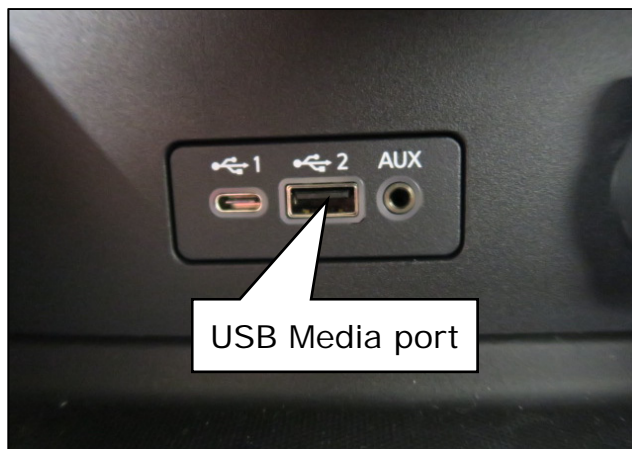
Figure 13

21. Insert the USB drive with the infotainment update-software into the vehicle's USB media port (Figure 13).

- Do not remove the USB drive during the update to the vehicle until instructed to.

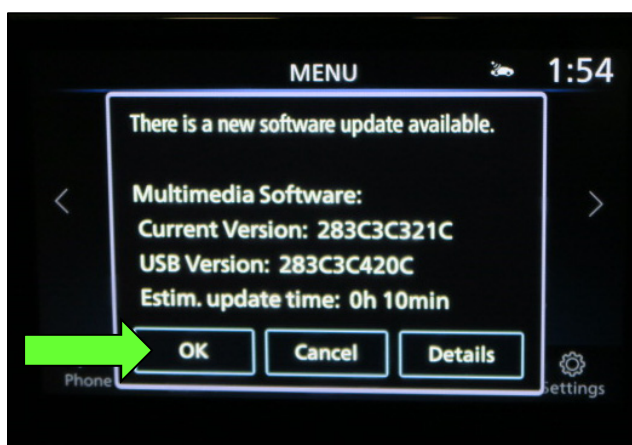
22. Wait approximately 10-30 seconds for the screen in Figure 14 to appear, and then select **OK**.

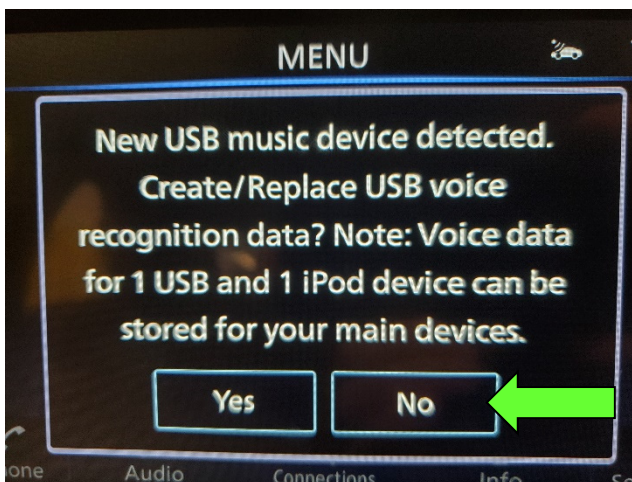
- If the screen in Figure 15 is shown, select **No**.

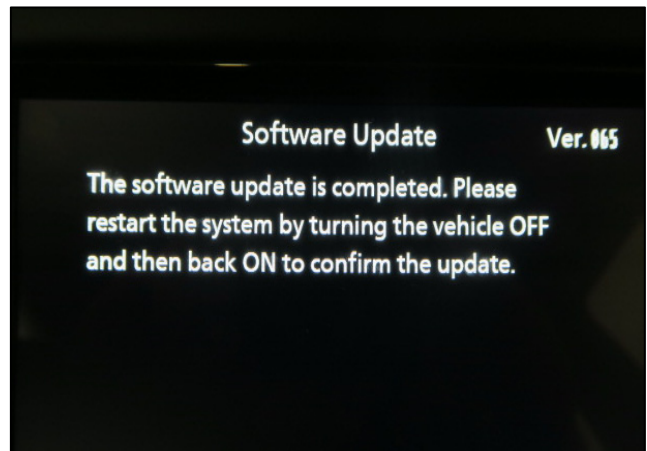
24. When the message shown in Figure 17 is displayed, remove the USB drive from the USB media port.

NOTICE Do not remove the USB drive until Figure 17 is displayed. If removed prior to this screen being displayed, the Audio Control Unit may be damaged.

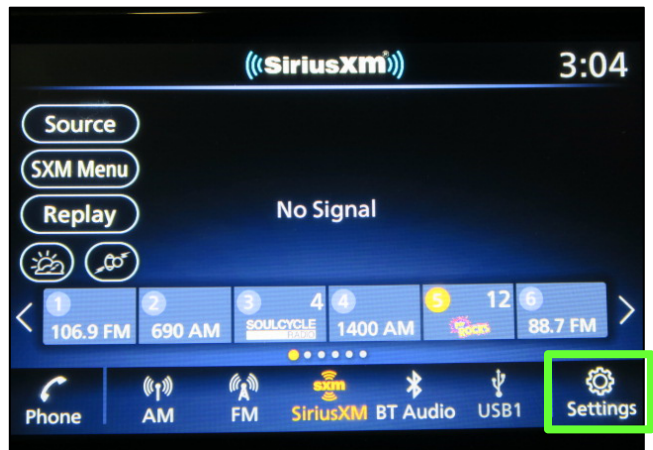
Figure 19

29. Select **Settings**, located in the lower right hand corner of the AV unit display shown in Figure 19.

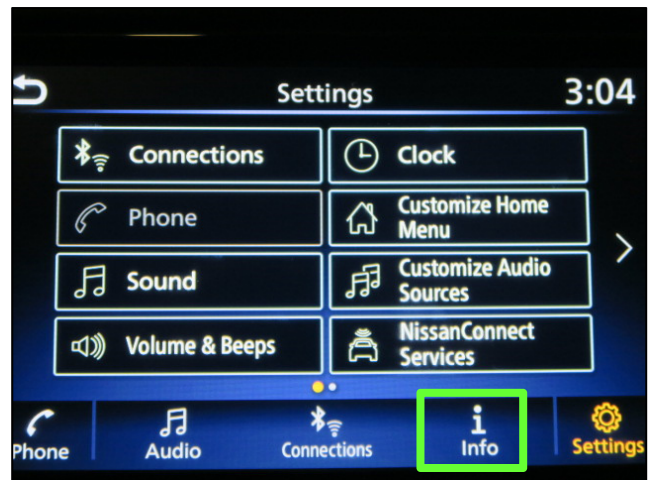
Figure 20

30. Select **Info**.

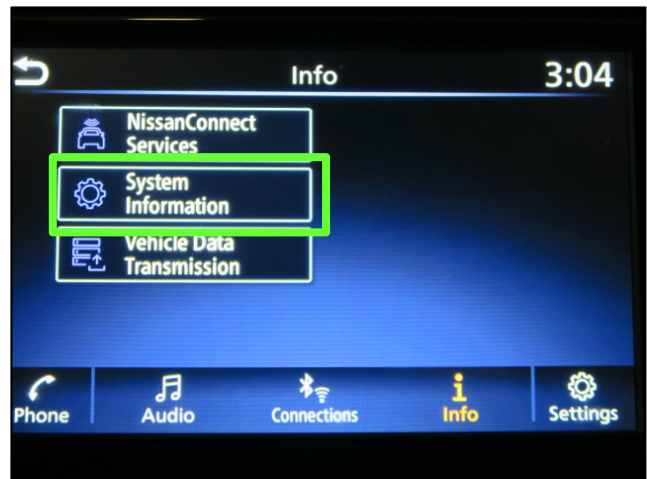
Figure 21

31. Select **System Information**.

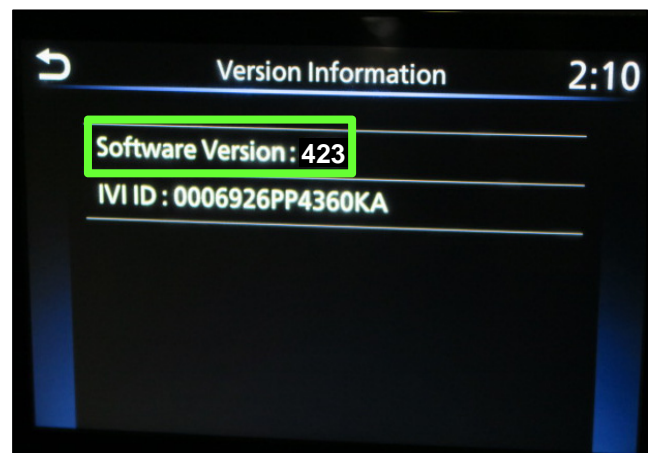
Figure 23

33. Verify the Software Version is now **423**.
