Audio Head Unit Software Update (Denso-Ten)

Service Category Audio/Visual/Telematics

Section Navigation/Multi Info Display

Market USA

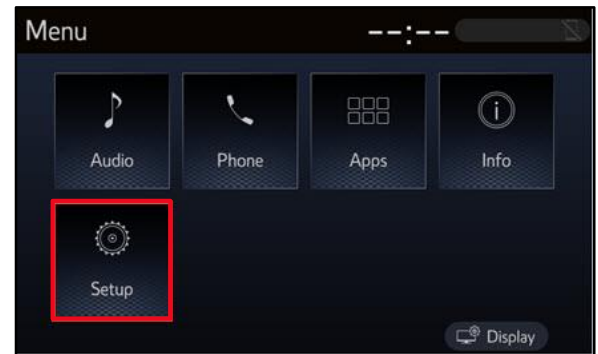
Figure 1.

1. Turn the ignition to IG-ON/Ready-OFF.
2. Is the vehicle currently being updated a 2020 – 2021 model year Highlander, Highlander HV, RAV4 and RAV4 HV, or 2021 model year RAV4 Prime equipped with Premium Audio?
 - **YES** — Continue to step 3.
 - **NO** — Go to step 8.
3. Is the radio experiencing a continuously rebooting condition?
 - **YES** — Continue to step 4.
 - **NO** — Go to step 8.
4. Apply the parking brake.
5. Shift the gear selector to Reverse.
6. Leave the vehicle in Reverse for a minimum of five minutes.
7. After the five minutes have elapsed, shift the gear selector back to Park. The radio will now boot up normally.
8. Press the Menu button on the radio faceplate, then select Setup.

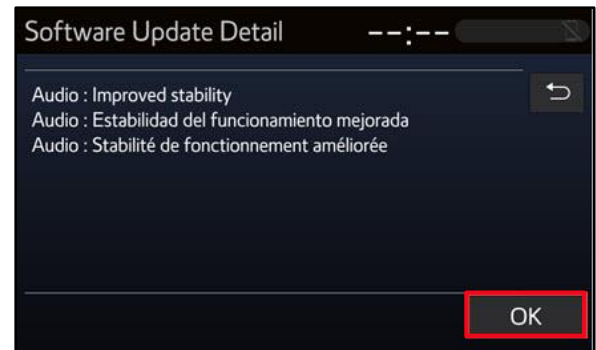
Figure 6.

16. Select OK on the Software Update Detail screen.

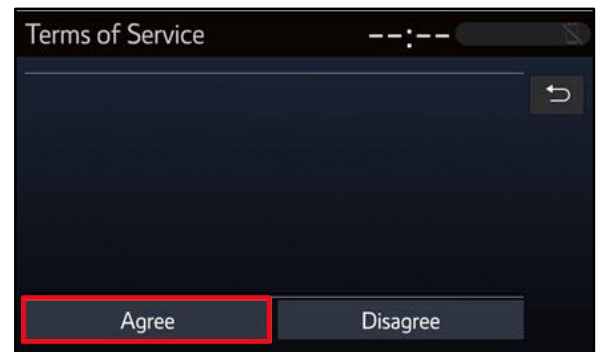
Figure 7.

17. Select Agree on the Terms of Service screen.

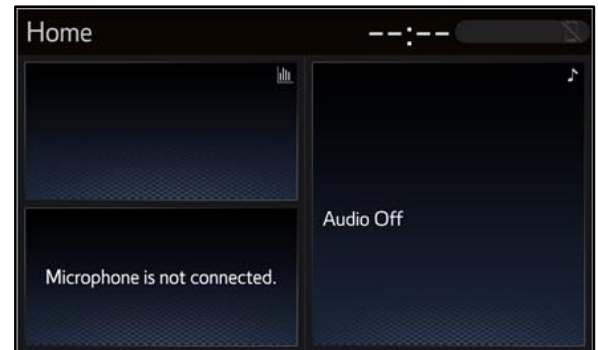
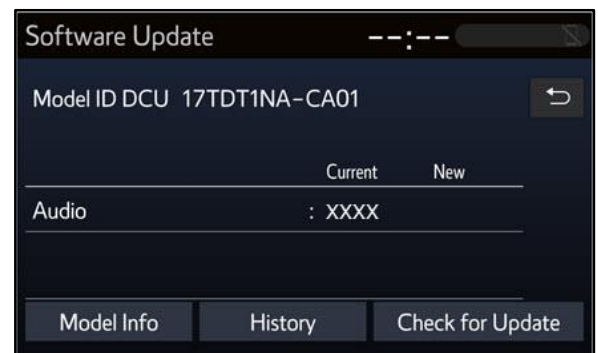
24. Perform steps 9 – 12 to verify the software version matches the current software version information table below.
