GROUP	MODEL
ELE	2019-2022MY Applicable Models Listed
NUMBER	DATE
246 (Rev 1, 09/10/2021)	August 2021

TECHNICAL SERVICE BULLETIN

FRONT VIEW CAMERA REPLACEMENT AND SOFTWARE UPGRADE INSTALLATION

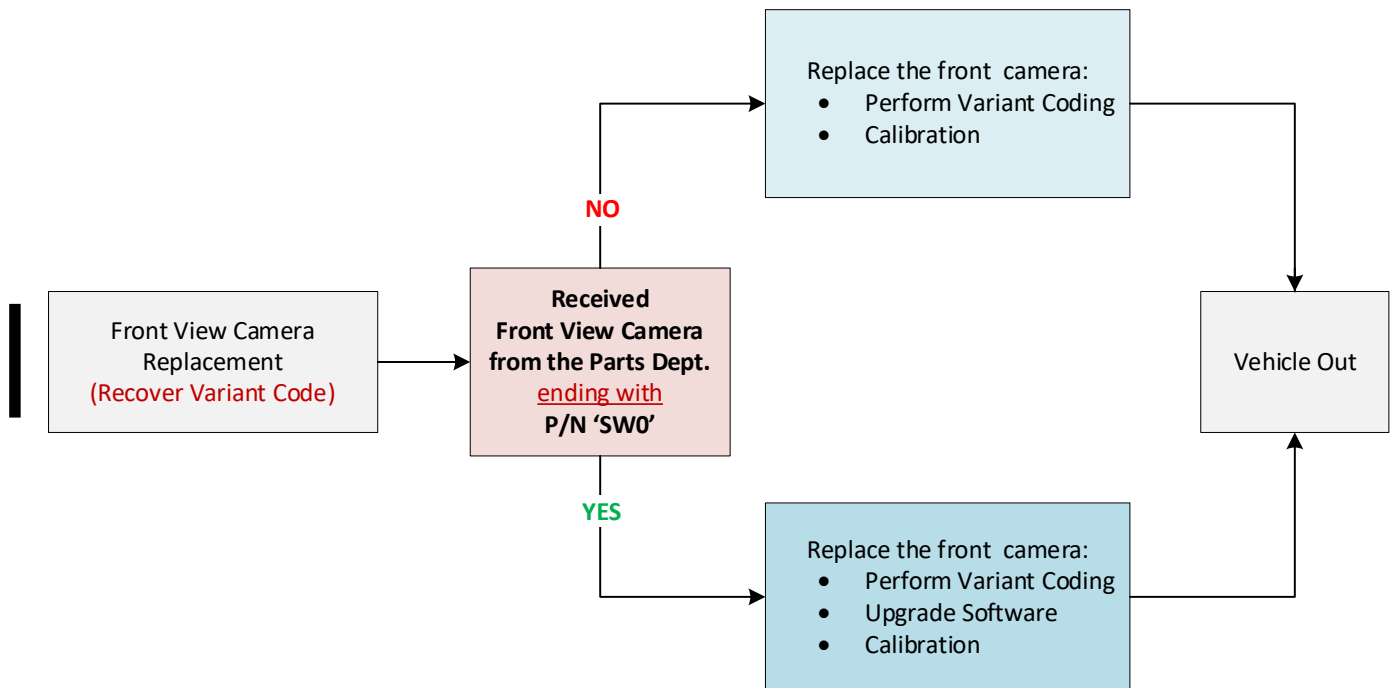
Flowchart:

When replacing the front view camera with a new one, perform the 'Variant Coding' procedure using KDS (Refer to KGIS for further instructions).

Record the prior variant coding value before removing the front view camera. Replace the front camera, apply the variant code from the removed camera and apply the software upgrade to the 'FR_CMR' system using the KDS ECU Upgrade function as described in this bulletin, then proceed to the calibration as described in KGIS.

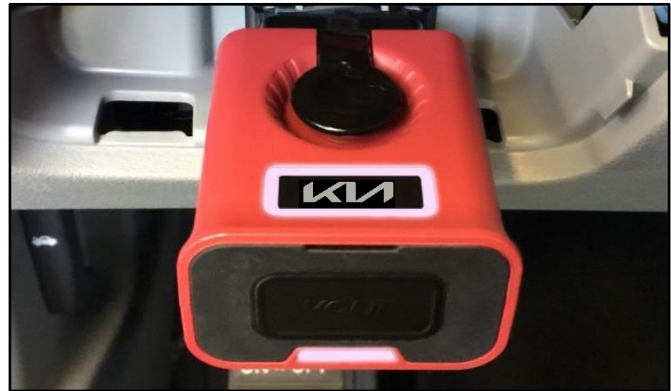
1. Connect the VCI-II to the OBD-II connector, located under the driver's side of the instrument panel.

The ECU upgrade function on KDS operates wirelessly. It is not necessary to perform the upgrade via USB cable.

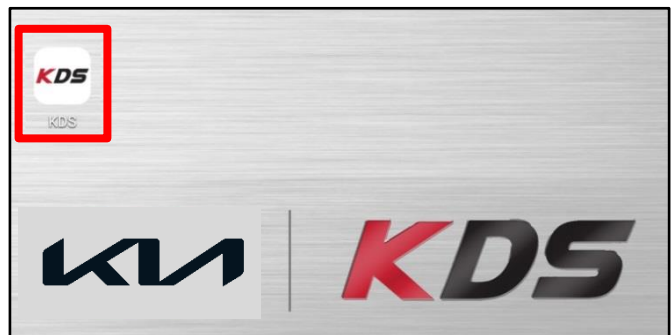
2. With the ignition ON, turn ON the KDS tablet. Select 'KDS' from the home screen.
