Service Action

Code: 93L9

Subject	High-Voltage Charging Unit Software																												
Release Date	September 21, 2021																												
Affected Vehicles

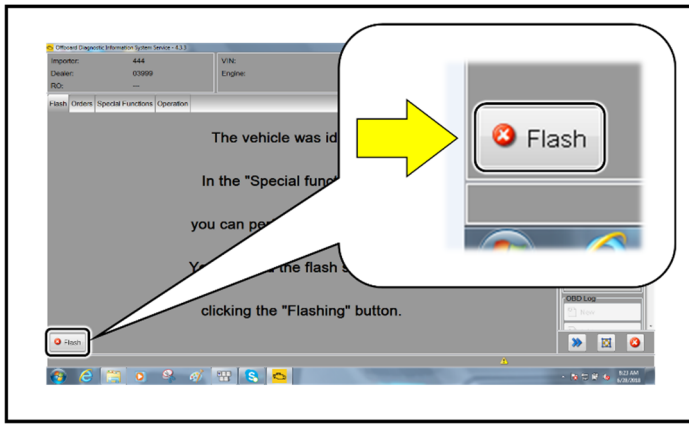
- Click “Flash” to exit the flash session.

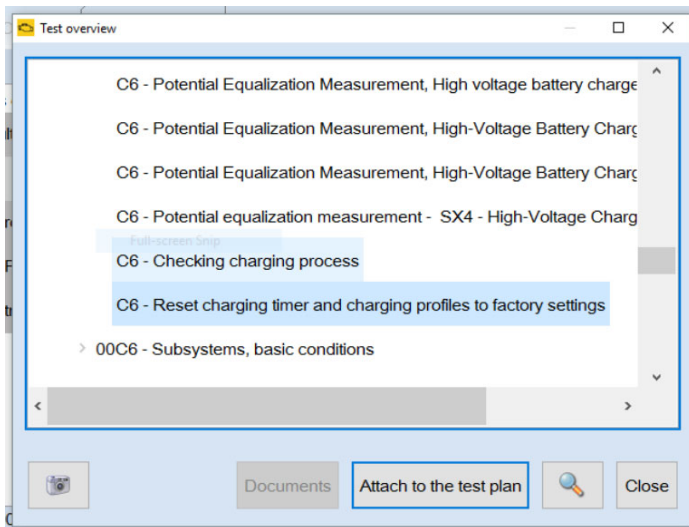
- Perform a GFF Diagnostic Scan of the vehicle.
- Select the Test Plan tab.
- Perform the self test “C6 – *Reset charging timer and charging profiles to factory settings.*”
- Follow the on-screen prompts.
- Exit GFF after the test plan completes.
