**SUBJECT:** **Customer Satisfaction Program 21B49**  
Certain 2021 Model Year Bronco Vehicles Equipped with a Hard Top Roof  
Roof Panel Delamination

In all of the affected vehicles, the exposed or unsealed edges on the molded in color hard top roof may cause an unsatisfactory appearance when exposed to extreme water and humidity. This concern is strictly an appearance issue as the function of the roof is uncompromised.

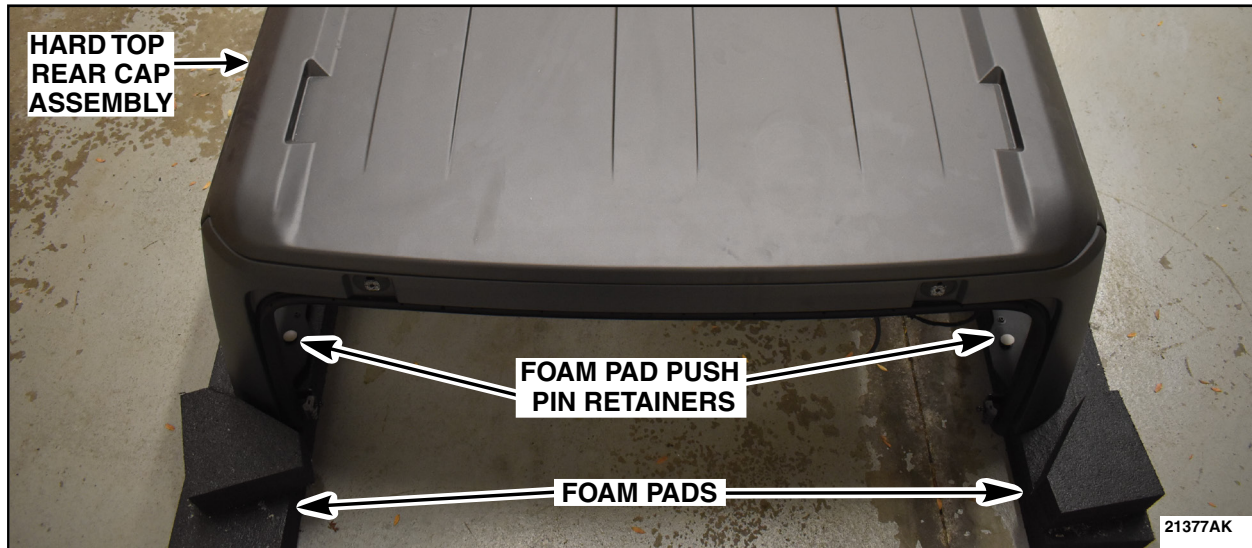
**FIGURE 1**

**NOTE:** At all times, the *new* hard top rear cap assembly must remain on the crate foam protective pads, flat and secure, until it is ready to be installed on the vehicle. See Figure 1.

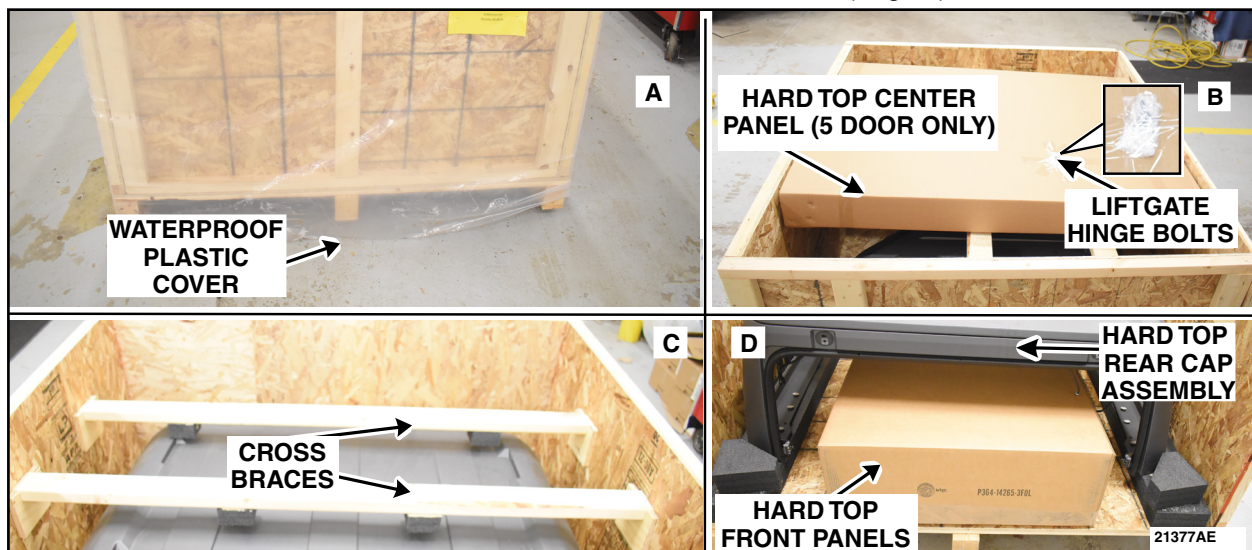
**FIGURE 2**

1. Carefully remove the waterproof plastic cover (A), the top of the crate (B), the cross braces (C), then the end that is screwed in (D). Set aside the cardboard boxes containing the hard top roof panels and the plastic bag containing the liftgate window hinge bolts that will be used later in this procedure. See Figure 2.

2. Carefully remove the hard top rear cap assembly from the crate. The foam protective pads should remain attached to the *new* hard top rear cap assembly until ready to install on the vehicle. Place the lid back on the crate, and secure it in place by installing the two screws back into the end that was removed. Place the *new* hard top rear cap assembly on the shipping crate for the quarter glass installation. Proceed to **FIXED QUARTER GLASS INSTALLATION**. (Page 3)

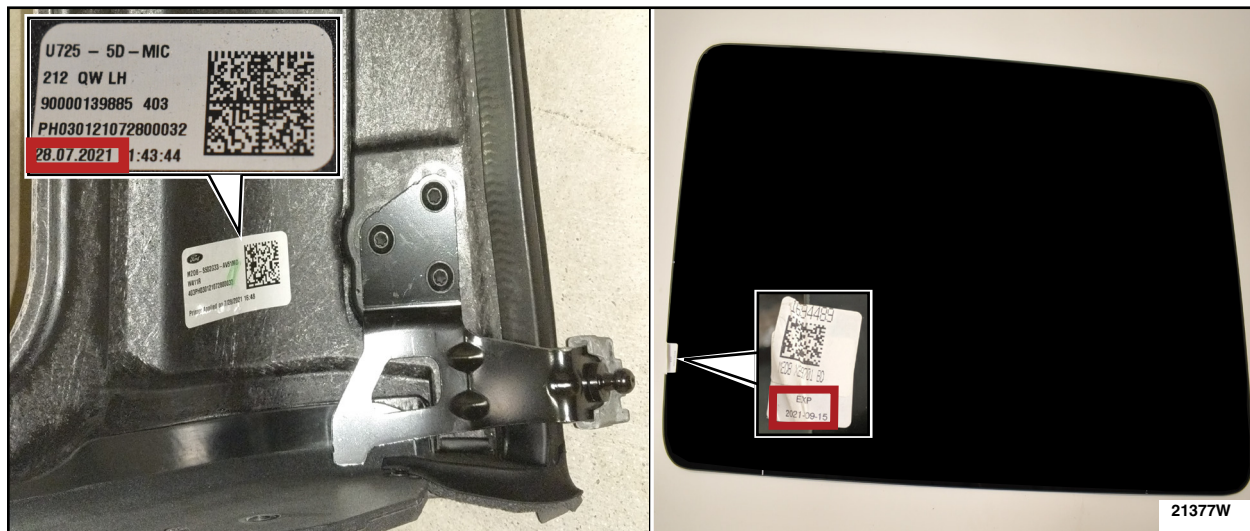
FIGURE 3

2. Inspect the *new* hard top rear cap assembly and the *new* quarter glass labels to make sure the primer has not expired. See Figure 3.

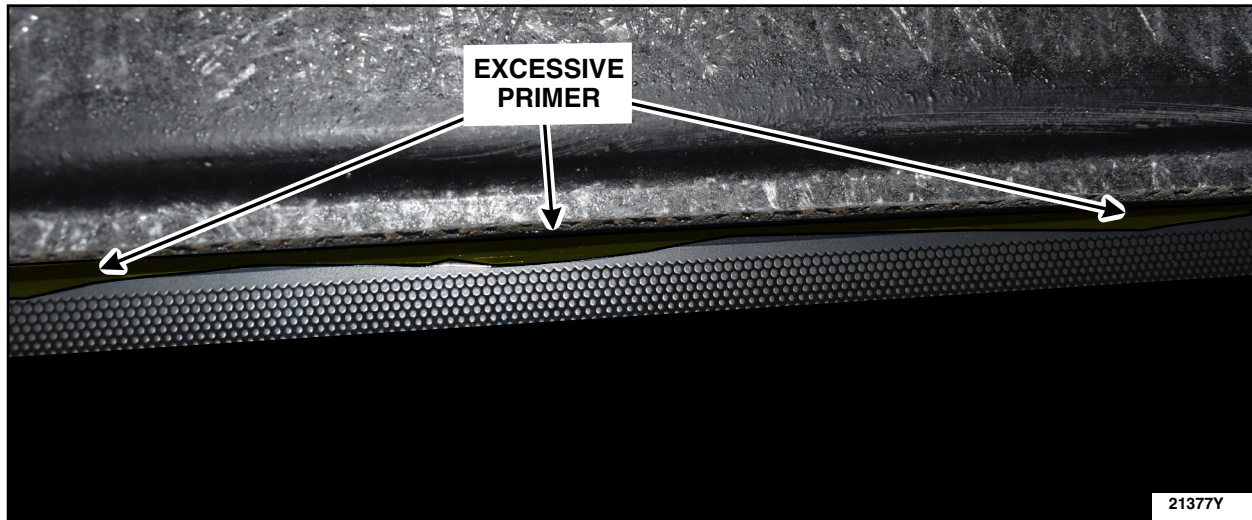
**FIGURE 4**

**NOTE:** Proper placement of the primer is crucial to avoid appearance concerns. Do not allow the primer to cross into the visible portion of the glass. See Figure 4.

**NOTE:** Fixed quarter glass shown installed on the hard top rear cap assembly for clarity. The view is from the inside of the vehicle looking out. See Figure 4.

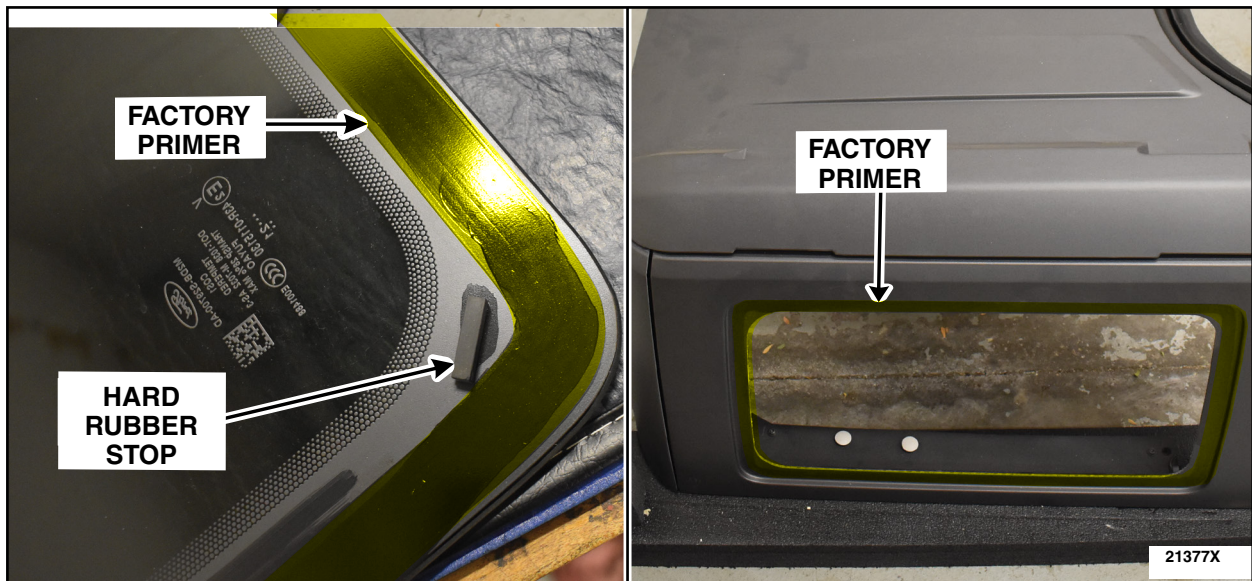
**FIGURE 5**

3. Carefully apply some Sika® Primer-207 or Dow® BETAPRIME™ 5504G primer to the *new* hard top rear cap assembly quarter window glass flanges and to both *new* quarter glass on top of the existing black primer. Minimize applying primer only over the existing black factory primer and allow at least 10 minutes to dry. See Figure 5.

1. Using a clean and dry lint-free cloth, wipe any contamination off the factory primer located on the hard top rear cap assembly quarter glass flanges and on both quarter glass. See Figure 5, on Page 4.

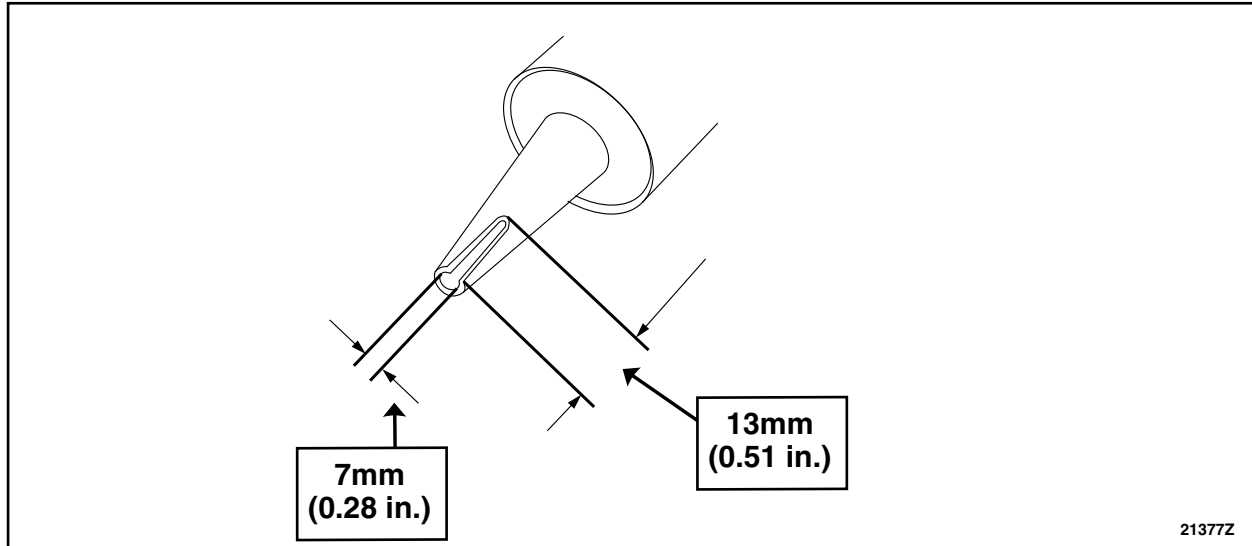
**FIGURE 6**

4. Cut the urethane adhesive applicator tip in triangular shape, to specification. See Figure 6.

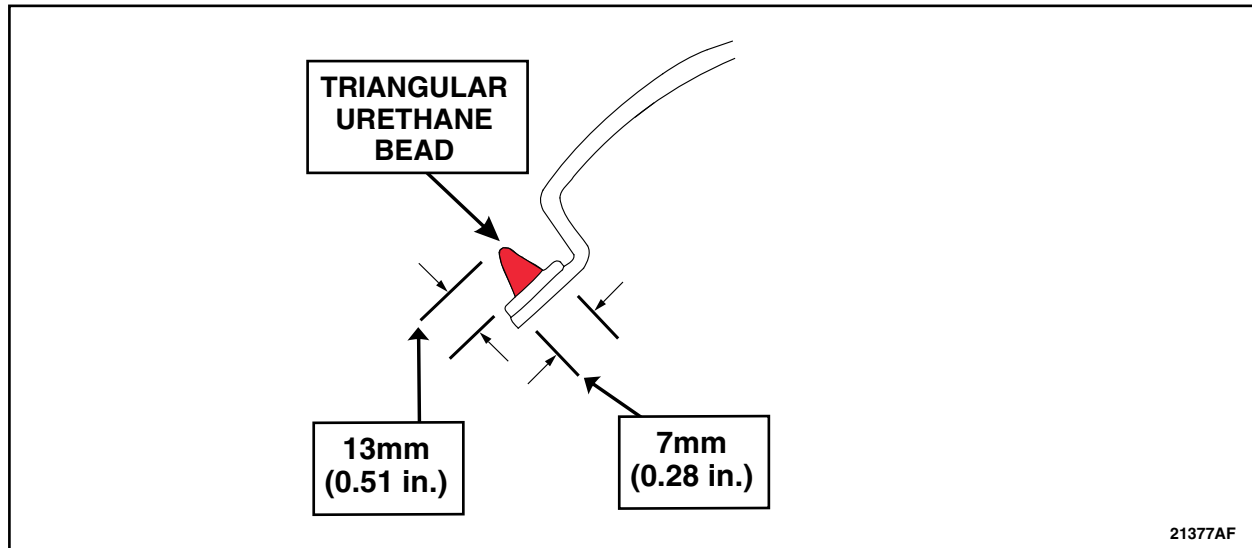
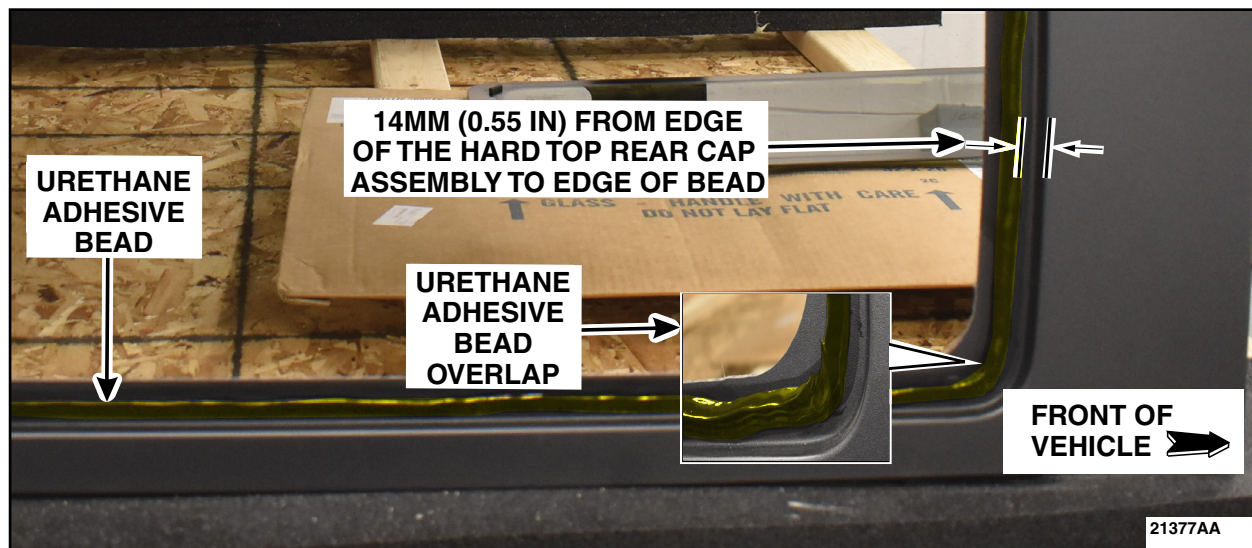
5. Using a mechanical or power caulk gun, apply some SikaTack® (MACH 60/MACH 30) or Dow® BETASEAL™ Express urethane in a triangular bead 7mm (0.28 in) wide by 13mm (0.51 in) high in the center the primed surface of the *new* hard top rear cap assembly quarter window glass flanges and overlap the bead along front edge of *new* hard top rear cap assembly quarter window glass flanges. The position of the urethane bead should be 14mm (0.55 in) from the outer edge of the *new* hard top rear cap assembly flange to the bead. See Figures 7 and 8.

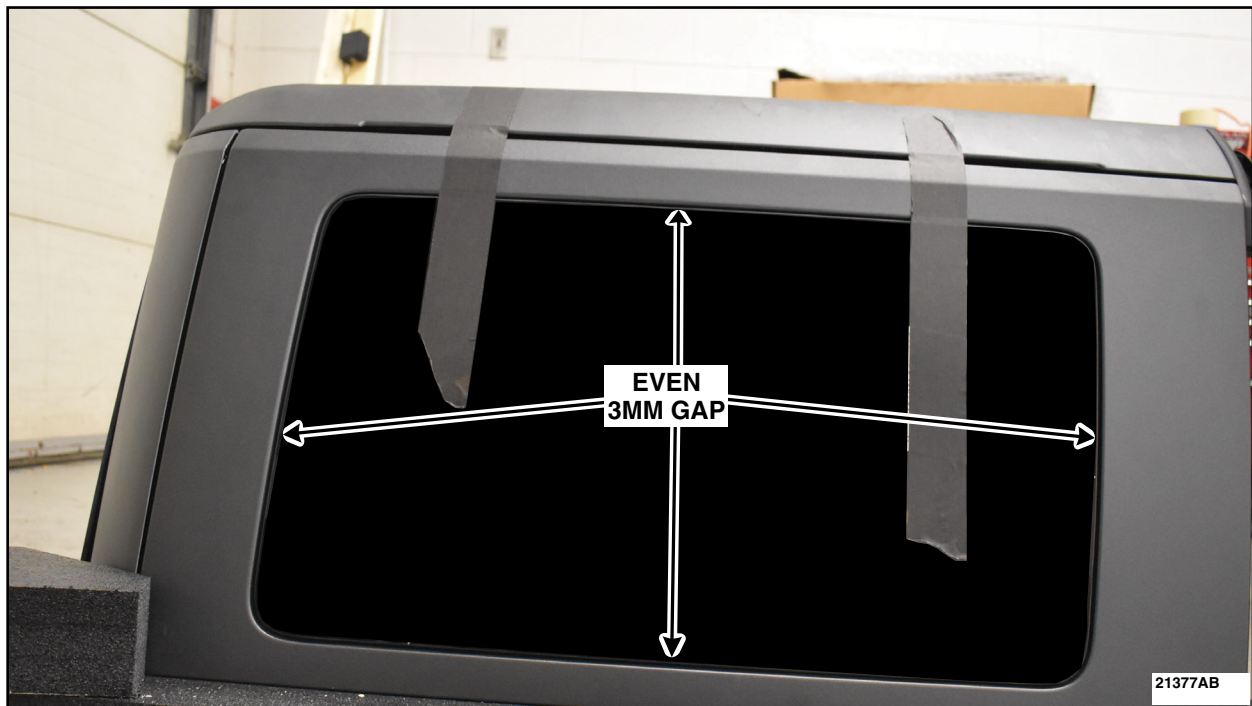
**FIGURE 9**

7. Using 50mm (2 in) wide masking tape, secure the *new* quarter glass to the *new* hard top rear cap assembly while the urethane cures. Ensure there is an even 3mm (0.12) gap all the way around the quarter glass. See Figure 9.

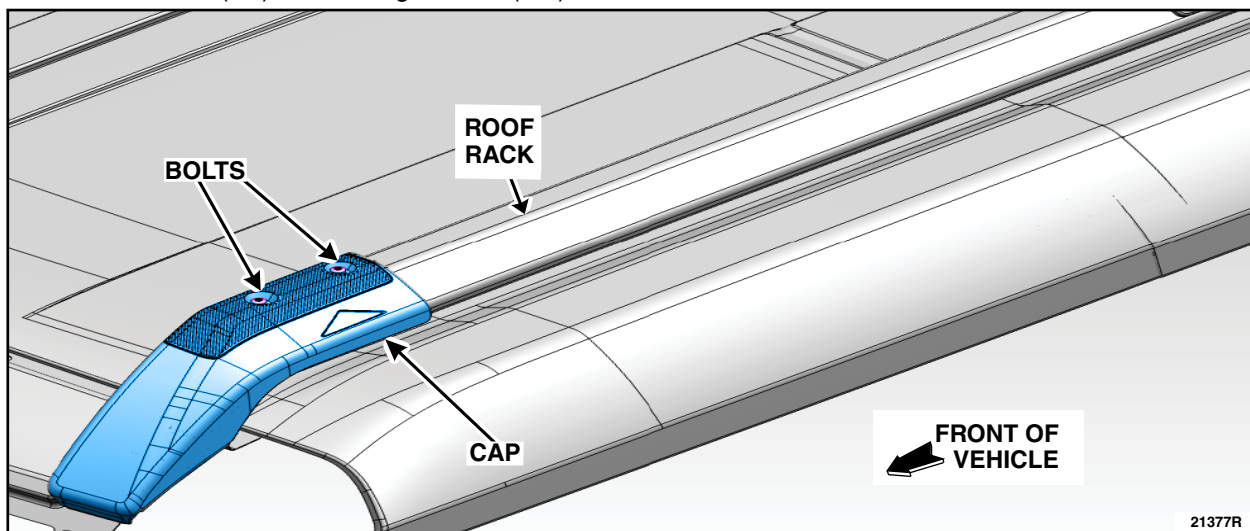
FIGURE 10

2. Remove the bolts and the cap from both sides of the front of the roof rack. See Figure 10.

- Torque: 5.9 lb.ft (8 Nm).

**NOTE:** Left Hand (LH) shown, Right Hand (RH) similar.

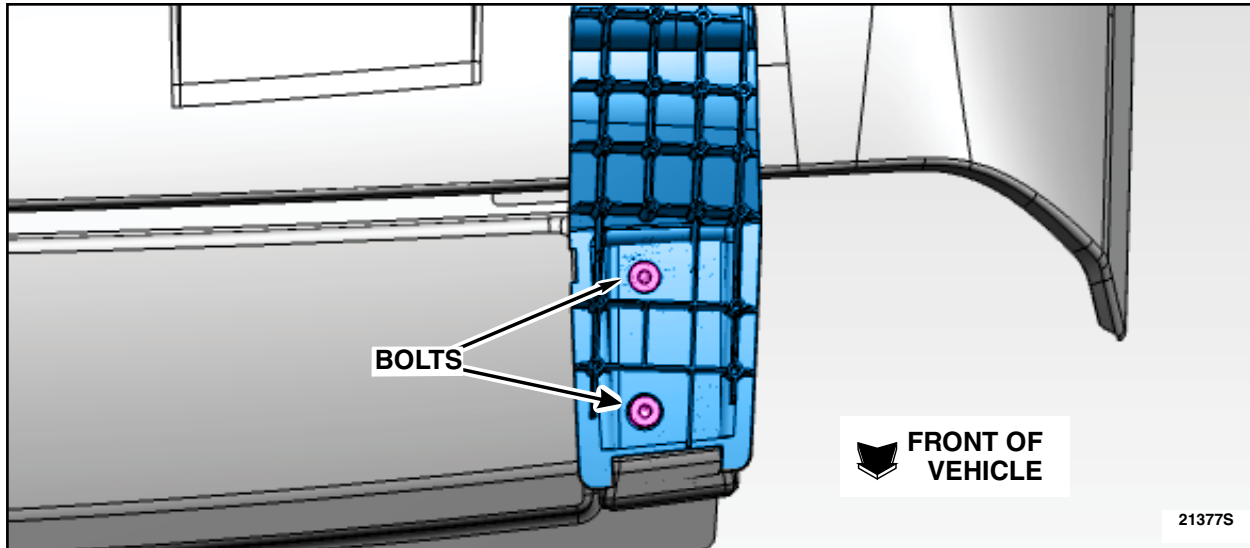
**FIGURE 11**

3. Remove the bolts from both sides of the front of the roof rack. See Figure 11.

- Torque: 7.7 lb.ft (10.5 Nm).

**NOTE:** LH shown, RH similar.

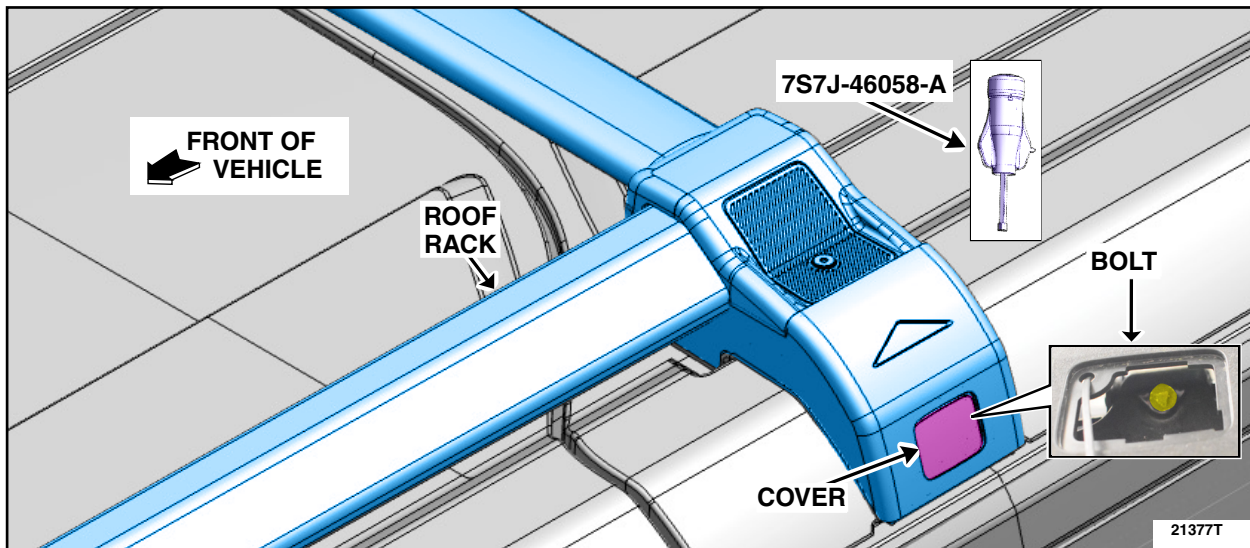
**FIGURE 12**

4. Remove the rear access cover and using the 7S7J-46058-A tool supplied with the roof rack kit (usually located in the glove box), loosen the bolt from both sides of the roof rack. See Figure 12.

**NOTE:** The 7S7J-46058-A tool is preset to the proper torque and will click once proper torque is achieved.

**NOTE:** LH shown, RH similar.

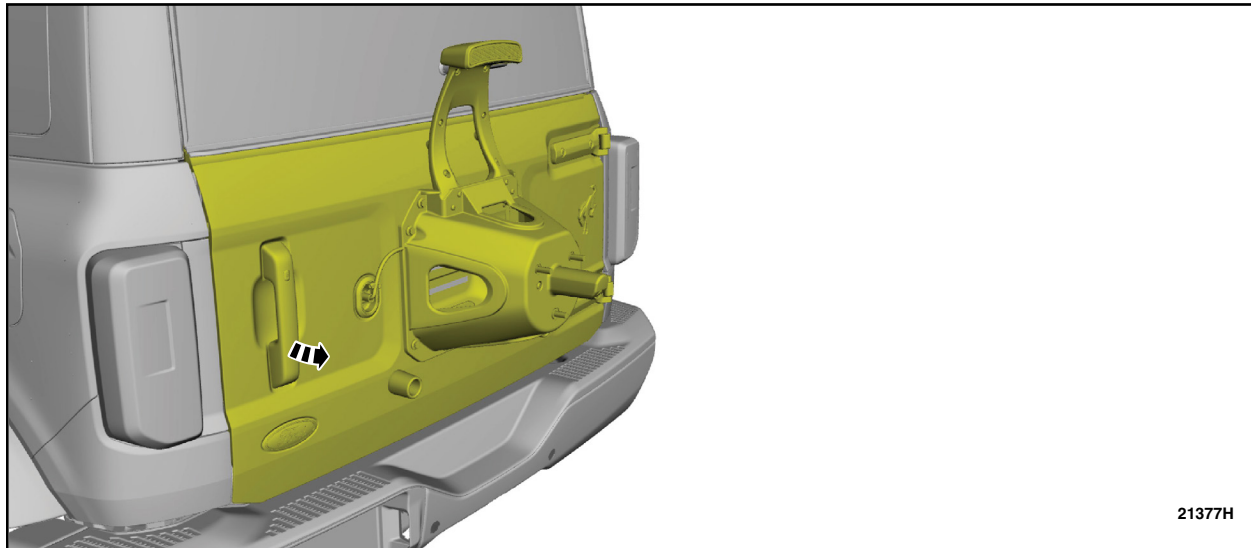
**FIGURE 14**

1. Open the tailgate. See Figure 14.

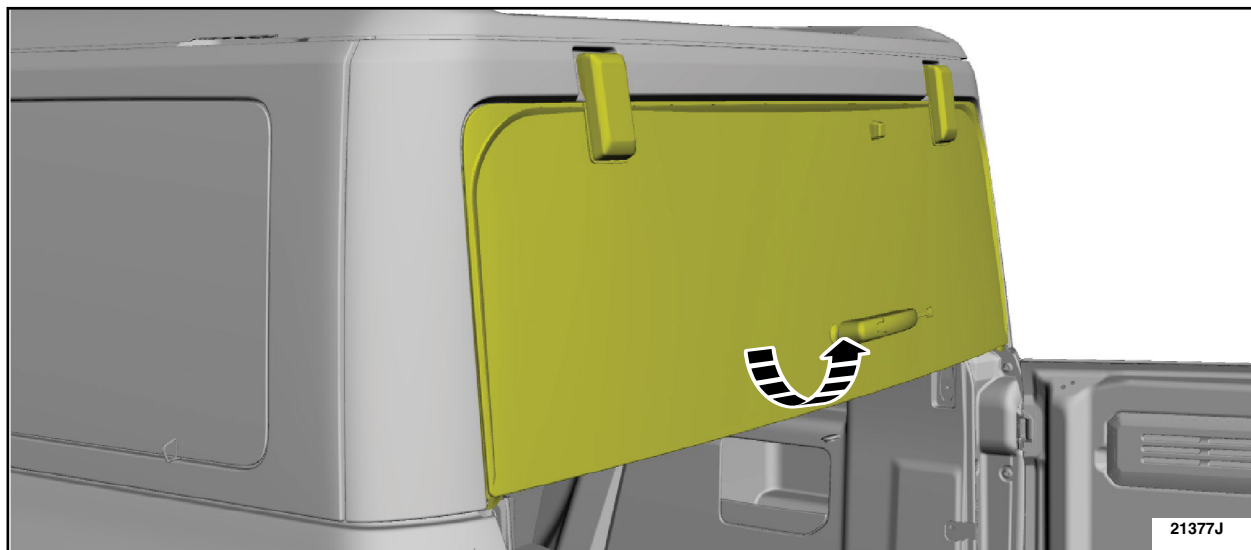
**FIGURE 15**

2. Open the liftgate window glass. See Figure 15.

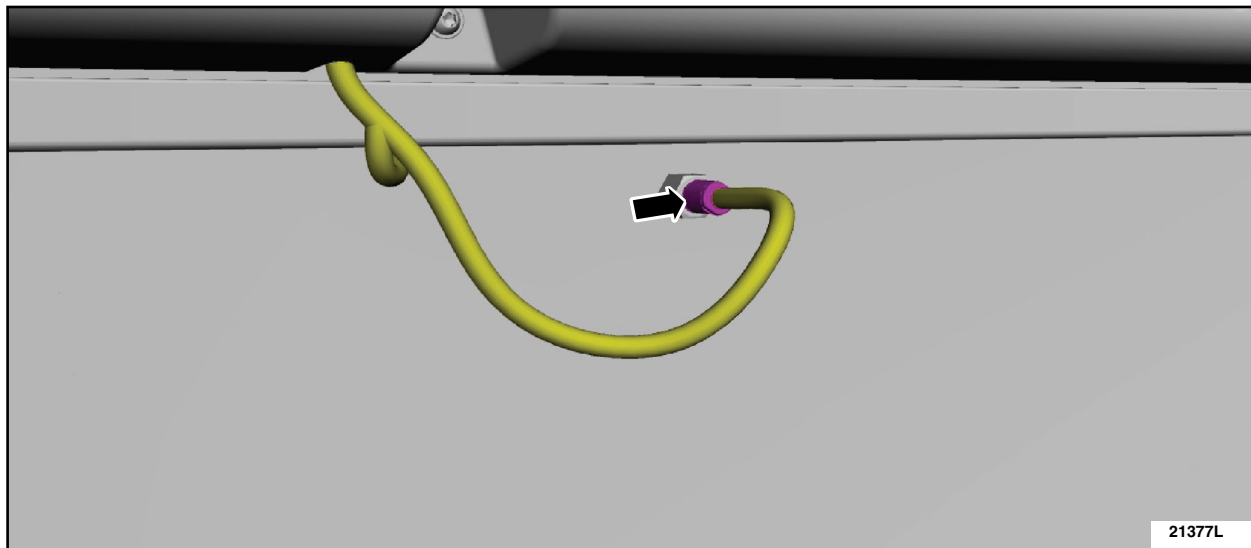
**FIGURE 17**

4. Disconnect the rear window washer hose. See Figure 17.

**NOTE:** Liftgate window glass shown closed for clarity.

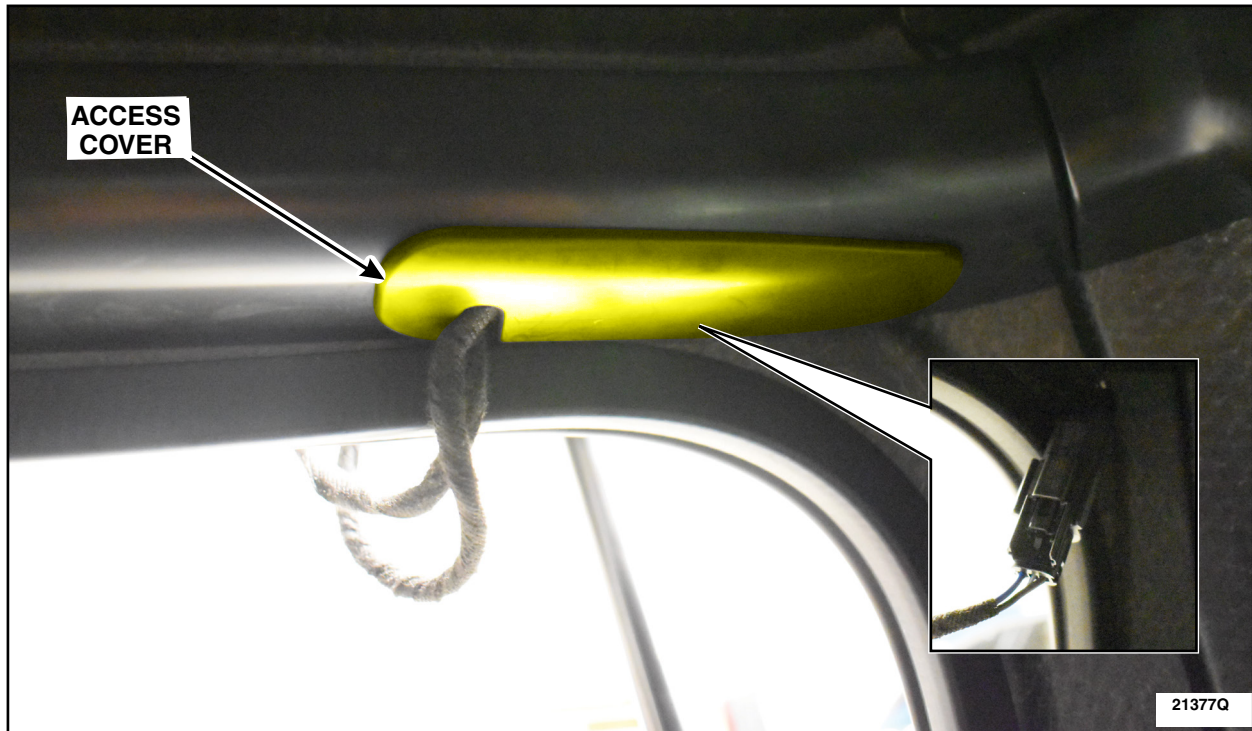
FIGURE 18

5. Remove the access cover located at the rear of the hard top rear cap assembly and disconnect the liftgate window glass electrical connector. See Figure 18.

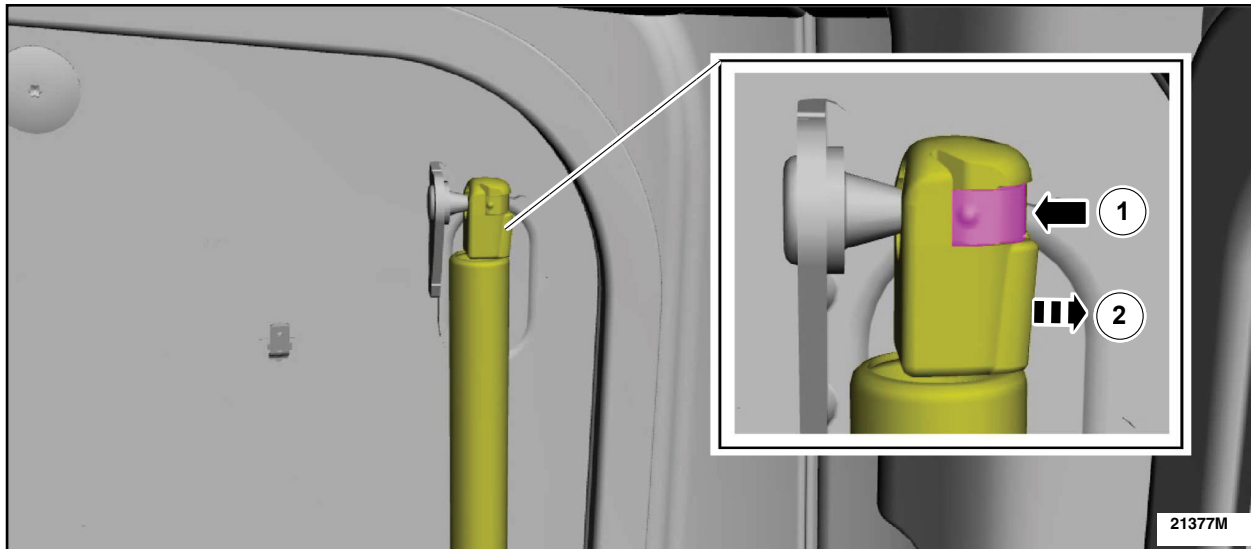
**FIGURE 19**

6. On both sides release the clips and disconnect the rear liftgate window glass strut. See Figure 19.

**NOTE:** Liftgate window glass shown closed for clarity.

**NOTE:** LH shown, RH similar

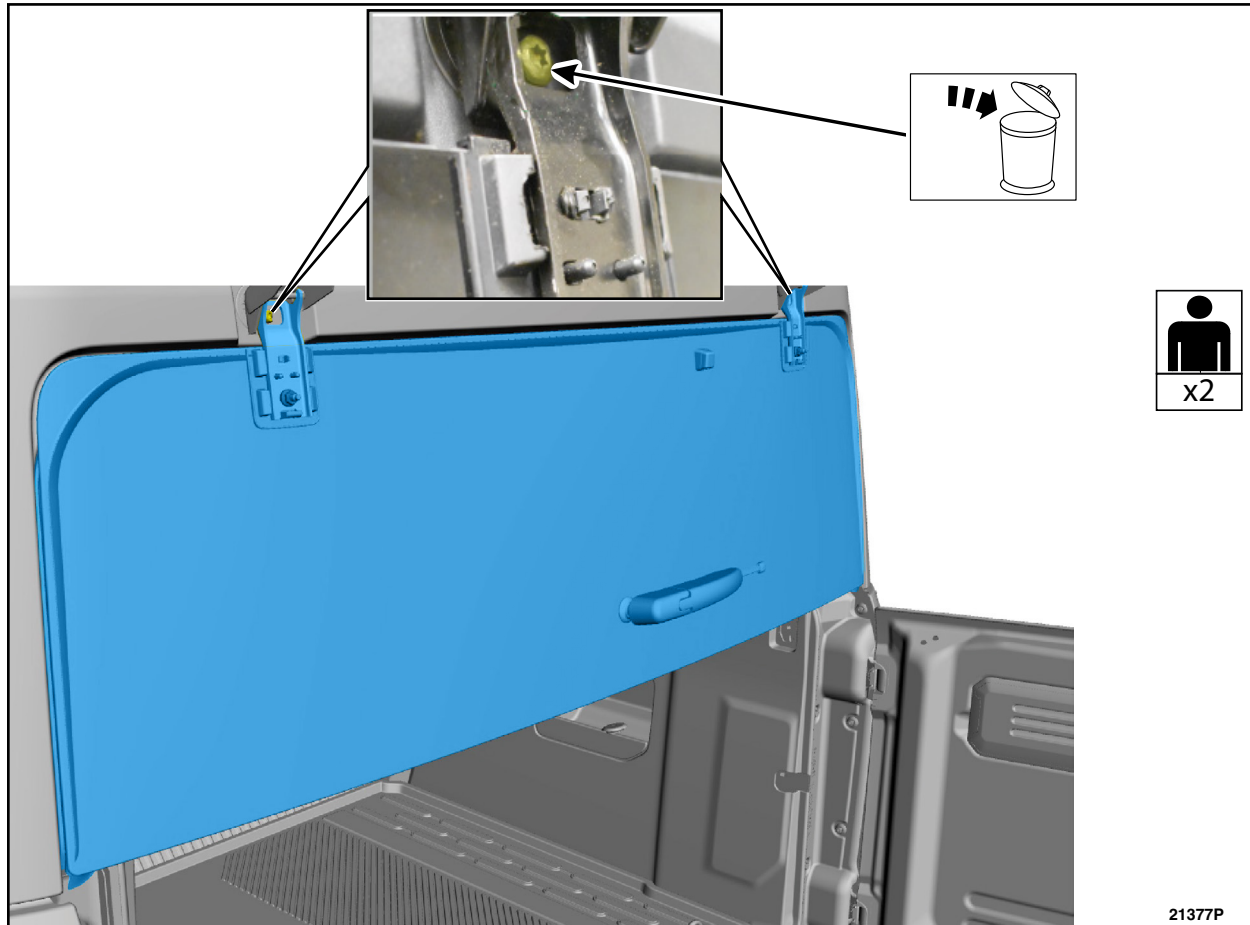
**FIGURE 21**

8. Remove and discard the two liftgate window glass hinge bolts, then remove the liftgate window glass. See Figure 21.

- Torque: 93 lb.in (10.5 Nm).

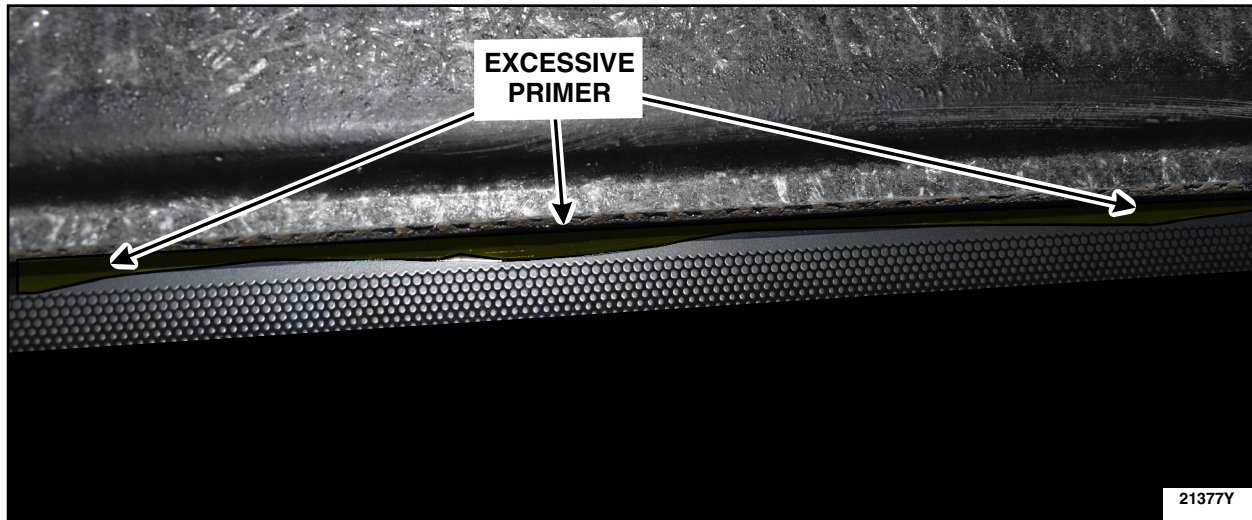
**FIGURE 2**

**NOTE:** Proper placement of the primer is crucial to avoid appearance concerns. Do not allow the primer to cross into the visible portion of the glass. See Figure 2.

**NOTE:** Fixed quarter glass shown installed on the hard top rear cap assembly for clarity. The view is from the inside of the vehicle looking out. See Figure 2.

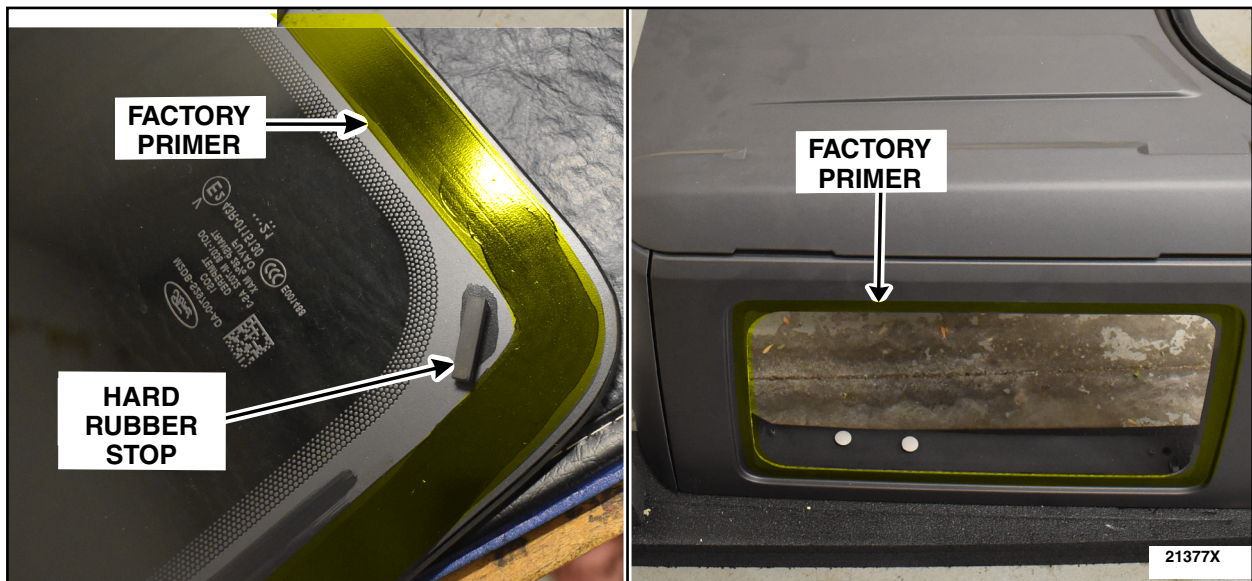
**FIGURE 3**

3. Carefully apply some Sika® Primer-207, Sika® Aktivator PRO or Dow® BETAPRIME™ 5504G primer to the *new* hard to rear cap assembly quarter window glass flanges and to both *new* quarter glass on top of the existing black primer. Minimize applying primer only over the existing black factory primer and allow at least 10 minutes to dry. See Figure 3.

1. Using a clean and dry lint-free cloth, wipe any contamination off the factory primer located on the hard top rear cap assembly quarter glass flanges and on both quarter glass. See Figure 3, on Page 3.

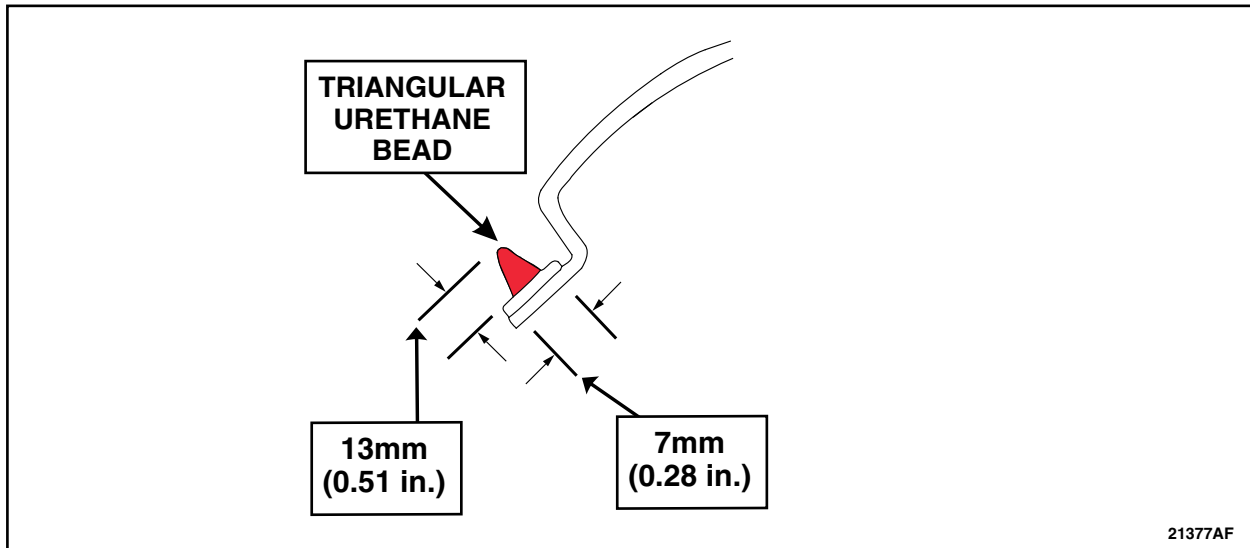
FIGURE 5

5. Using a mechanical or power caulk gun, apply some SikaTack® (MACH 60/MACH 30) or Dow® BETASEAL™ Express urethane in a triangular bead 7mm (0.28 in) wide by 13mm (0.51 in) high in the center the primed surface of the *new* hard top rear cap assembly quarter window glass flanges and overlap the bead along front edge of *new* hard top rear cap assembly quarter window glass flanges. The position of the urethane bead should be 14mm (0.55 in) from the outer edge of the *new* hard top rear cap assembly flange to the bead. See Figures. See Figures 5 and 6.

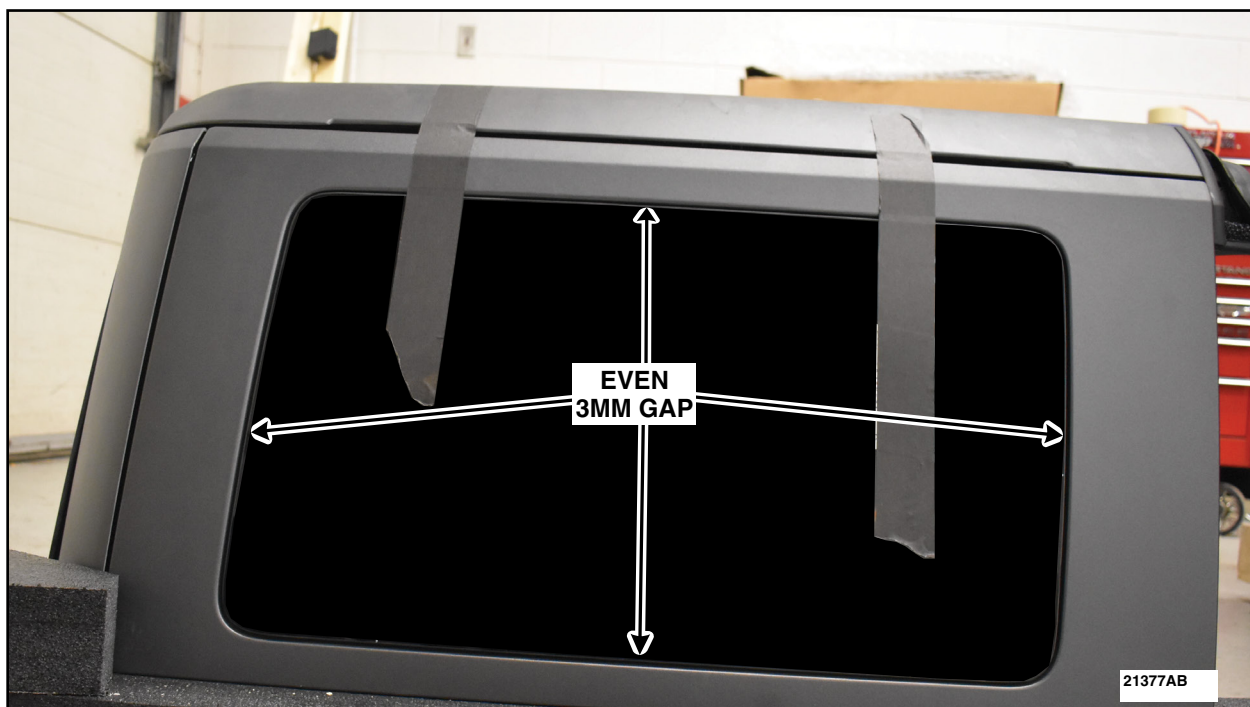
**FIGURE 7**

7. Using 50mm (2 in) wide masking tape, secure the *new* quarter glass to the *new* hard top rear cap assembly while the urethane cures. Ensure there is an even 3mm (0.12) gap all the way around the quarter glass. See Figure 7.
