# Technical product information

<b>Topic</b>	Interior trim - Creak and rattle - Noise identification
<b>Market area</b>	Bentley: worldwide (2WBE),Hongkong-Macau (5HK)
<b>Brand</b>	Bentley
<b>Transaction No.</b>	2056582/4
<b>Level</b>	EH
<b>Status</b>	Approval
<b>Release date</b>

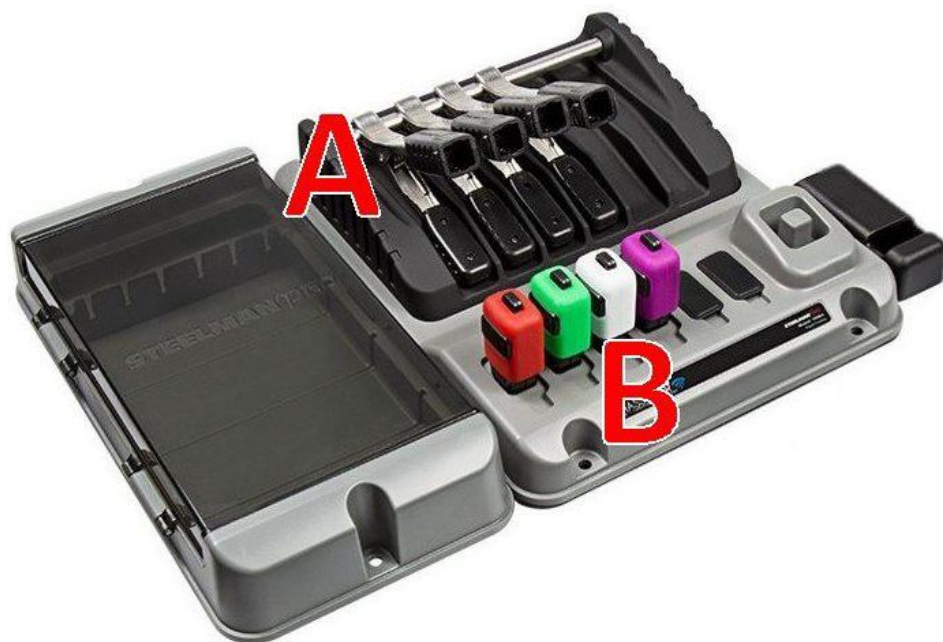
3) Referring to Figure 1 - Using the sensor clamp/s (Point A) and Bluetooth module/s (Point B) provided in the kit - Record the noise

TIP: In order to locate the noise it could be necessary to use multiple clamp and module assemblies, the operative must refer to the appropriate user instructions

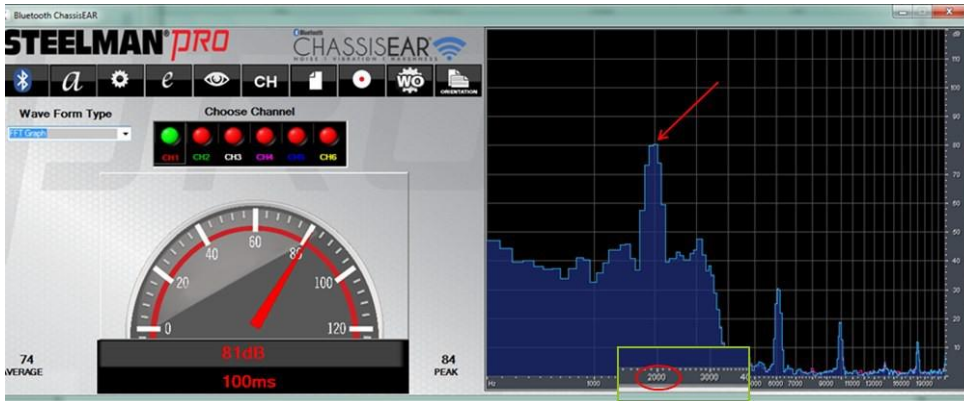
TIP: To capture the frequency - Select 'FFT Graph' as Wave Form Type (Figure 2) and read the peak achieved during the recording as highlighted in Figure 2 (in this EXAMPLE the frequency is 2000Hz)
