**Complaint – Charging is Canceled / Check Engine Warning Light is Active: Re-Program High-Voltage Charger (OBC) Control Unit (36/21)**

Vehicle Type: **Panamera 4 E-Hybrid (971)  
Panamera 4S E-Hybrid (971)**

Concerns: **High-voltage charger (OBC) control unit (3.6 kW)**

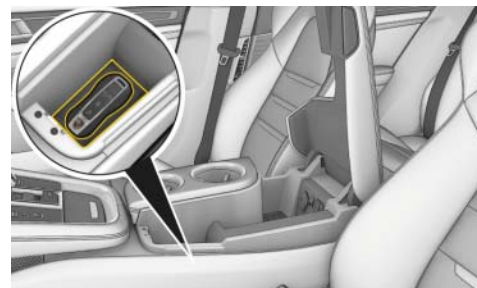
*Emergency start tray*

- Work Procedure: 1 Place the driver's key with the back facing down into the front left storage compartment in the center console (emergency start tray) to guarantee a continuous radio link between the vehicle and the driver's key ⇒ *Emergency start tray*.
- 2 Carry out general preliminary work for control unit programming as described in ⇒ *Workshop Manual '9X00IN Basic instructions and procedure for control unit programming - section on "Preliminary work"*.

- If the driver's key is not recognized in the vehicle, programming cannot be started or will be interrupted.
- ⇒ Place the driver's key with the back facing down into the front left storage compartment in the center console to guarantee a continuous radio link between the vehicle and the driver's key.

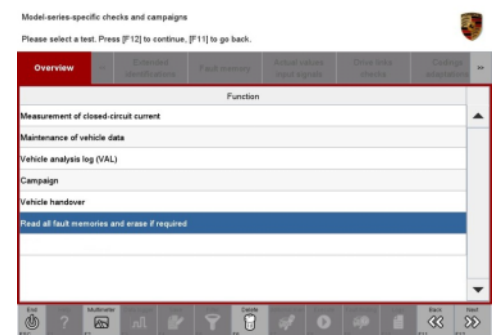
*Erasing fault memories*

- 2.1 Press **•F7** in the control unit selection screen ('Overview' menu) to call up the Additional menu.
- 2.2 Select the function 'Read all fault memories and erase if required' and press **•F12** ('Next') to confirm your selection ⇒ *Erasing fault memories*.

- 2.4 Press **•F8** to delete fault memory entries.

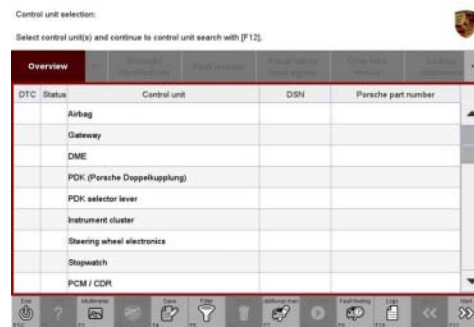
Control unit selection

- 2.6 Once you have erased the fault memories, select the **'Overview'** menu to return to the control unit selection screen ⇒ *Control unit selection*.
