SERVICE BULLETIN

Classification: AT21-004	Reference: NTB21-086	Date: September 14, 2021
-----------------------------	-------------------------	-----------------------------

A/T WARNING LIGHT IS ON WITHOUT PAST OR CURRENT DTC STORED

APPLIED VEHICLES: 2020-2021 Titan/Titan XD (A61)
2020-2021 Frontier (D40)
APPLIED TRANSMISSION: 9 Speed (GE9R01A)

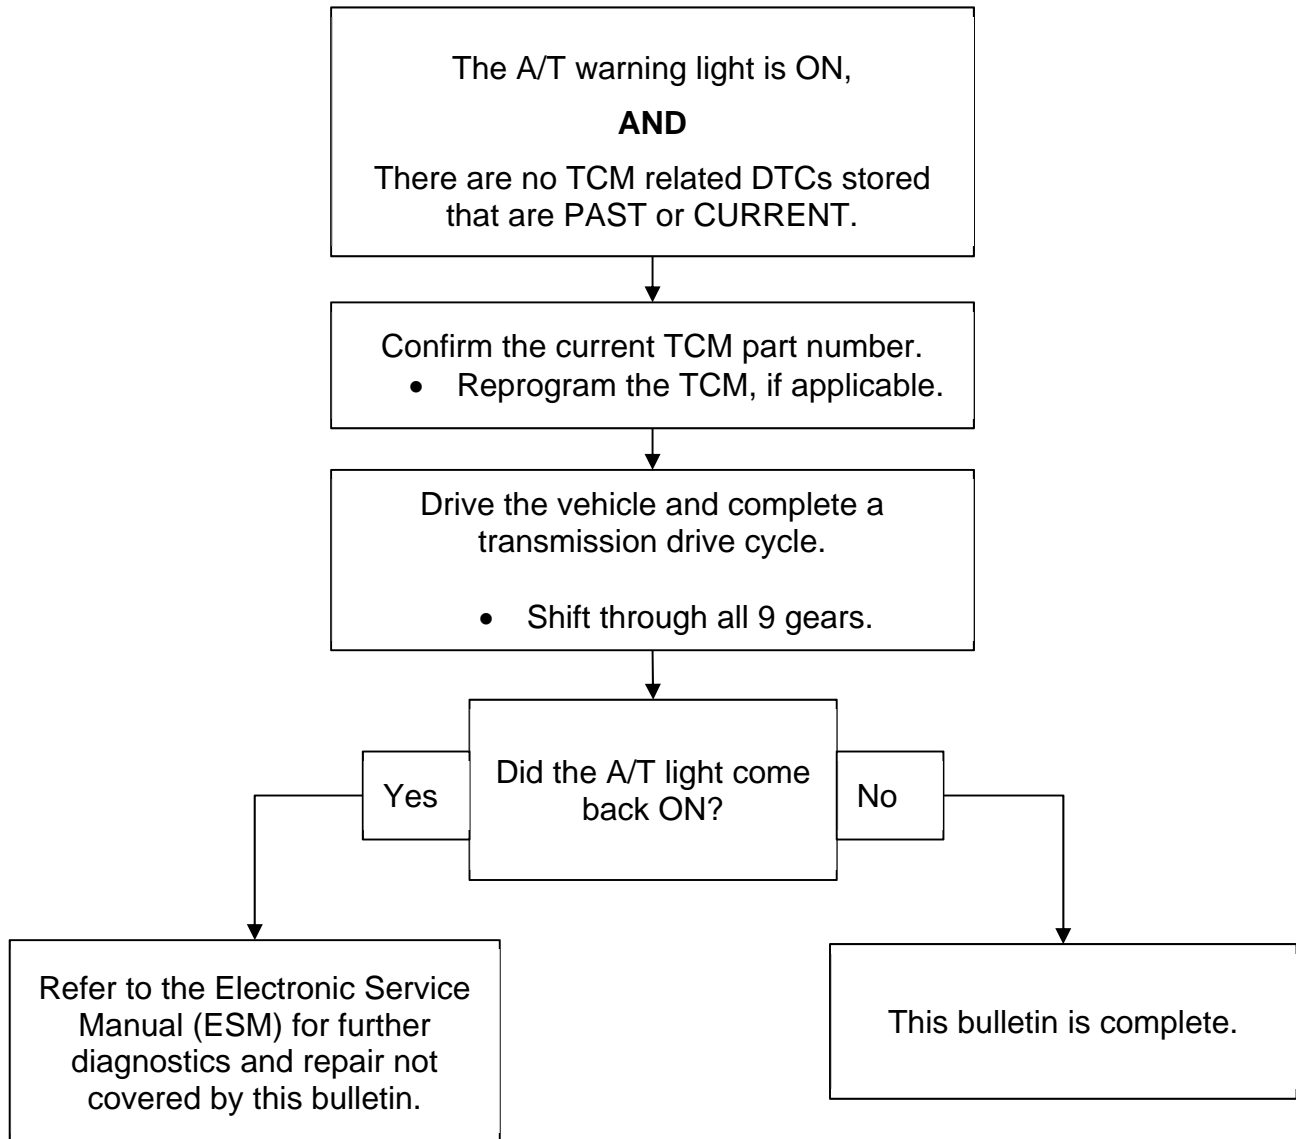
Repair Overview

1. Confirm the current TCM part number.
2. Reprogram the TCM, if applicable.
3. Drive the vehicle and complete a transmission drive cycle.
4. Confirm that the A/T warning light does not come back ON.
 - See the **Repair Overview** on page 2.

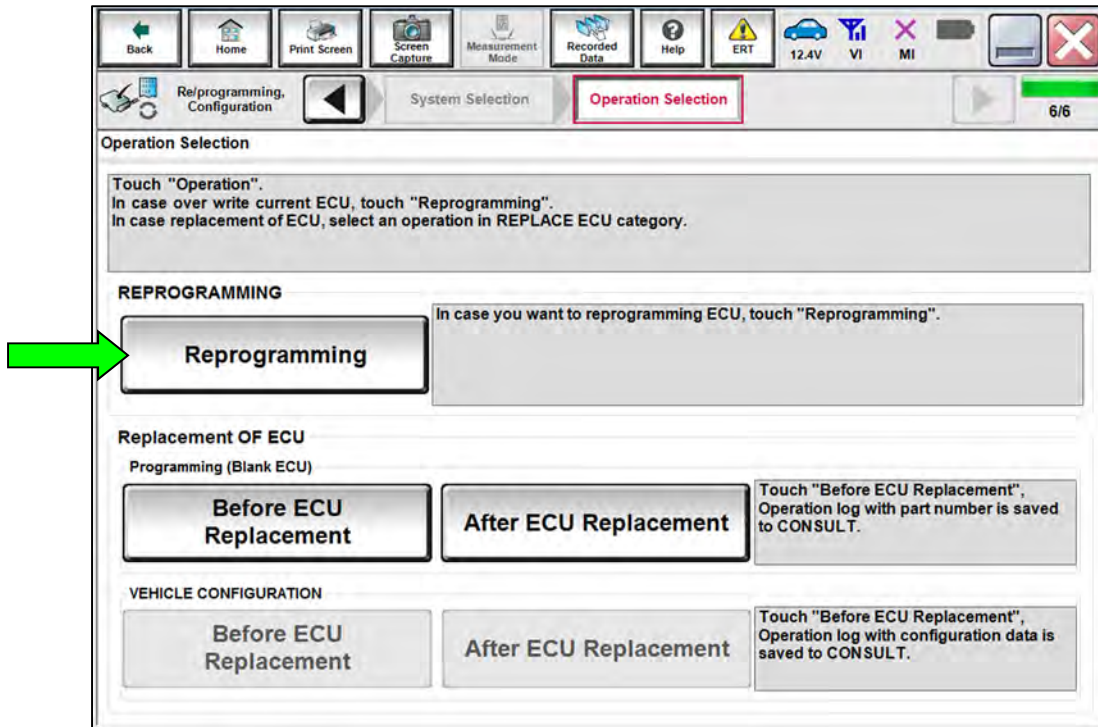
Figure 9

13. Select **Reprogramming**.

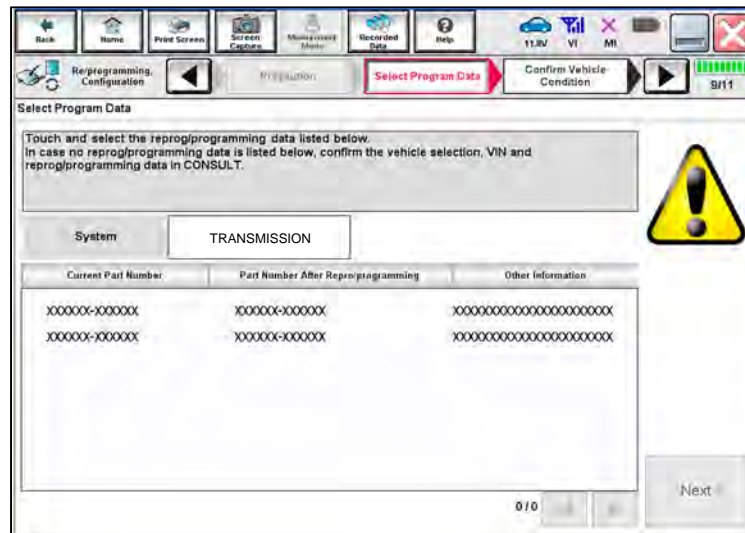
NOTE: In some cases, more than one new P/N for reprogramming is available.

- If more than one new P/N is available, the screen in Figure 11 displays.
- Select and use the reprogramming option that does **not** have the message “Caution! Use ONLY with NTBXX-XXX”.
- If you get this screen and it is blank (no reprogramming listed), it means there is no reprogramming available for this vehicle.

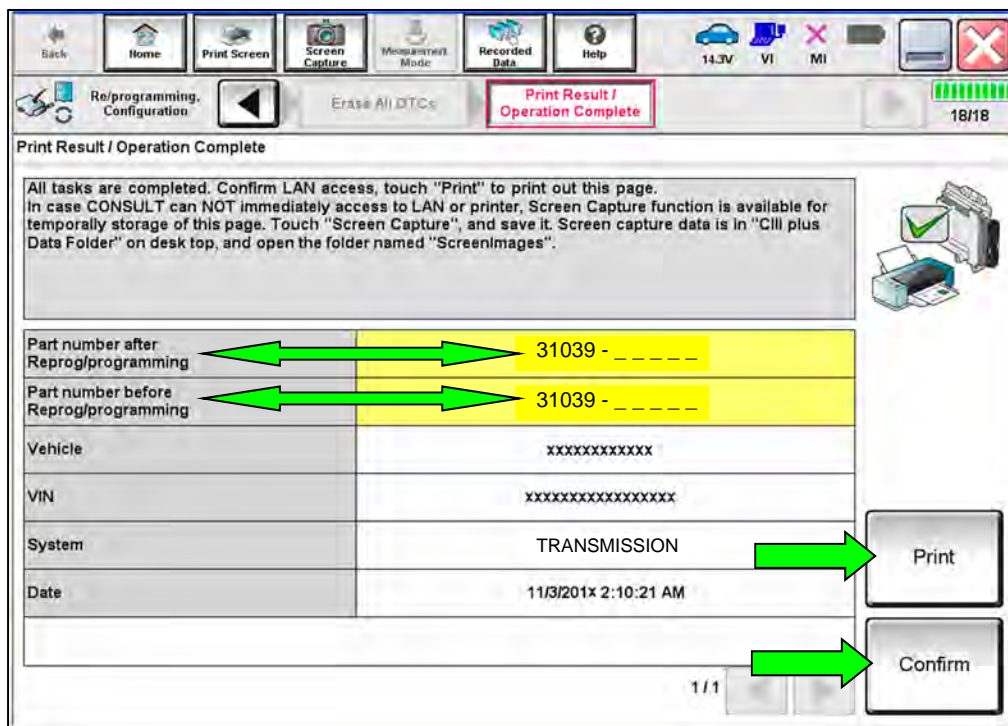
20. Follow the on-screen instructions to **Erase All DTCs**.
 - When the entire reprogramming process is complete, the screen in Figure 17 will display.
21. Verify the before and after part numbers are different.
22. Print a copy of this screen (Figure 17) and attach it to the repair order for warranty documentation.
23. Select **Confirm**.
