## Insufficient charging or no wireless charging with iPhone 12

| Topic number | LI82.70-P-073025 |
| Validity | All Model series with SA code 897 or 899 |

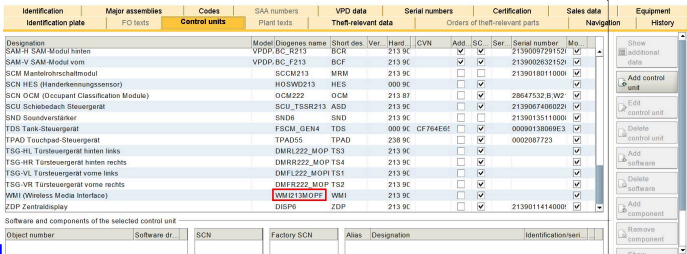
| Attachments | |
|---|---|
| <p><a href="#">WMI control unit variant Ve-</a></p> <p><a href="#">doc.jpg</a></p> | WMI control unit variant as seen in Vedoc |
| <p><a href="#">WMI control unit variant</a></p> <p><a href="#">QT.jpg</a></p> | WMI control unit variant as seen in a quick test |

Note: The Mobile phone cradle control unit variant can be seen on an initial quick test or in Vedoc under "control units" -> "Diogenes name" (see attachments)
